Weapons of Tank Battalions Illustrations

Chapter 3: Medium Tanks

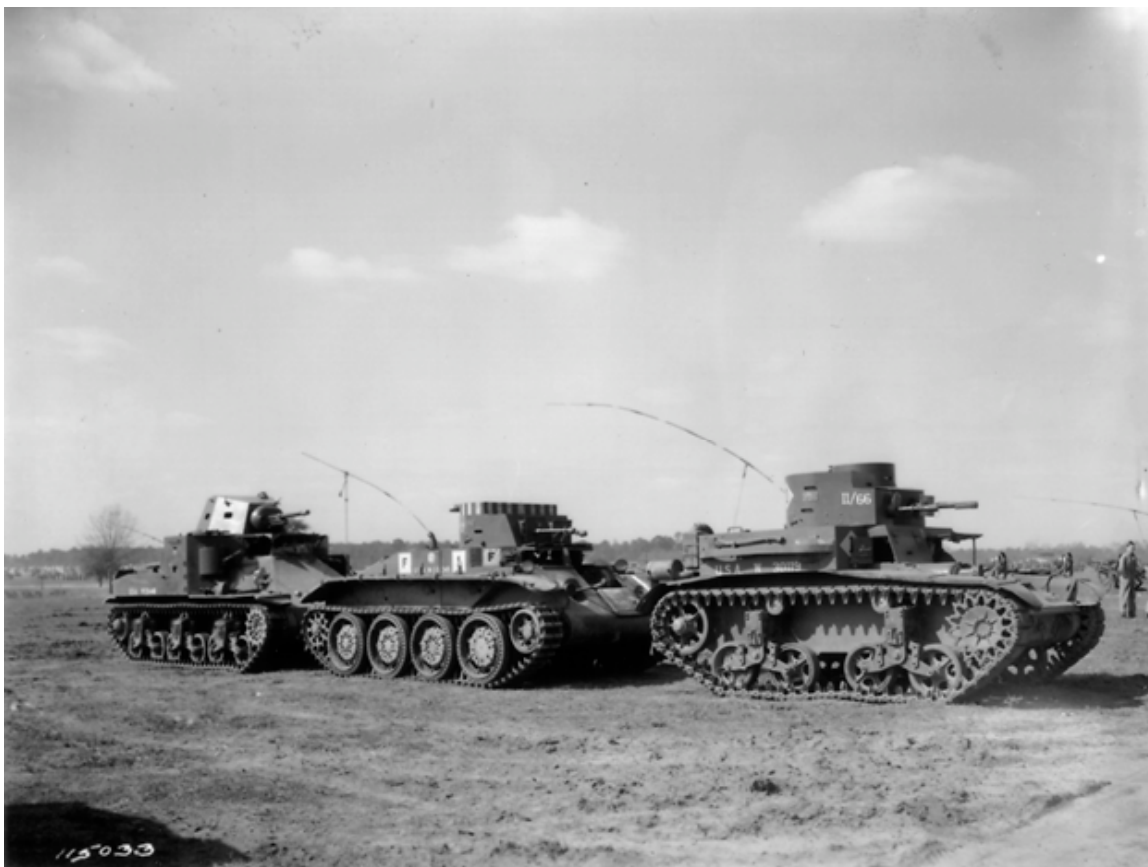
SC-115033: Some of the menagerie of tanks the Armored Force inherited at its creation (left to right): the M2 medium tank, with a 37mm main gun and up to eight machine guns (this one lacks two normally mounted on the turret sides); the T4 medium tank, which had a Christie suspension and three machine guns; and the M2A2 light tank, which had two turrets and three machine guns. (NARA, Signal Corps photo)

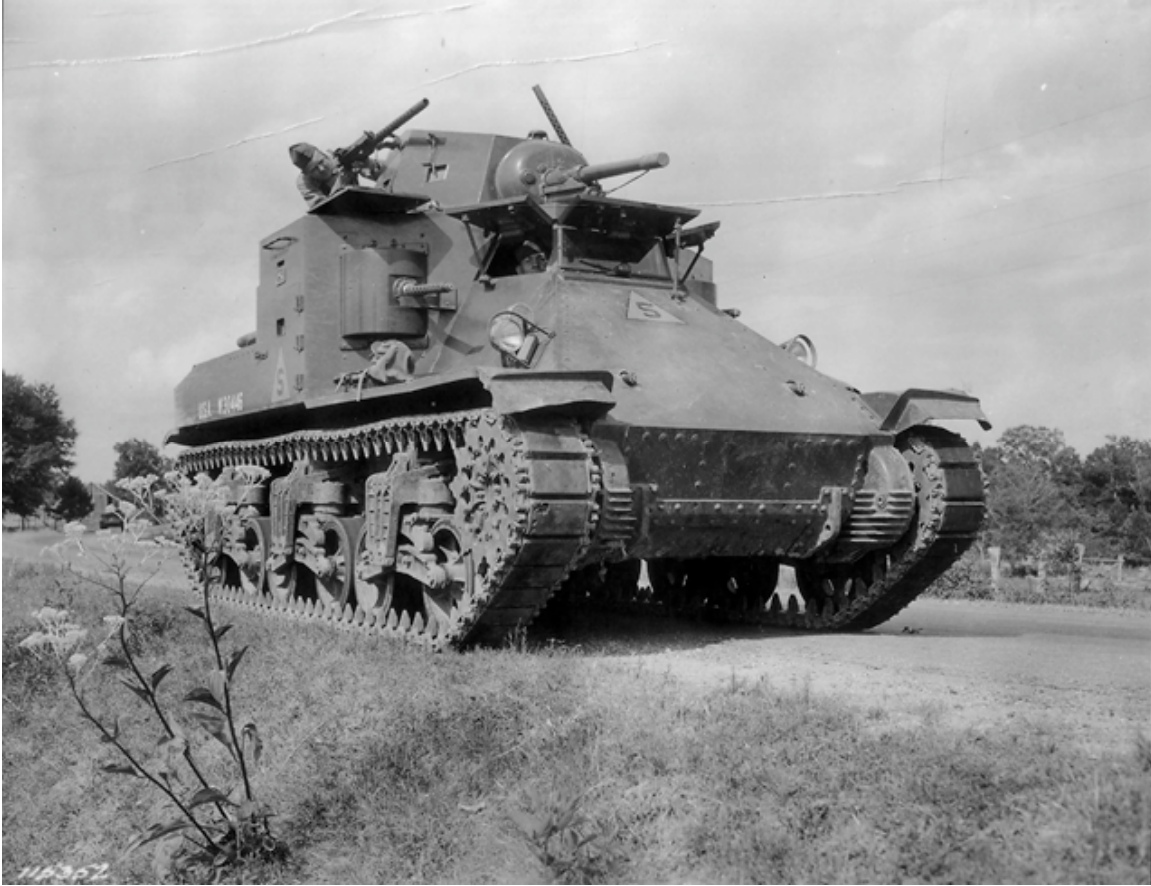
SC-115352: An M2A1 medium tank belonging to the 67th Infantry Regiment (Tanks) in 1940. The M2A1 had slightly thicker armor than the M2 and a supercharger on the engine to boost horsepower. Note the two fixed machine guns in the lower glacis armor. The vehicle passed on its chassis, the suspension arrangement, the power train, and much of its superstructure design to the M3. (NARA, Signal Corps photo)

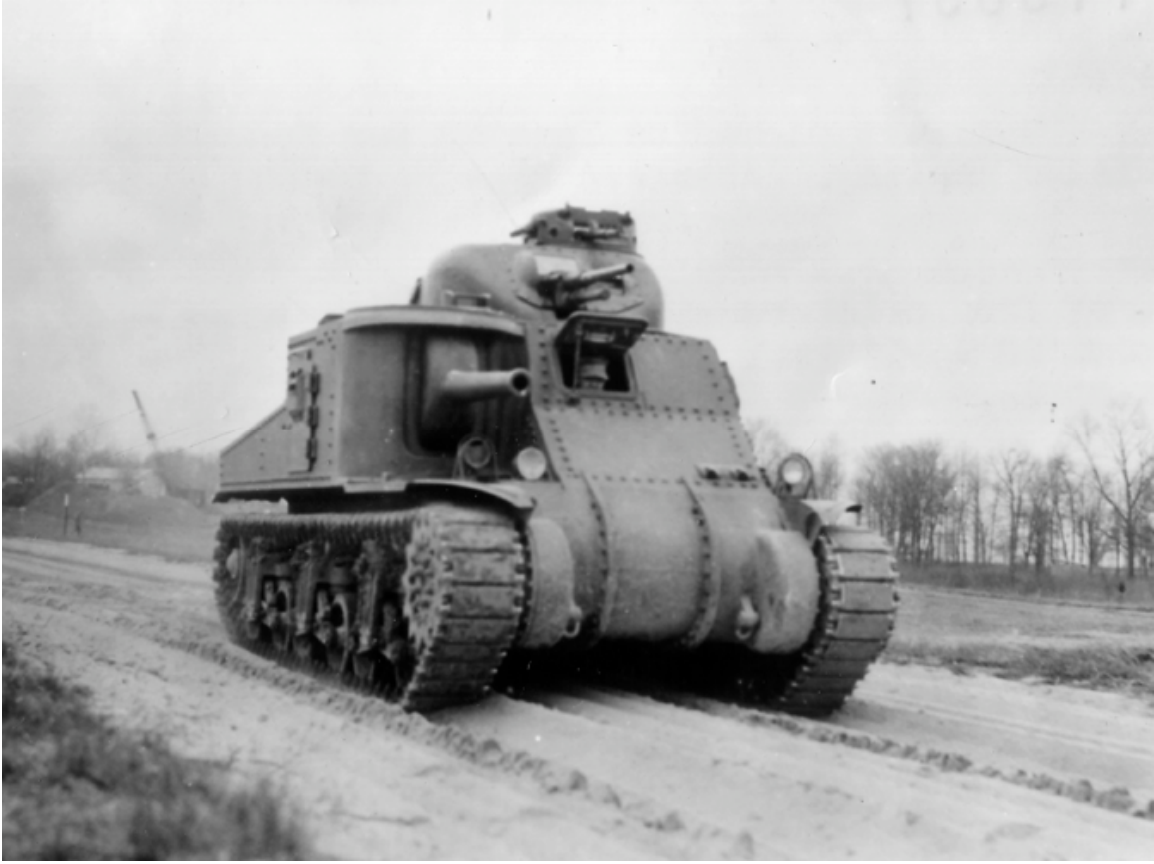
SC-118857: One of the first M3 medium tanks undergoes testing at Aberdeen Proving Ground in April 1941. Note the holes for fixed machine guns beside the left headlamp, the short-barreled 75mm Gun M2 without gyrostabilizer, and the absence of stowage bins on the back deck that were added to later vehicles. (NARA, Signal Corps photo)

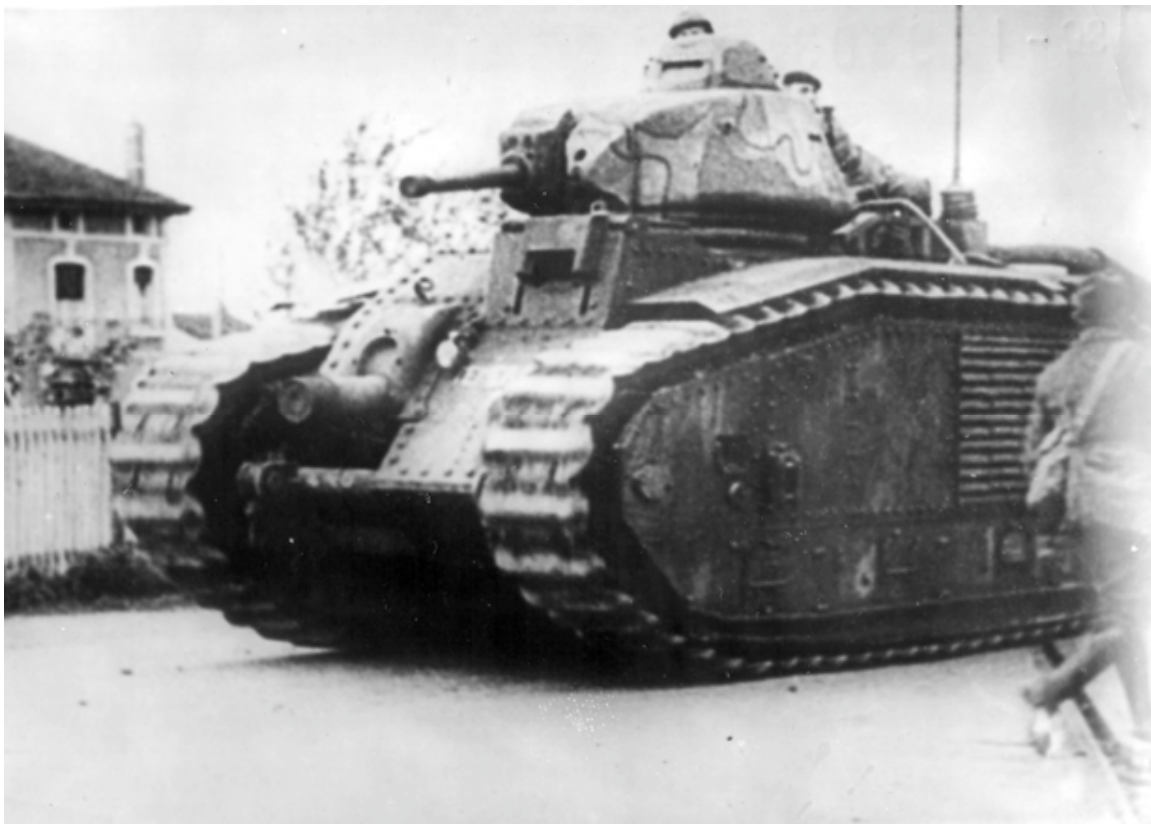
SC-119303: The French Char B1 bis heavy tank carried its 75mm gun in the hull. The upper turret sported a 47mm gun and coaxial machine gun. (NARA, Signal Corps photo)

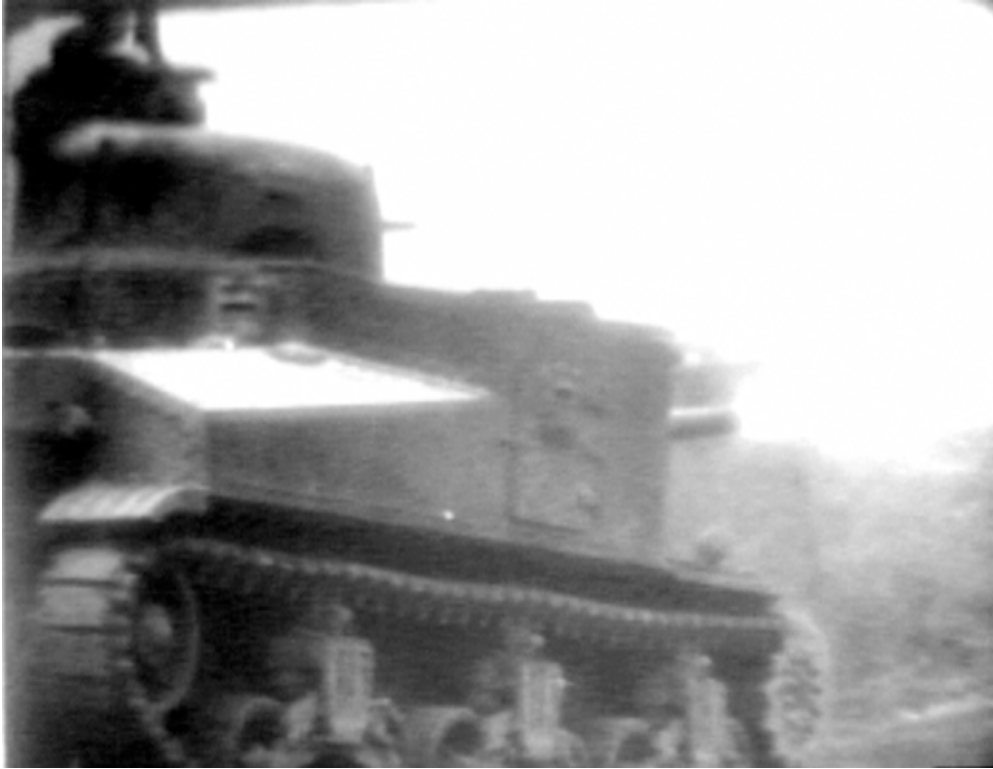
208.45_2: An early-production M3 Lee fires its main gun.
(NARA, Signal Corps film)

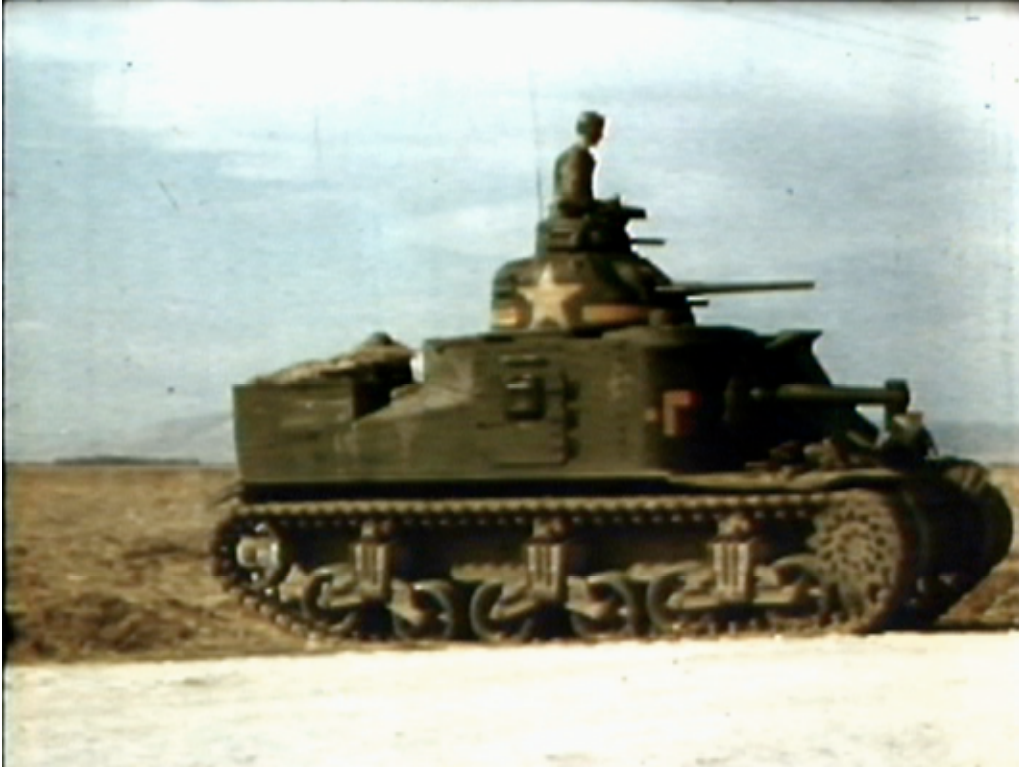
111-M-1001_1: An M3 from Company D, 2/13th Armored Regiment, heads toward the Tunisian front in late November 1942. This tank has the short-barreled 75mm gun M2 with added weight. (NARA, Signal Corps film) [color photo]

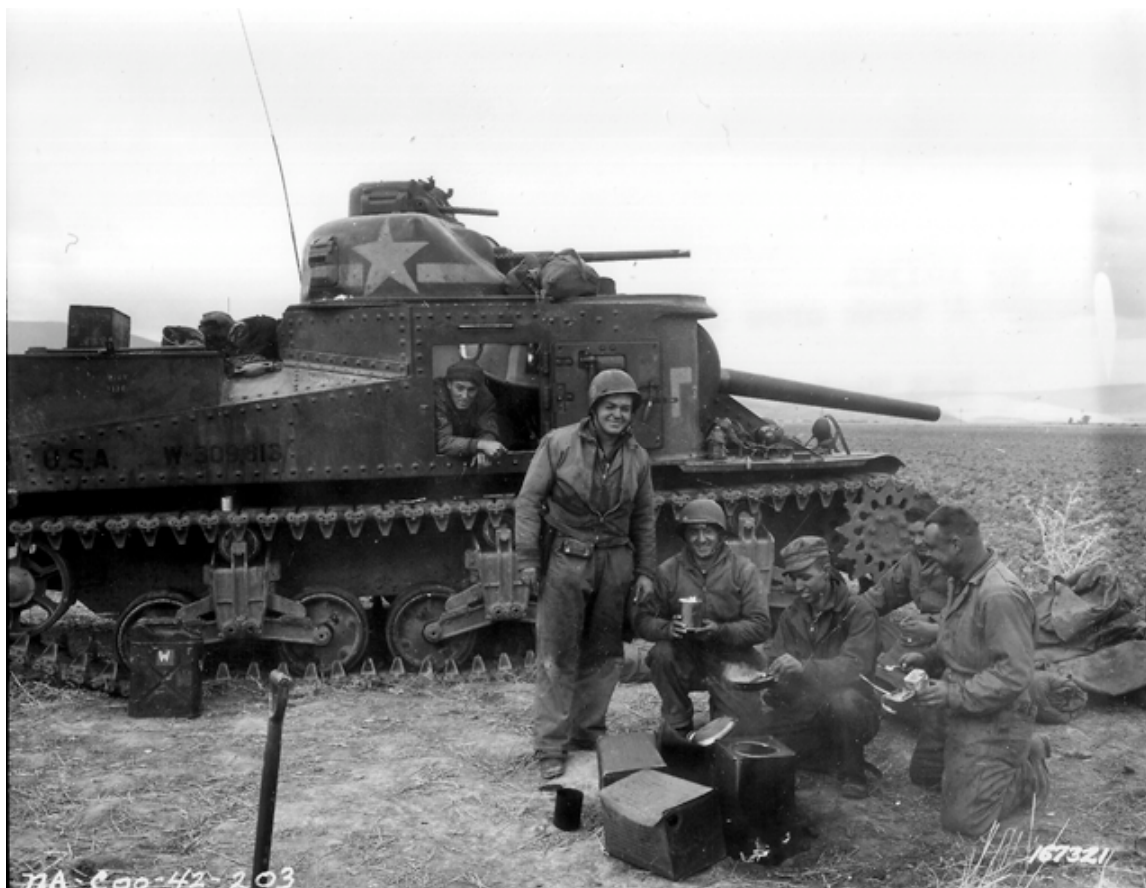
SC-167321: A Company D crew prepares chow near Souk el Arba, Tunisia, on 23 November 1942. Note the longer barreled 75mm Gun M3. The men are wearing tanker jackets over herringbone twill one-piece coveralls, which remained standard garb through the war. (NARA, Signal Corps photo)

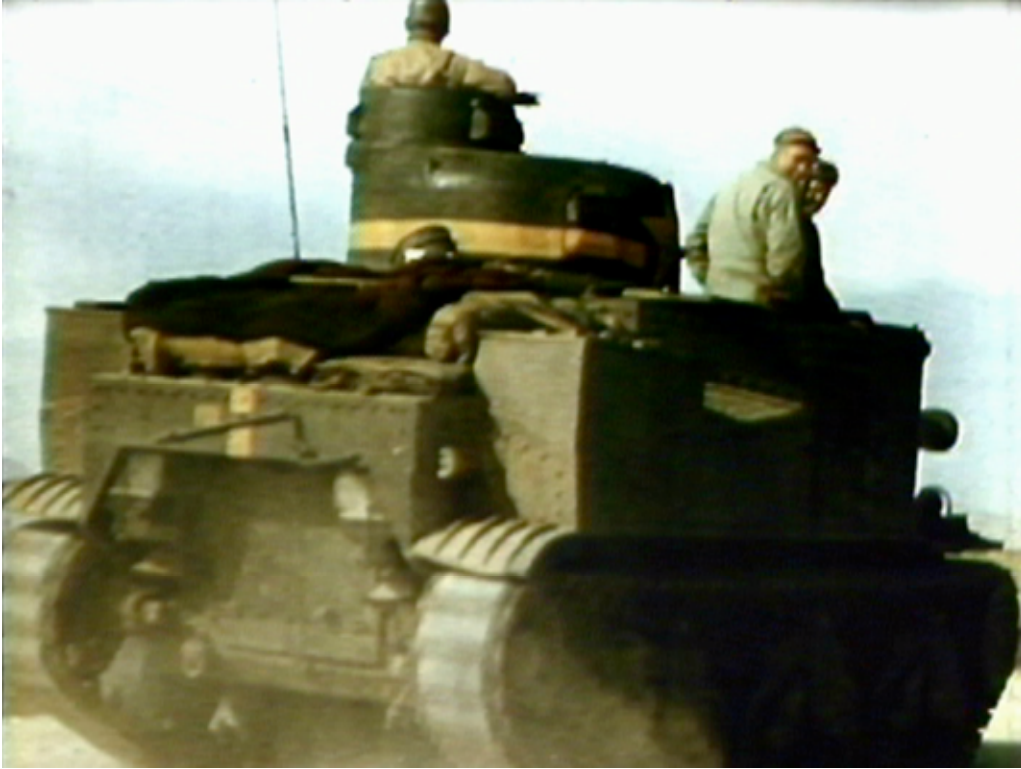
111-M-1001_16: A rear view of the M3 medium tank, with two crewman squeezed through the gunner's hatch. (NARA, Signal Corps film) [color photo]

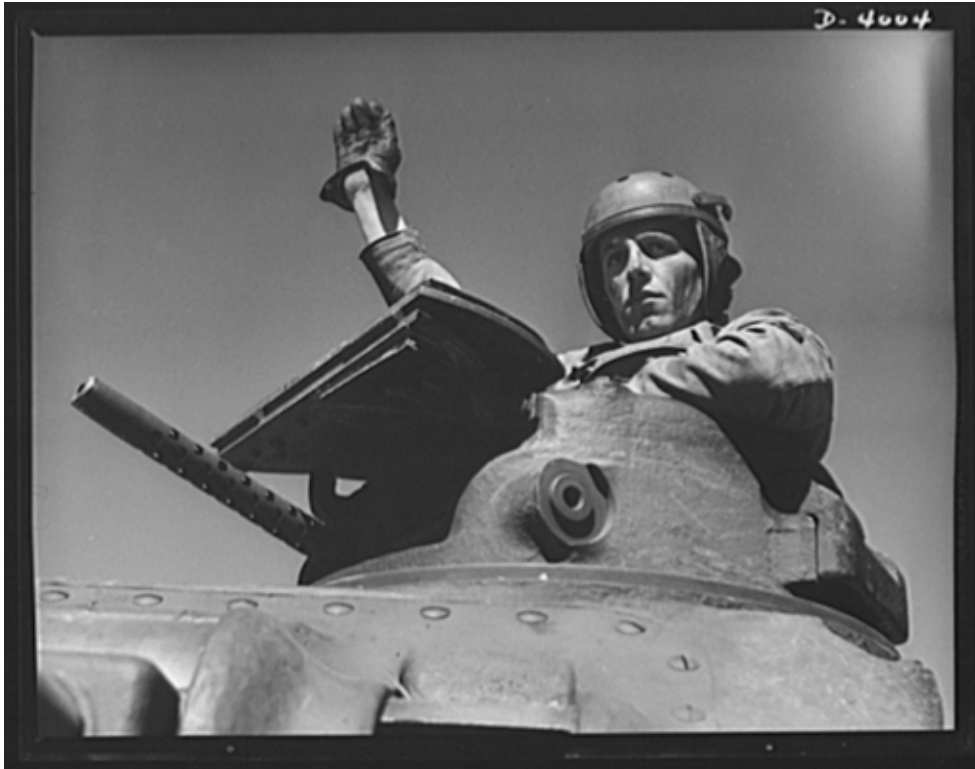
8b02863u: A closeup view of the commander's cupola.
(Library of Congress, Prints & Photographs Division, FSA-OWI Collection)

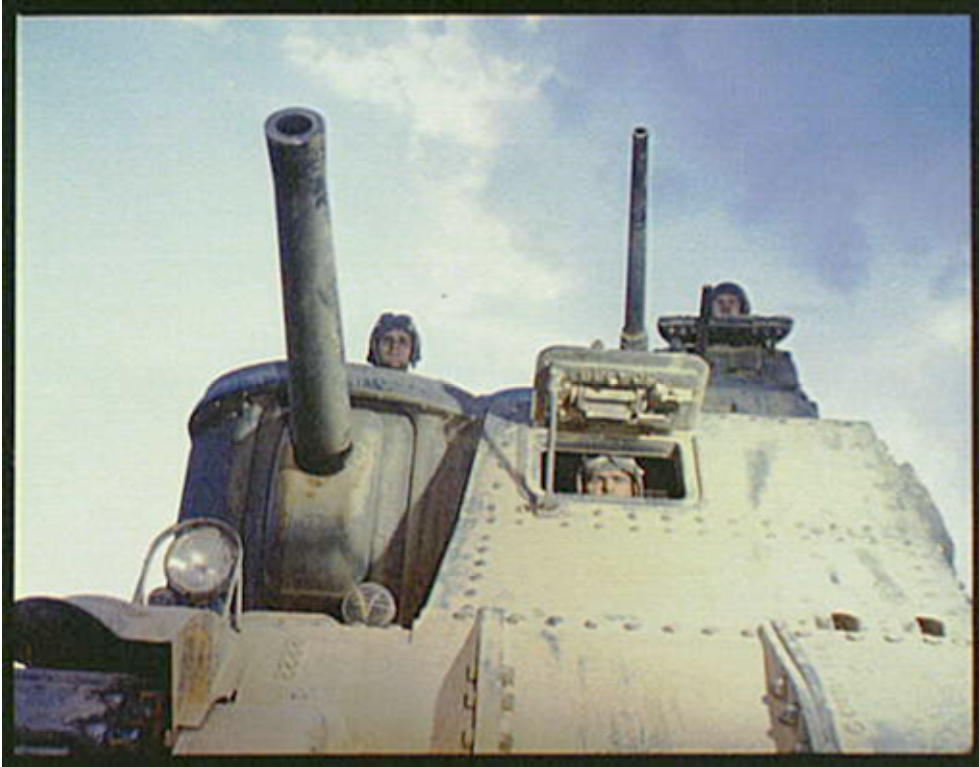
1a35201r: The M3 was a tall mountain of tank. The 75mm gunner had his own hatch topside. (Library of Congress, Prints & Photographs Division, FSA-OWI Collection) [color photo]

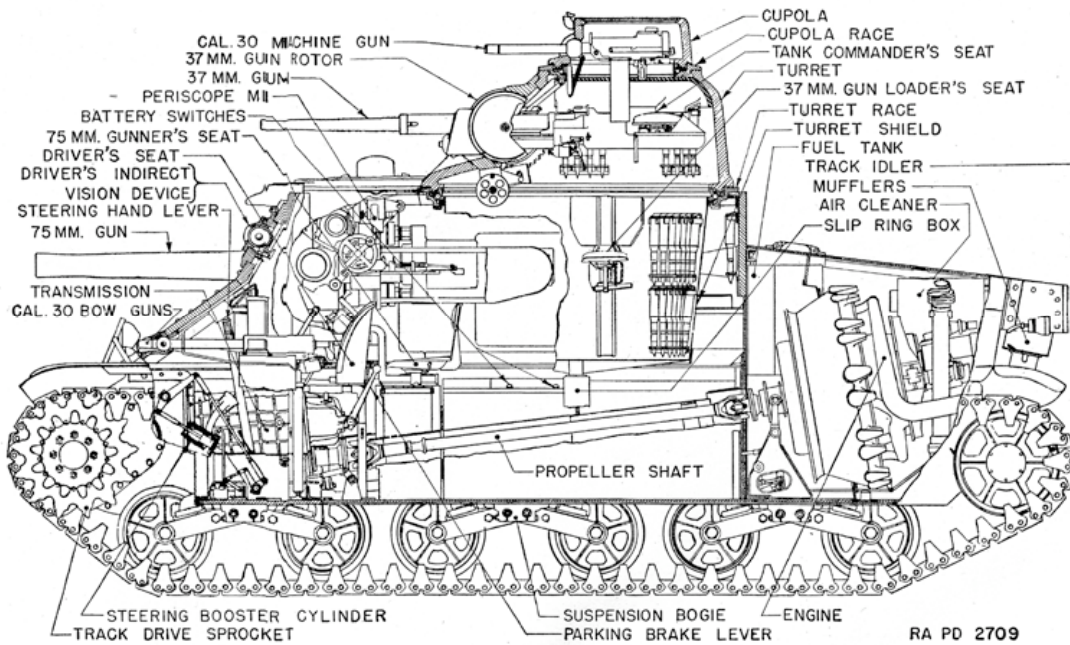
TM 9-750_2: This M3 Lee cut-away view illustrates the standard internal layout for all models. Why use of an aircraft engine forced design of a tall hull for the M3 and M4 medium tanks becomes apparent. (NARA, records of the Government Printing Office)

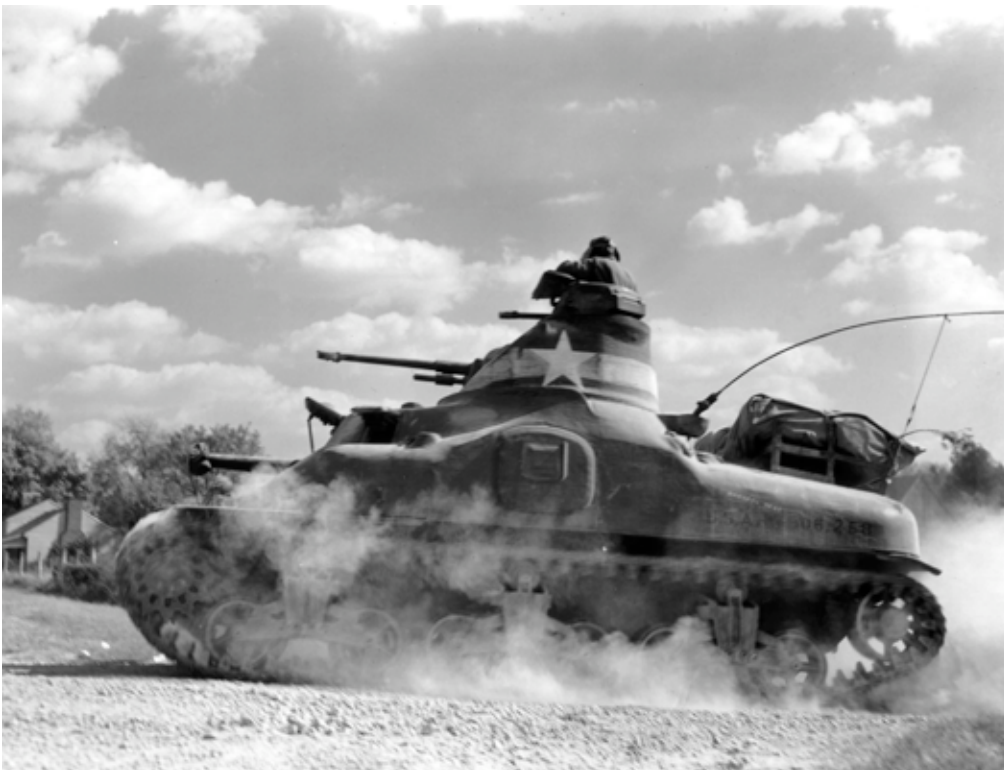
SC-169063: The rounded contours of the M3A1 with cast hull.
(NARA, Signal Corps photo)

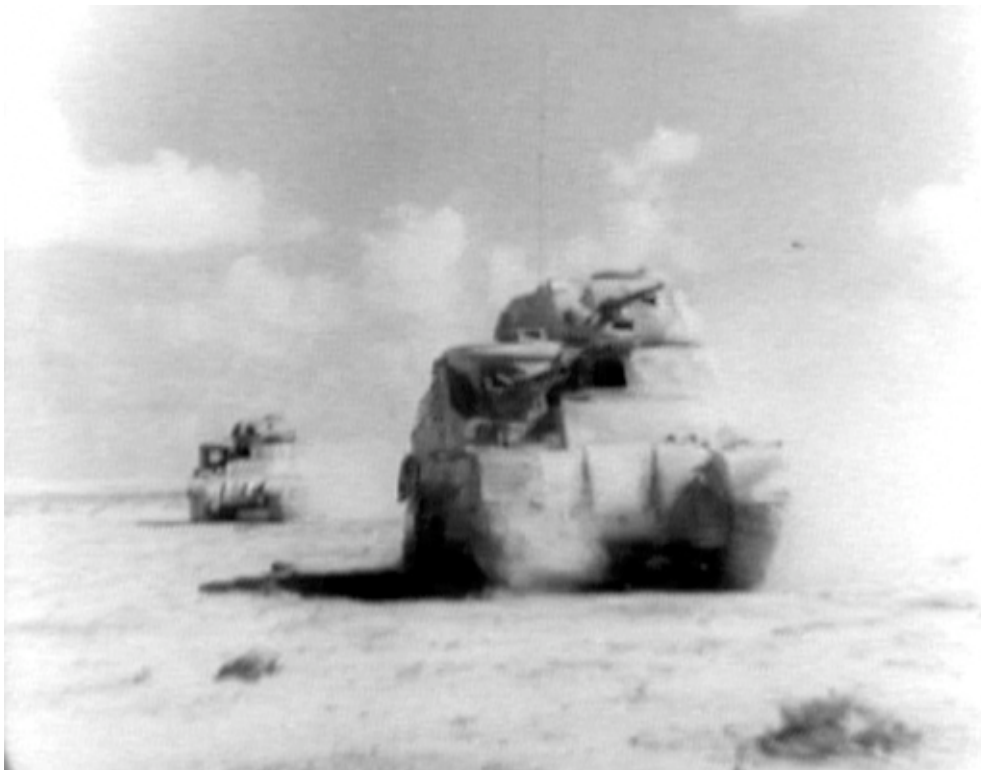
111-FB-51_2: The British M3 variant, dubbed the Grant, lacked the commander's cupola and had a longer turret to make room for a wireless set. (NARA, Signal Corps film)

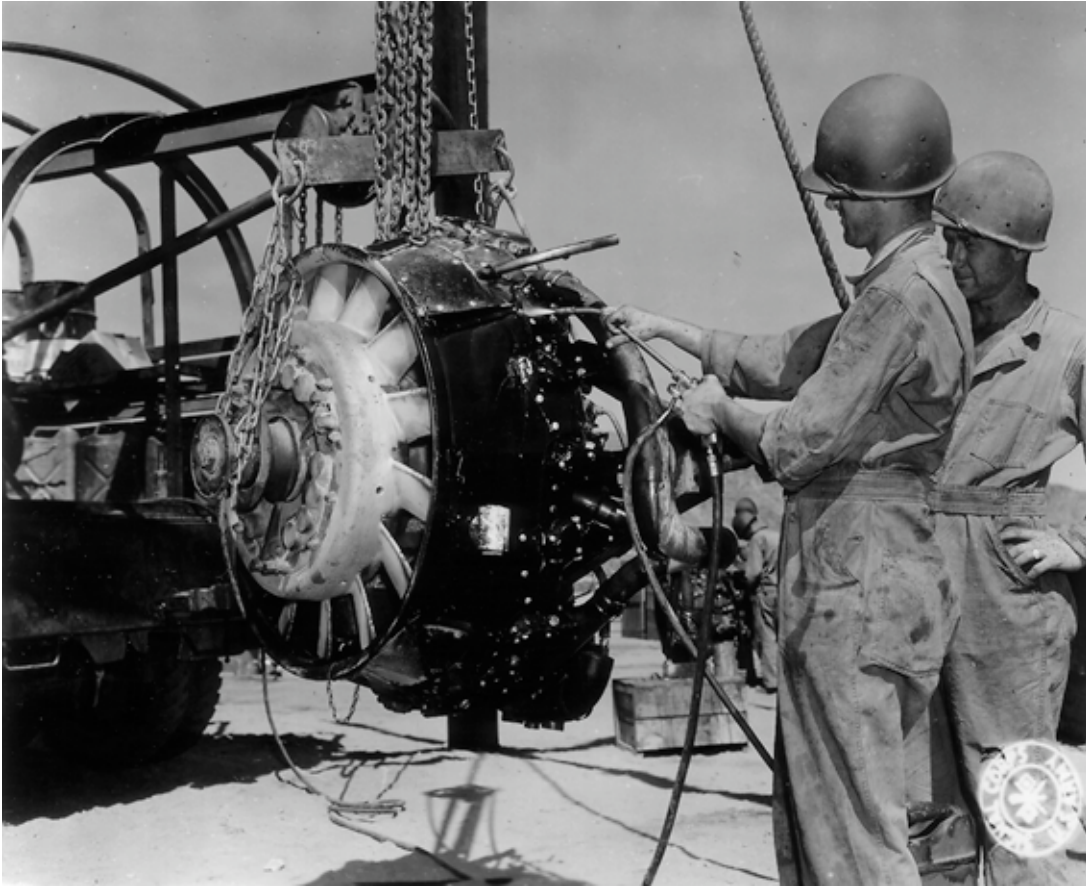
SC-239900: GIs clean a Continental 400 hp aircraft engine for an M3 tank. This engine also powered most M4 Sherman tanks. (NARA, Signal Corps photo)

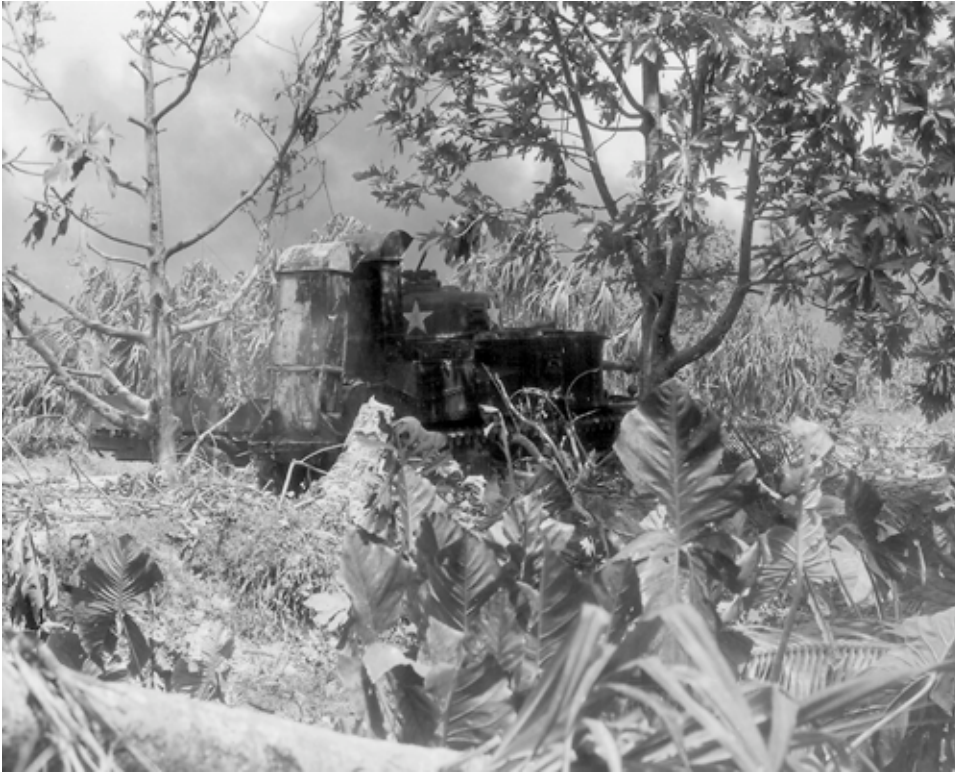
SC-183513: A rare picture of an M3 Lee with wading gear; the tank is oriented to the right. This one is crashing through underbrush on Makin Atoll during the first moments of battle on 20 November 1943. (NARA, Signal Corps photo)

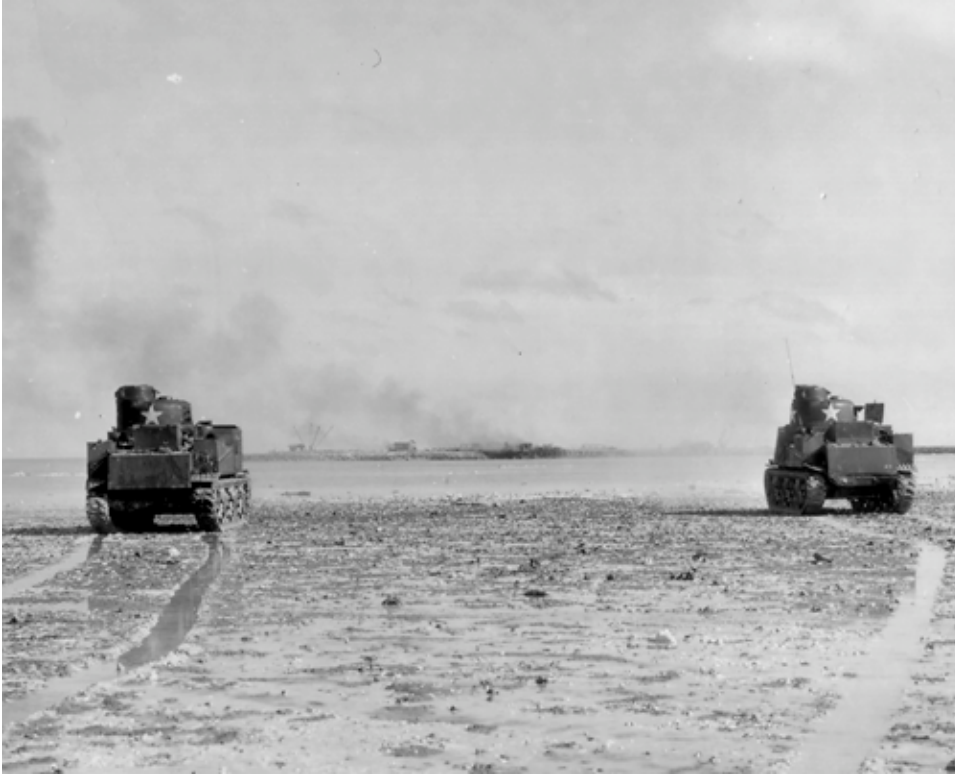
SC-183581: M3 tanks shell the Japanese at King's Wharf, Makin Atoll, on 21 November 1943. These Lees belong to Company A, 193d Tank Battalion. The lower elements of the wading stacks are still mounted. (NARA, Signal Corps photo)

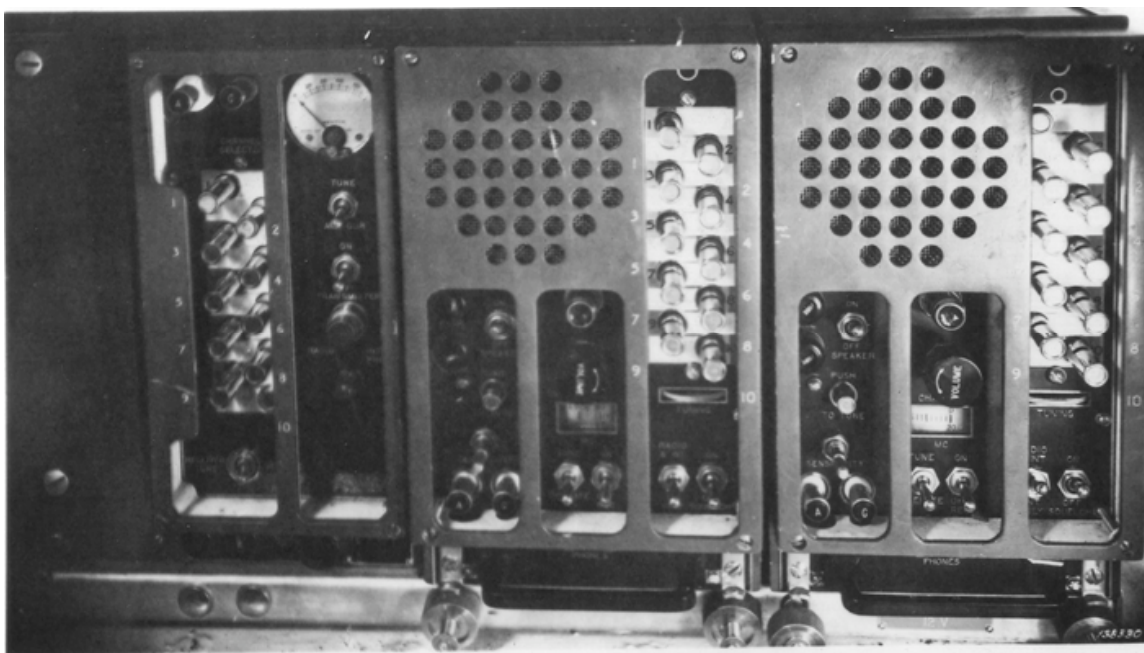
SC-138330-R: The FM Radio Set SCR-508. The push buttons selected among pre-set frequencies. (NARA, Signal Corps photo)

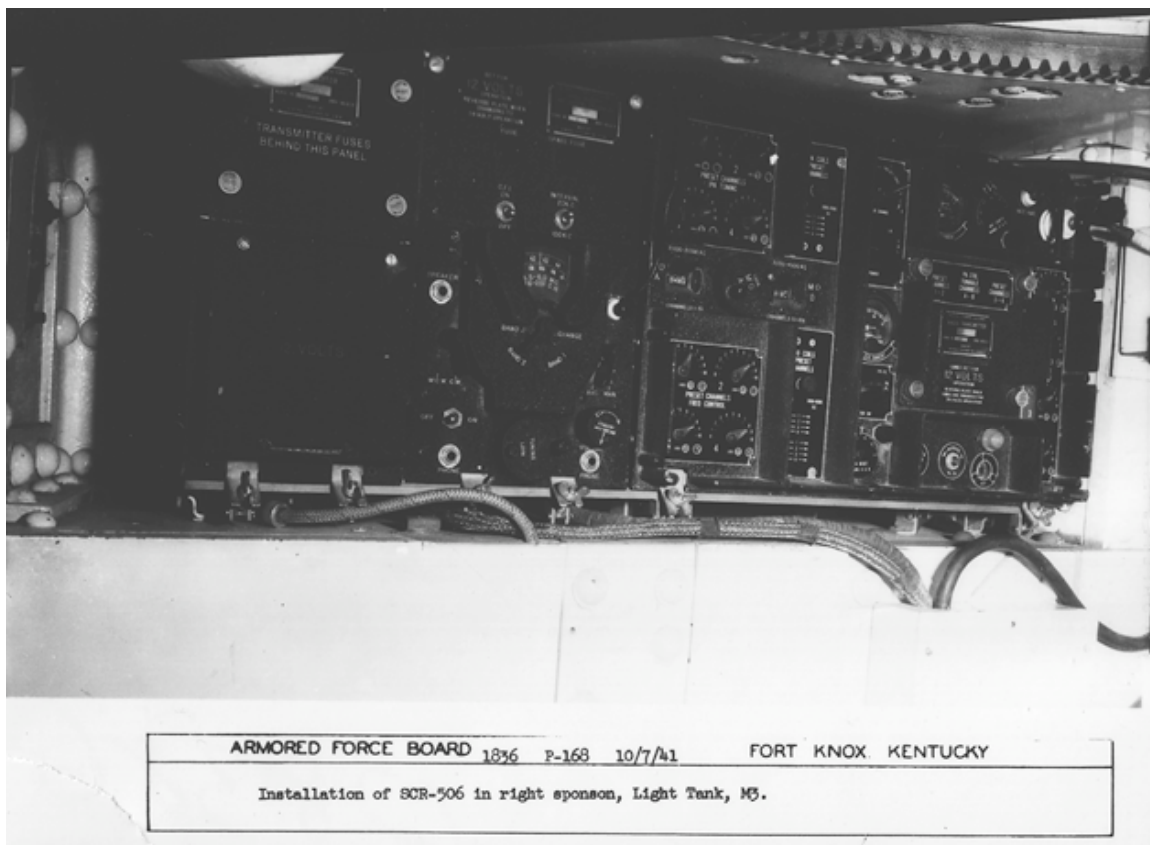
SC-128386: The radio was installed in the sponson of the M3 and early M5 light tanks, in this case an SCR-506 AM command set. The turret gear is visible in the upper right-hand corner. (NARA, Signal Corps photo)

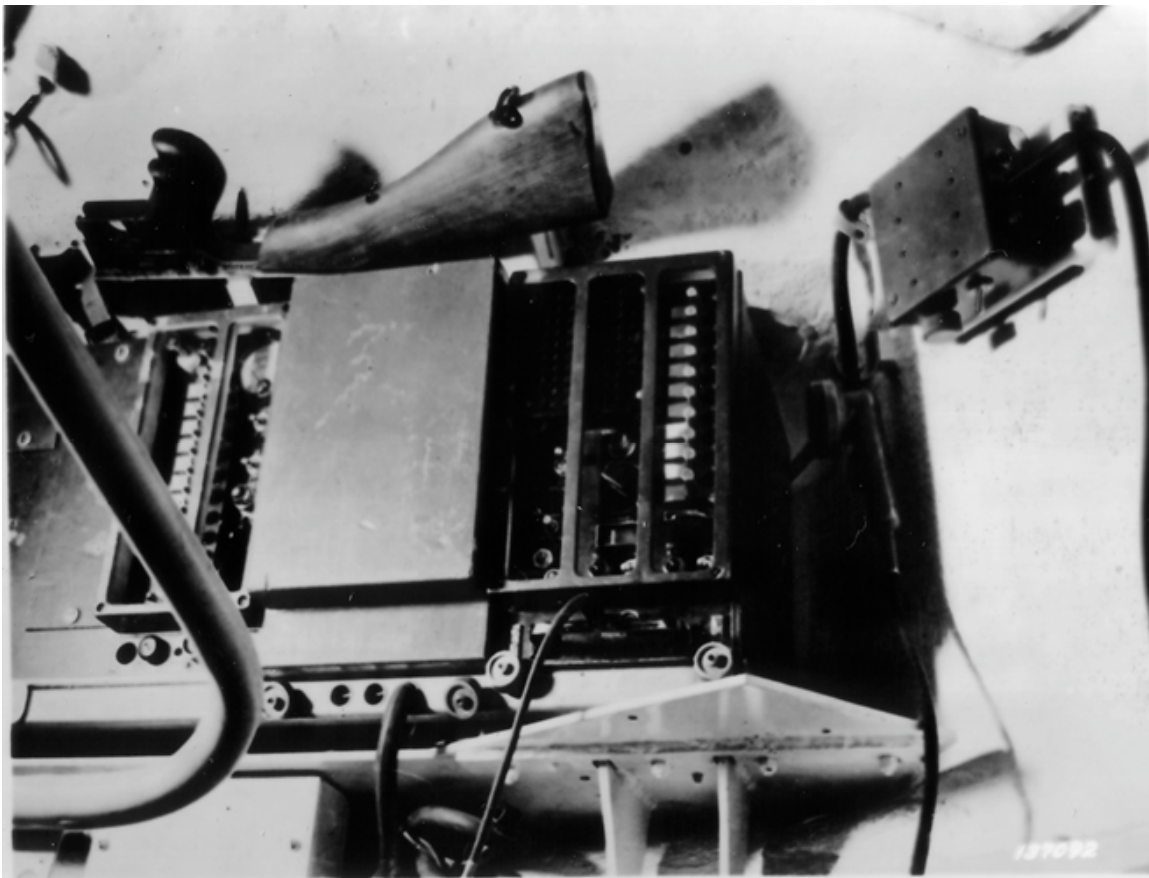
SC-137092-R: Principal components of Radio Set SCR-508 installed in the center-rear turret of an M4A3 medium tank. The Tommy gun rack is visible above the radio. The bar in the lower left is the breach guard on the main gun. An intercom box is to the right of the radio set. (NARA, Signal Corps photo)

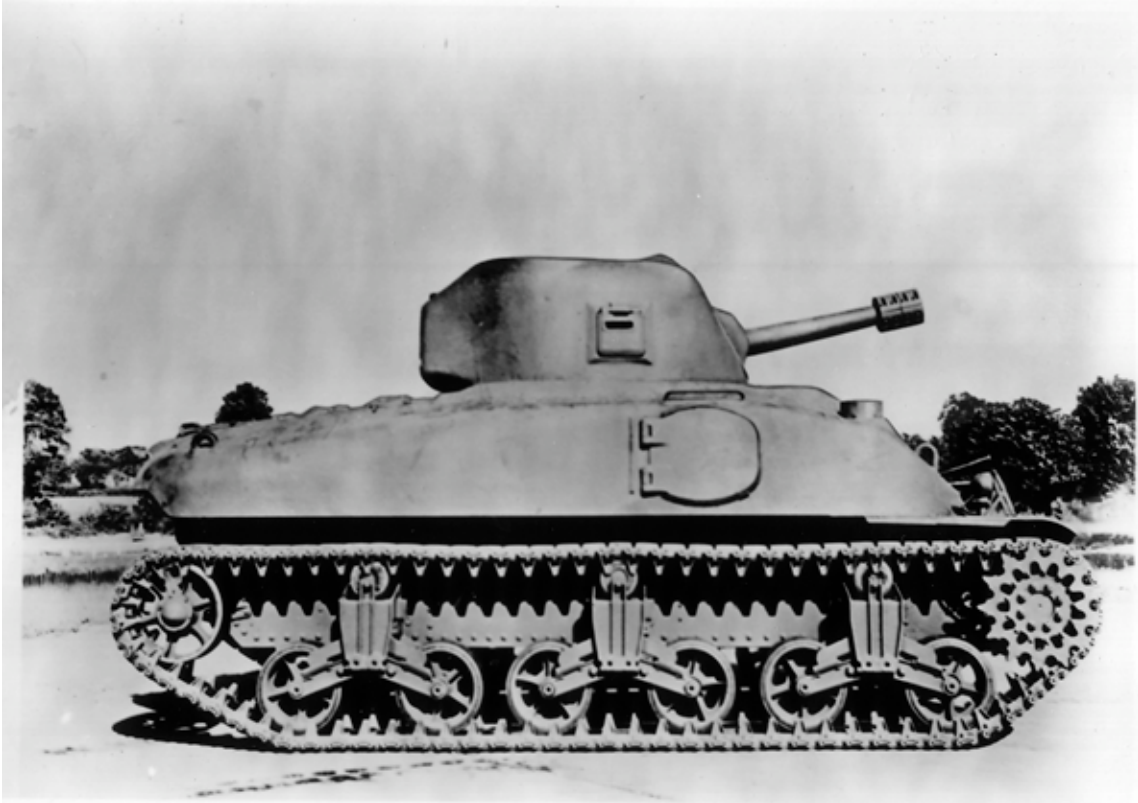
SC-130896: The T6 medium tank pilot was completed in September 1941, nine months after the first M3 Lee. (NARA, Signal Corps photo)

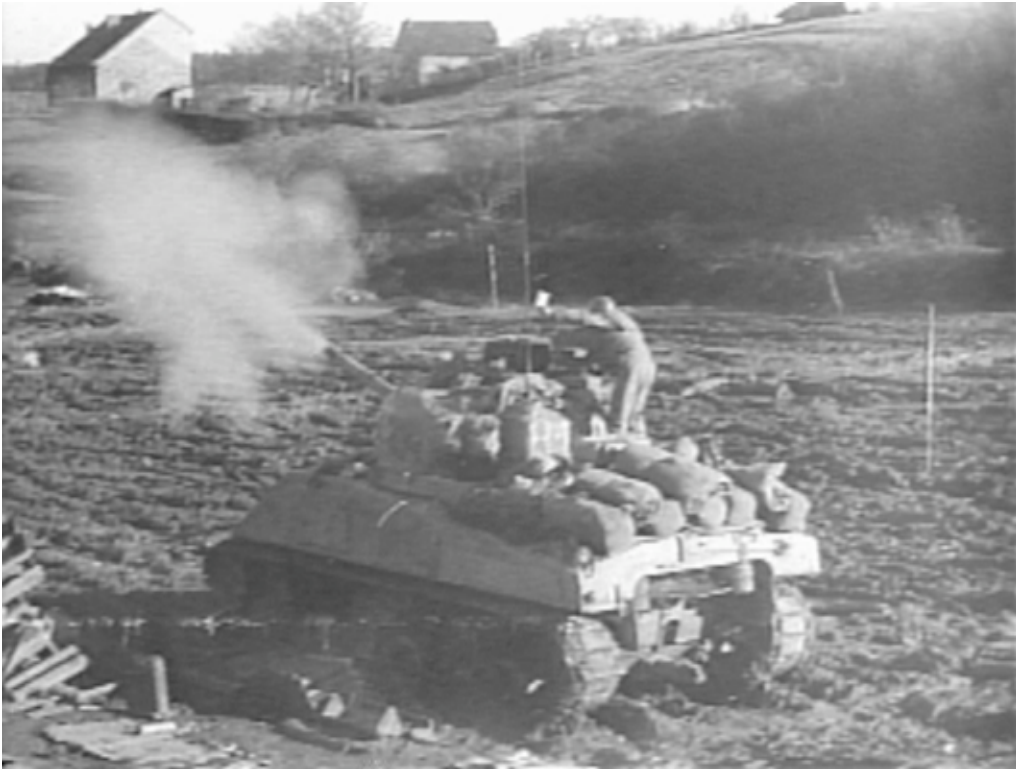
111-CB-31_1: An M4, probably from the 2d Armored Division, fires indirectly during the Roer River offensive in November 1944. The 75mm gun produced a modest muzzle blast. (NARA, Signal Corps photo)

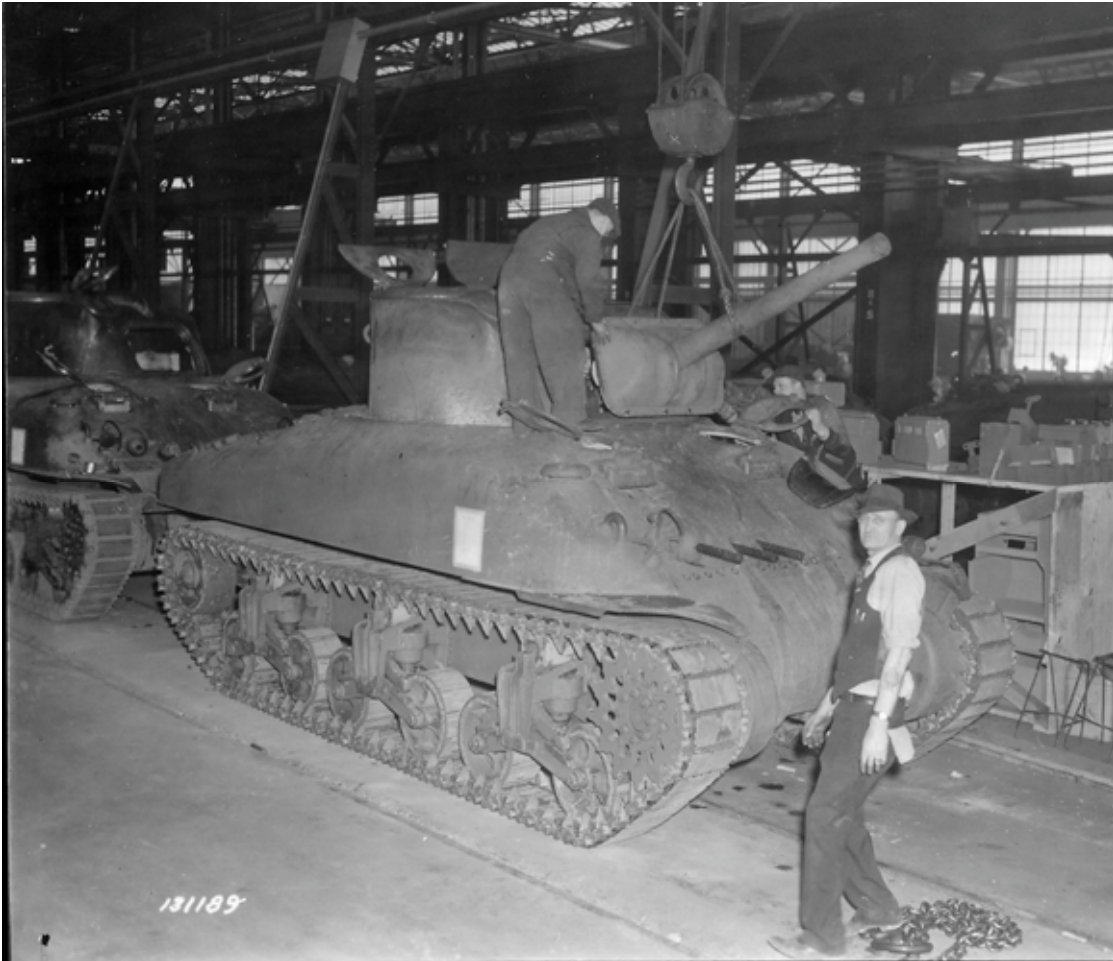
SC-131189: The cast-hull M4A1 preceded the welded-hull M4 into production. The first Shermans issued to the Armored Force had two fixed machine guns in the hull front and bogie assemblies with the return rollers above the center. The extra MGs were dropped almost immediately, and the return rollers were soon shifted back and replaced at the top of the bogie assembly by a skid plate. (NARA, Signal Corps photo)

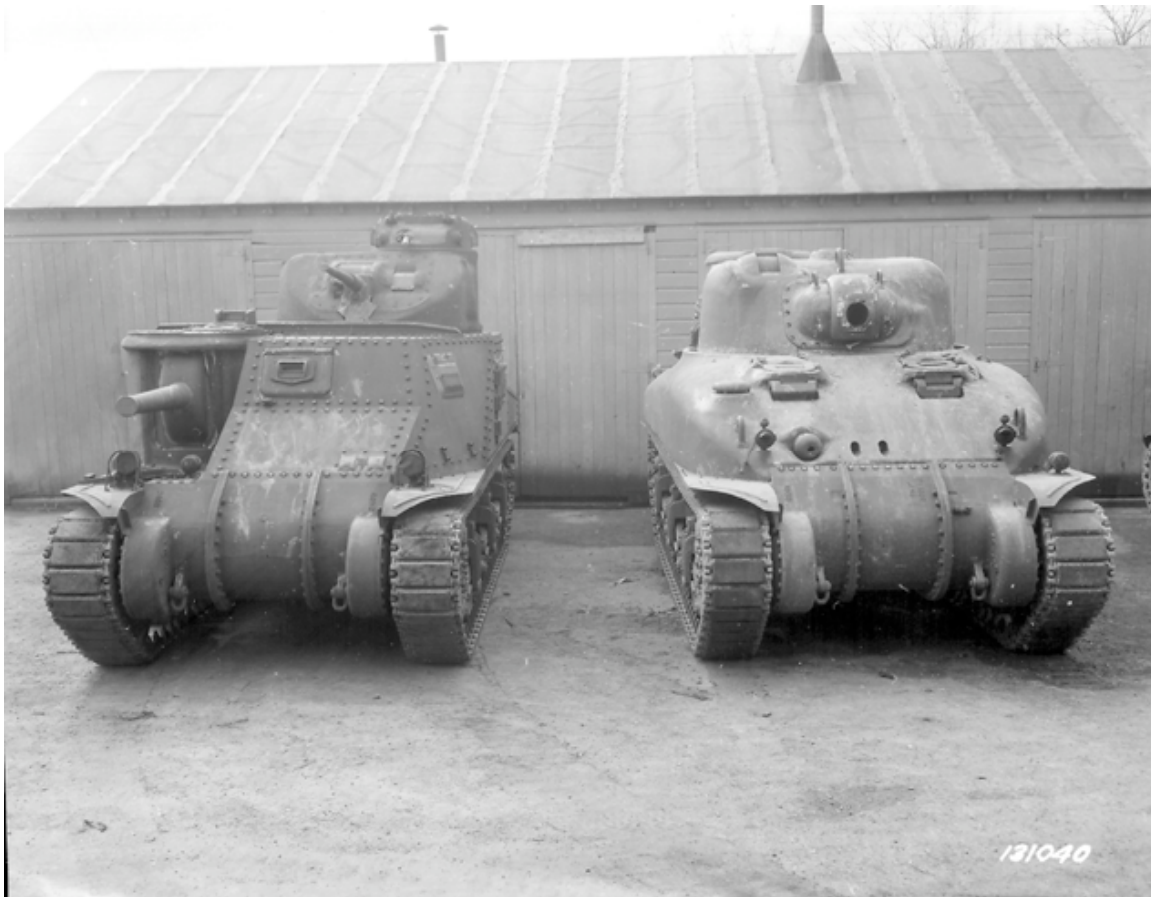
SC-131040-R: The M3 and new M4A1 medium tanks in spring 1942. The early M4A1 had solid vision blocks for the driver and bow gunner instead of periscopes. The bulge atop the M4A1 turret is an early version of the main gun sight; the gun itself is missing. (NARA, Signal Corps photo)

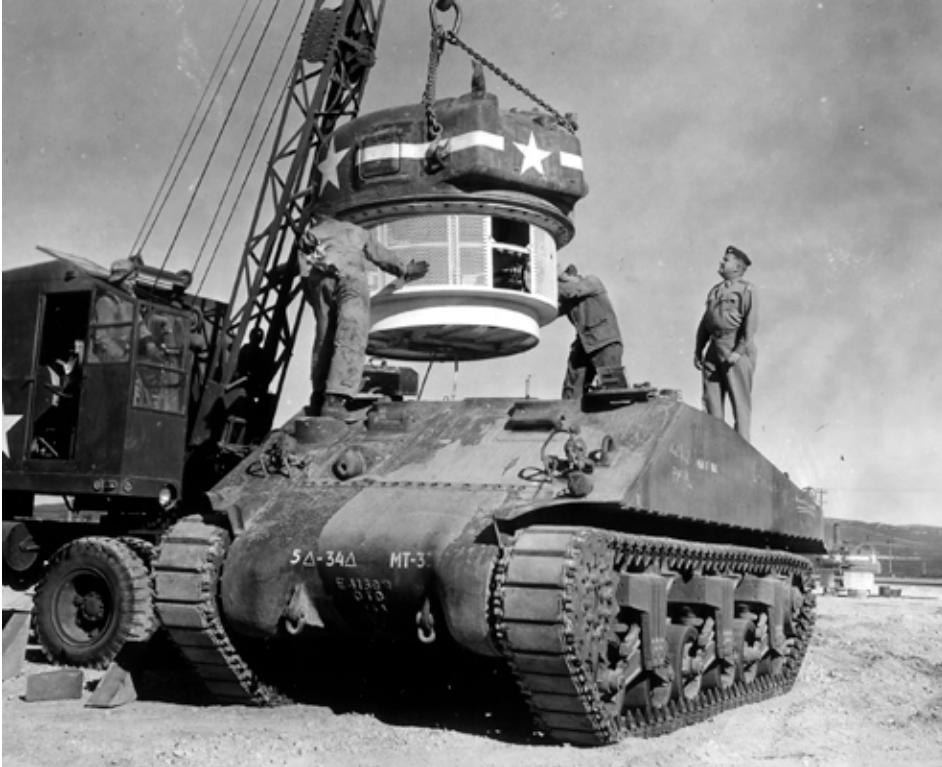
SC-186633: The turret basket of an M4 tank from the 34th Armored Regiment, 5th Armored Division. This tank has early vision blocks but a cast final drive housing. (NARA, Signal Corps photo)
