Weapons of Tank Battalions Illustrations

Chapter 3: Medium Tanks

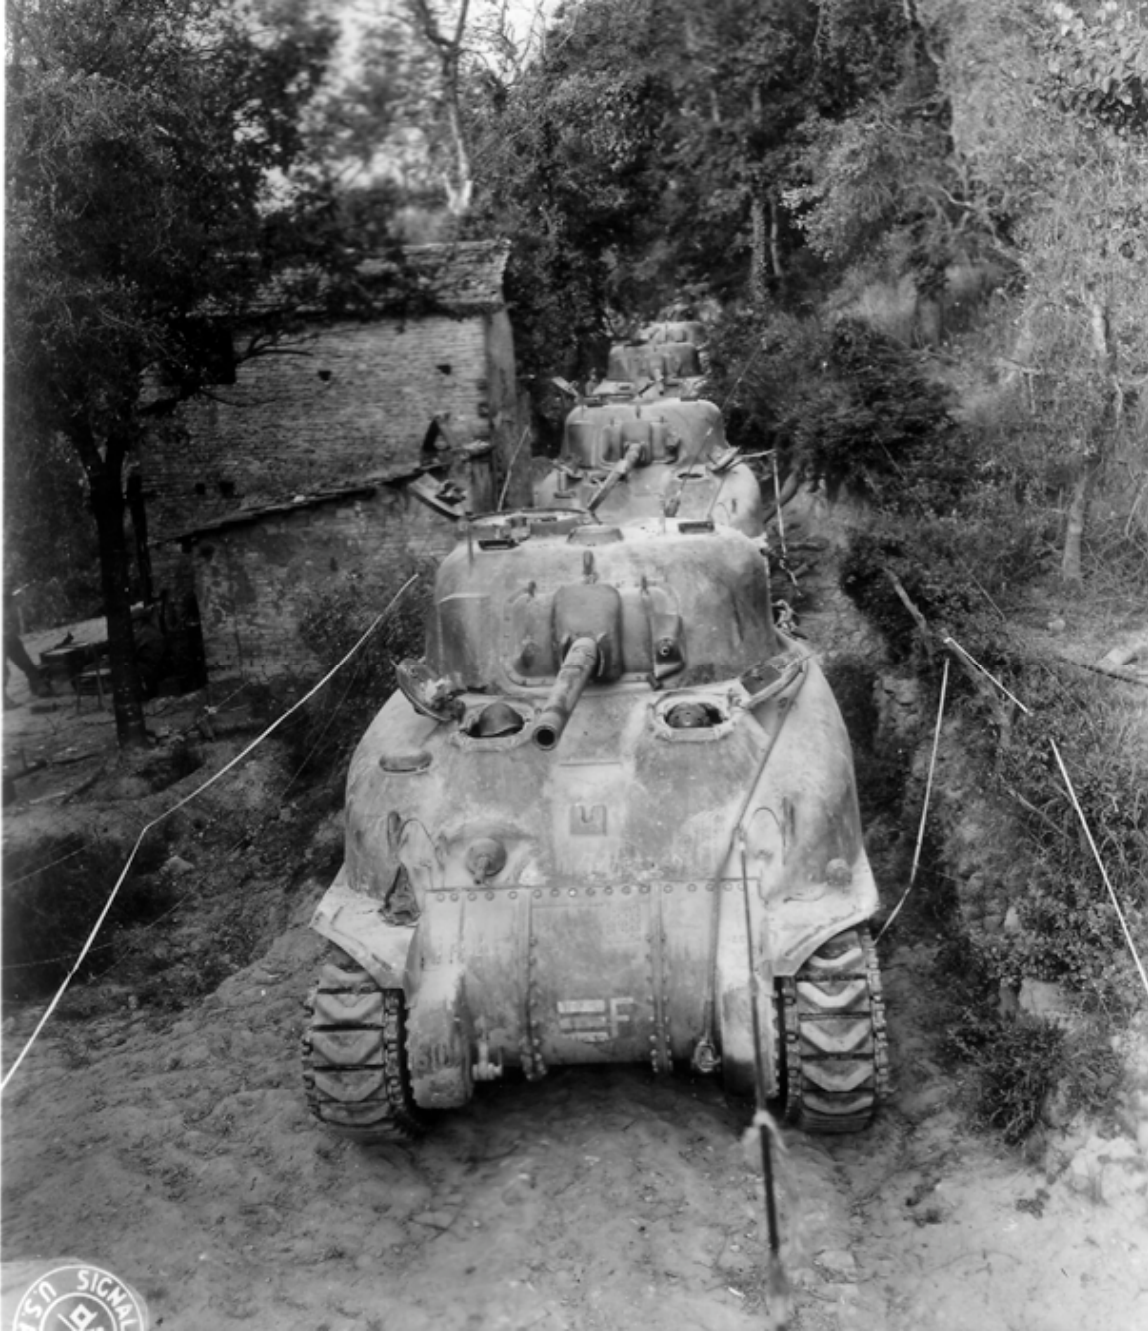
SC-190188: M4A1s from the 760th Tank Battalion near Turo, Italy, on 12 May 1944. The original hatches for the driver and bow gunner were an extremely tight fit. The lead tank has appliqué armor over the gunner's position. (NARA, Signal Corps photo)

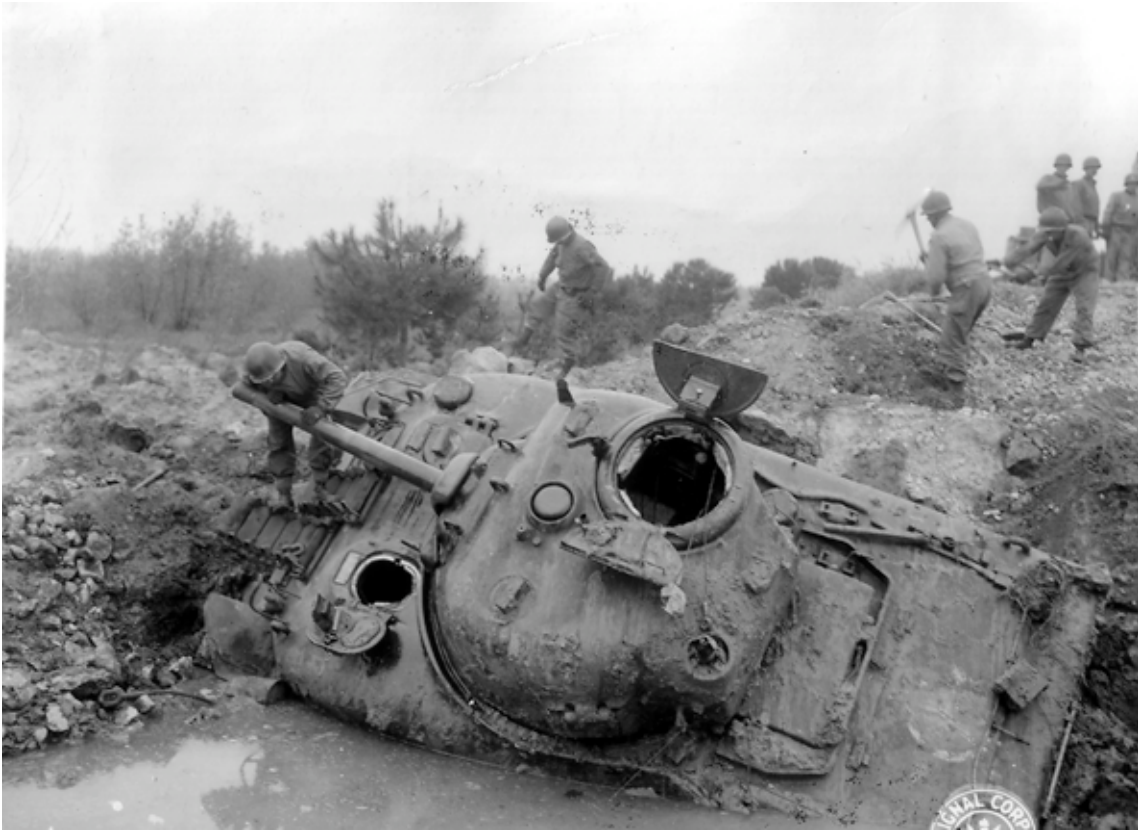
SC-189595: An unfortunate incident involving a bomb crater near Littoria, Italy, provides a top view of an M4A1. All three members of the turret crew had to make it out of the single hatch in case the tank caught fire. Periscopes are visible in the driver's and commander's hatches. (NARA, Signal Corps photo)

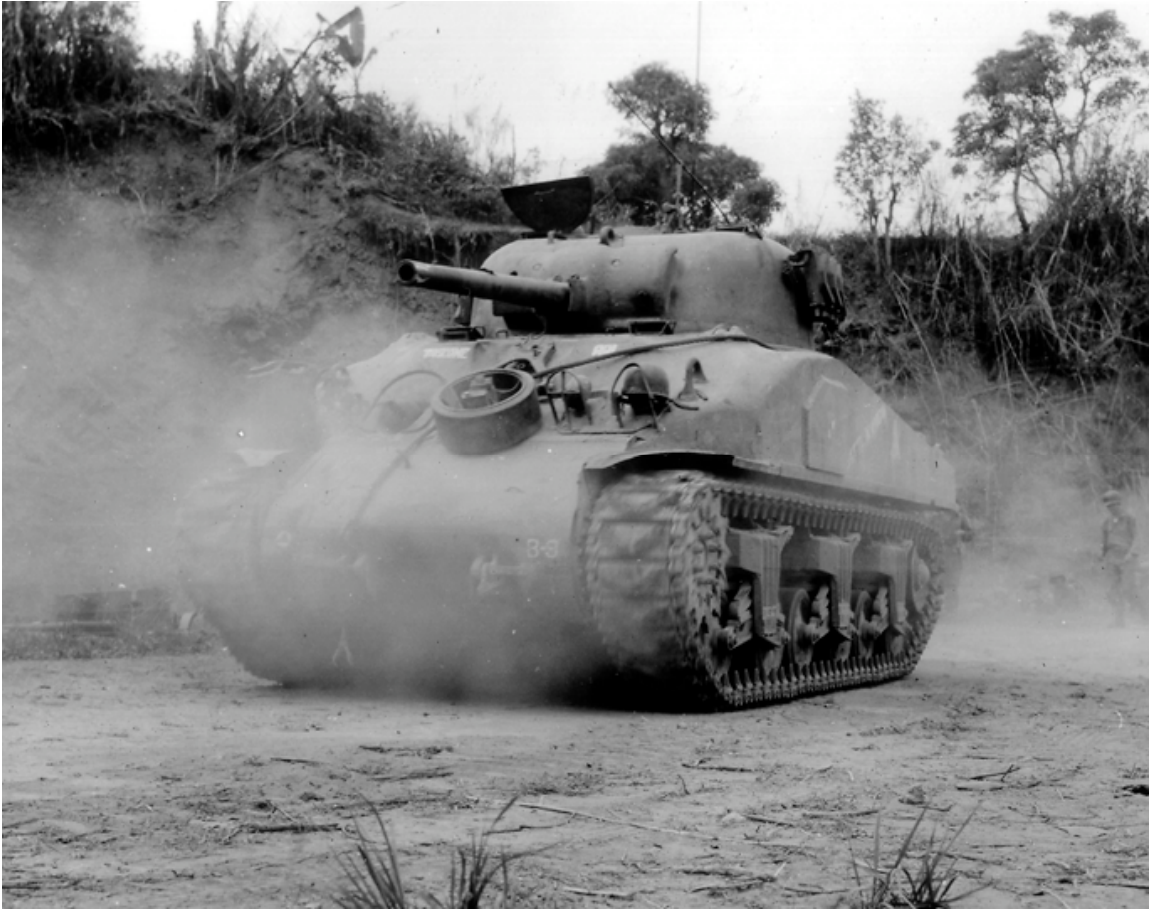
SC-208550: The composite hull, which mated a cast glacis with a welded main hull, was produced in limited numbers. (NARA, Signal Corps photo)

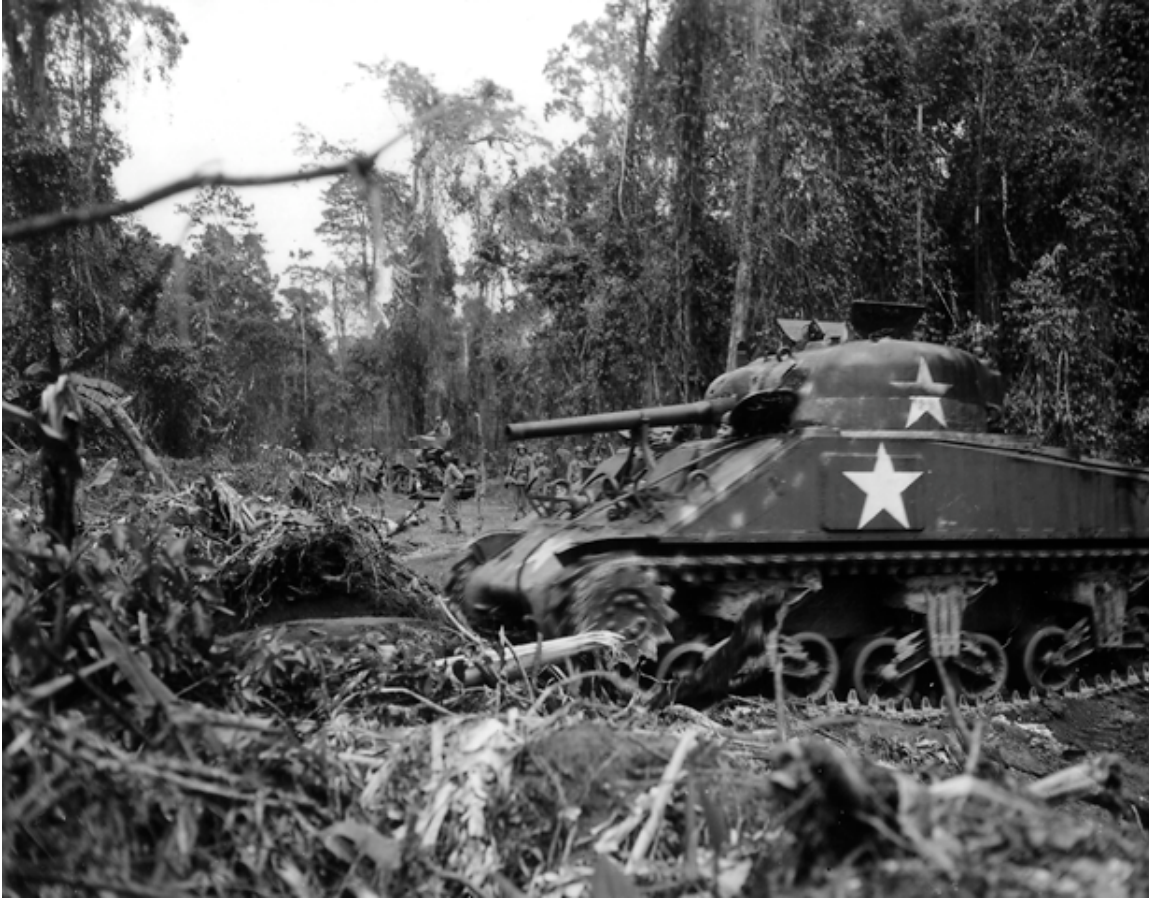
SC-188332: An M4 with the 56-degree glacis operates with the Americal Division on Bougainville in February 1944. This tank has appliqué armor in front of the hull hatches and over the sponson ammo racks (one on the left side and two on the right). It also has extra armor around the lower part of the turret, a modification common in the Pacific and possibly inspired by the Japanese practice of throwing explosive charges onto the deck. (NARA, Signal Corps photo)

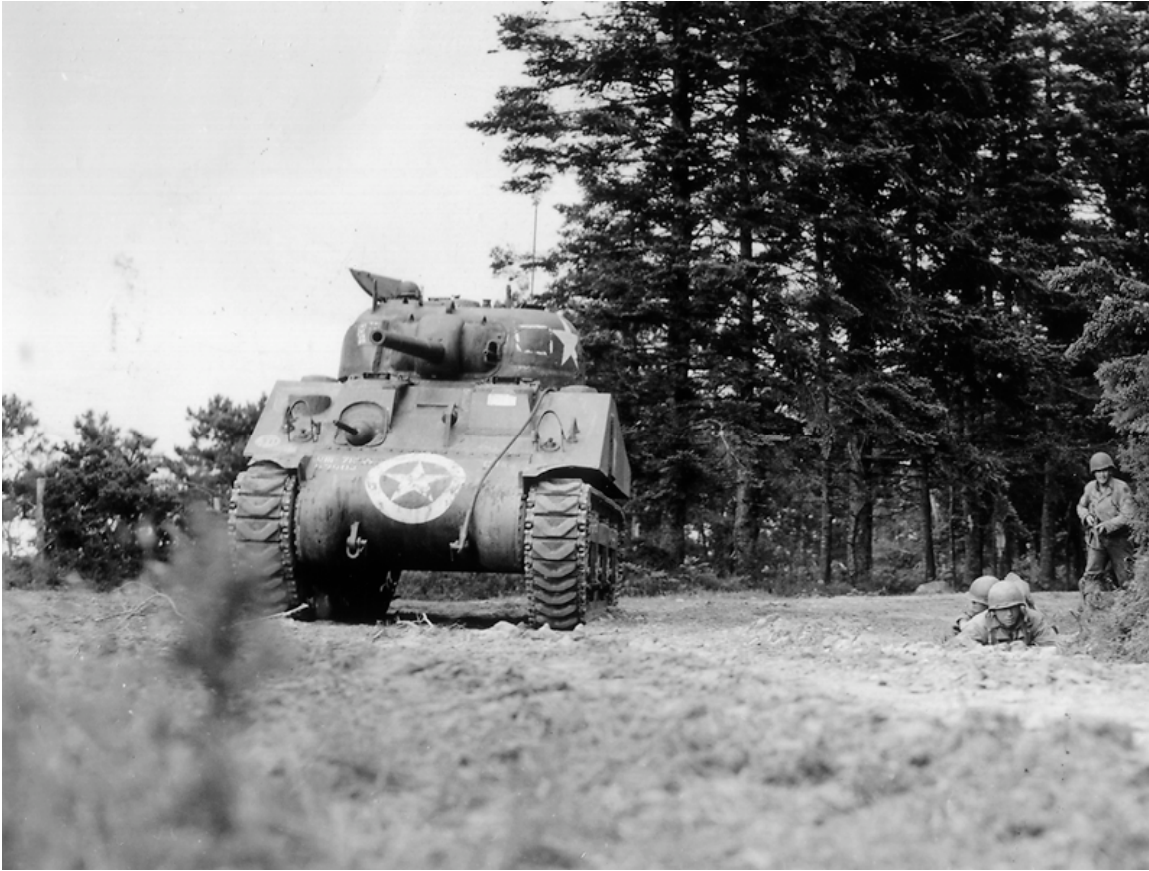
SC-191353: A venerable 712th Tank Battalion M4 advances with riflemen near St. Jores, France, on 7 July 1944. The tank displays the elimination of the hatch shot traps accomplished by welding angled iron plates in front of them. It also has appliqué armor on the right turret side over the gunner's position. (NARA, Signal Corps photo)

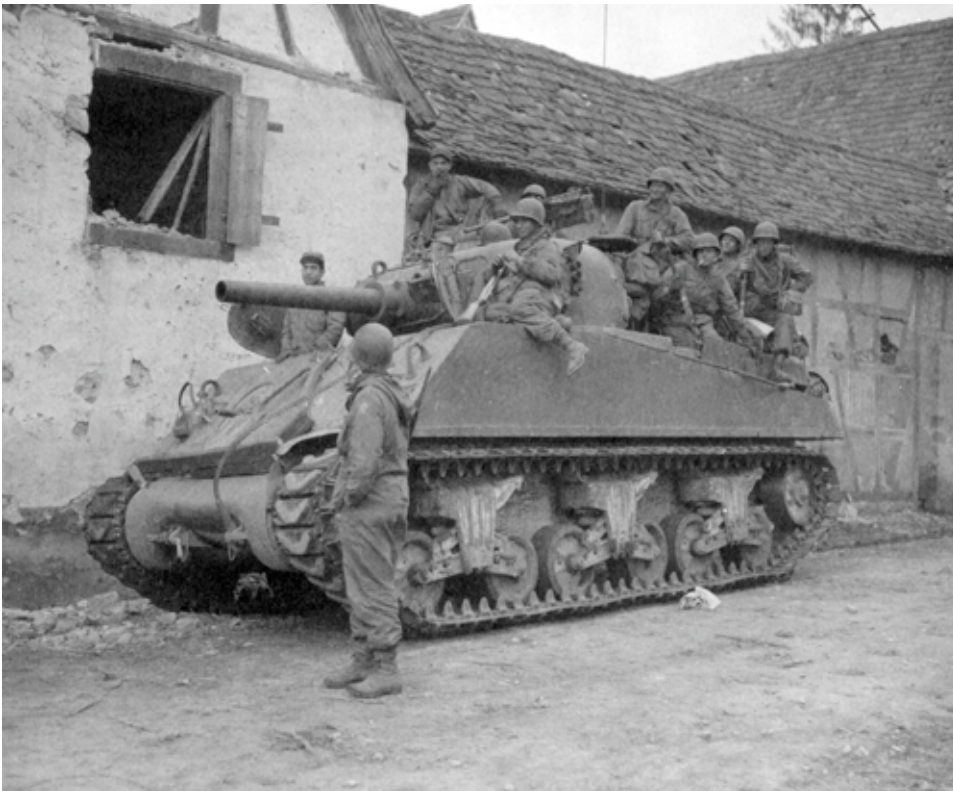
SC-337939: This 105mm assault gun has the 47-degree glacis, which both eliminated the shot traps and provided bigger hatches to the driver and bog. (NARA, Signal Corps photo)

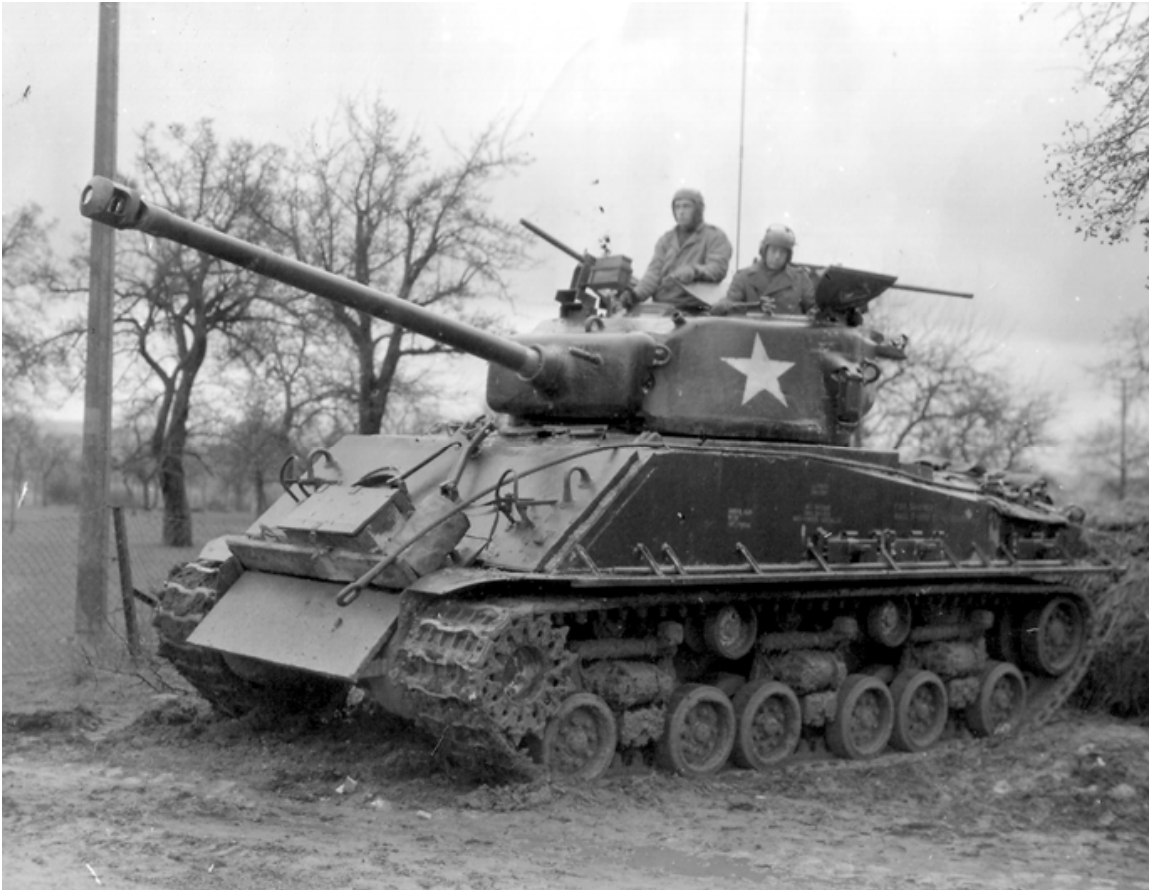
SC-203698: An M4A3E8 with a 1-inch add-on armor plate welded to the glacis. The loader's position is fitted out with an old-style commanders ring hatch. (NARA, Signal Corps photo)

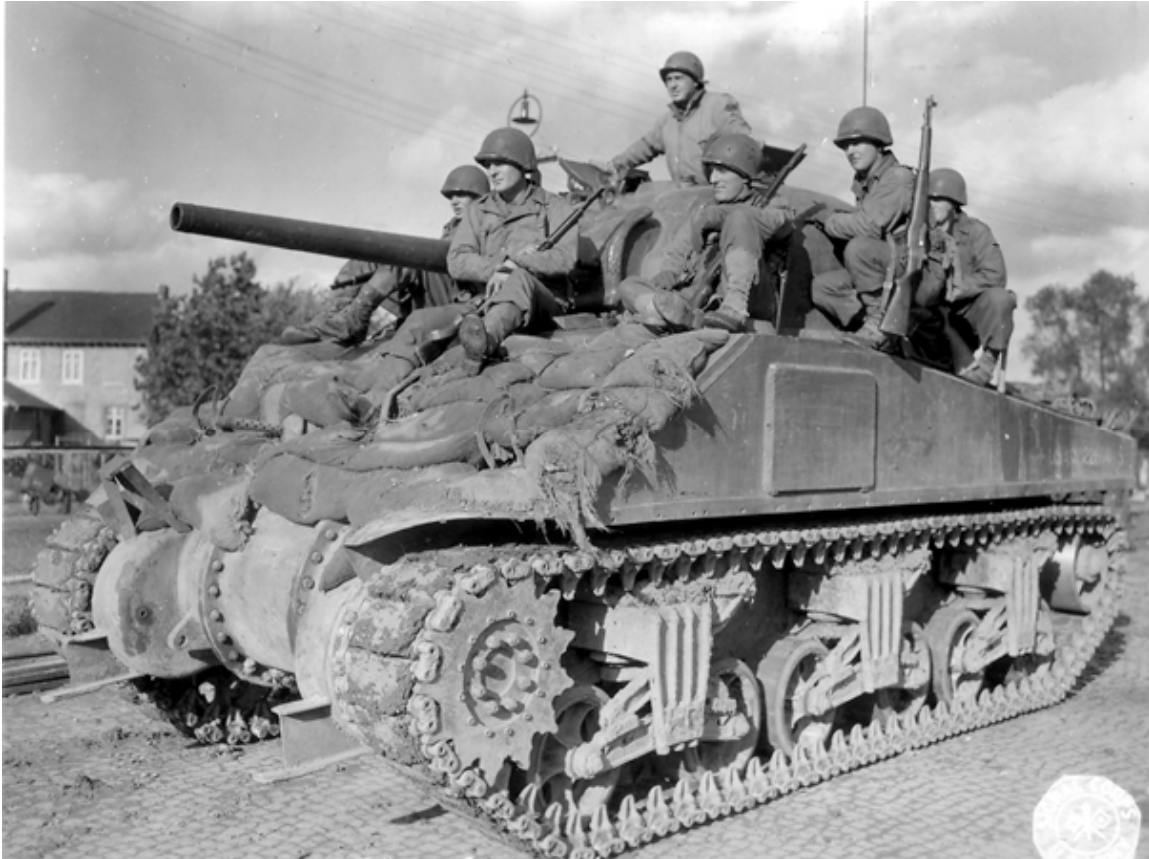
SC-195693: Tankers resorted to field expedients to reduce the likelihood of a penetration, at least by the ubiquitous German bazooka-style weapons. They first turned to sandbags during the fighting in Normandy; tests offered mixed results as to whether the bags worked, but they made tankers feel safer. Here, a 3d Armored Division Sherman displays a typical sandbagging job near Stolberg, Germany, on 14 October 1944. (NARA, Signal Corps photo)

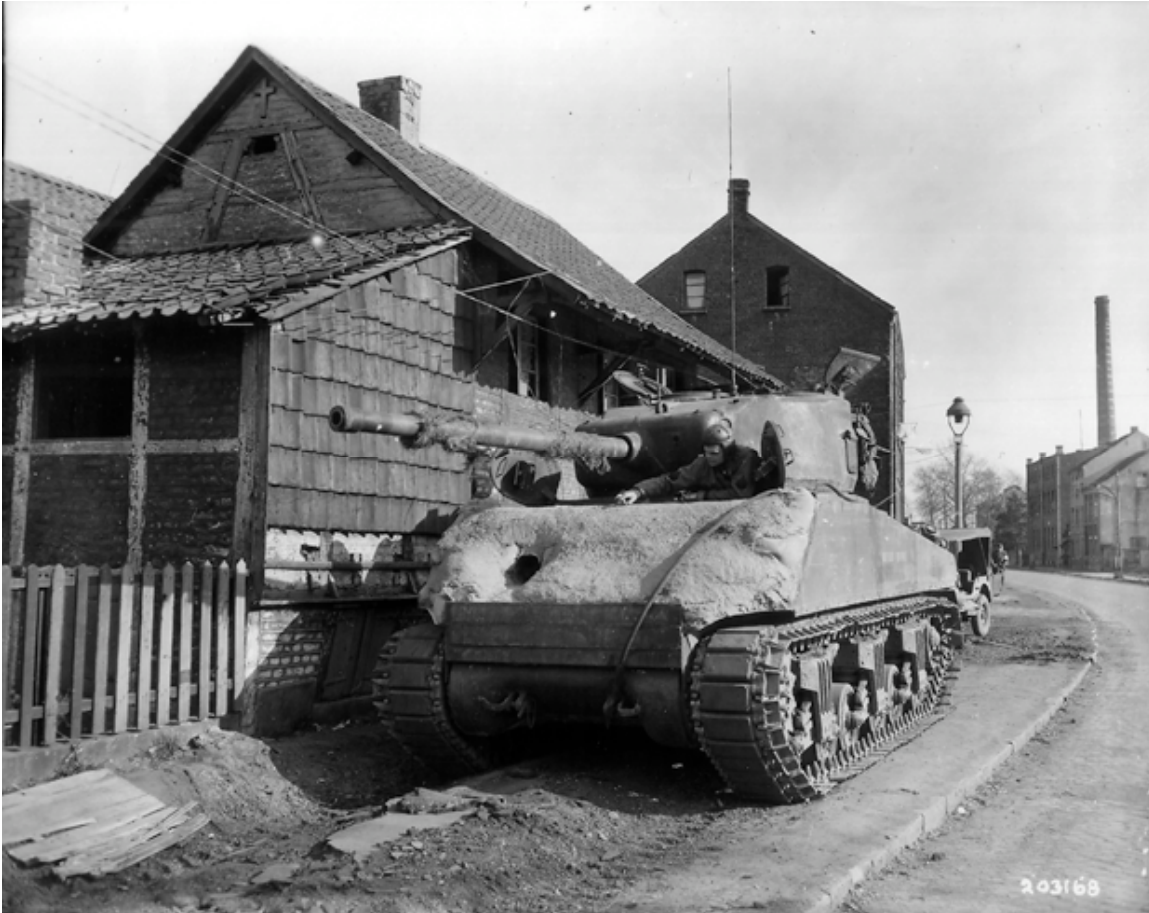
SC-203168: A 2d Armored Division M4A3 (76mm) displays another field expedient armor: a layer of concrete poured on the glacis. Experiments conducted by the 709th Tank Battalion in February 1945 indicated that poured concrete did not stop bazookas from penetrating the armor plate, but that it did reduce the splash of molten steel inside the tank caused by the warhead to "negligible" proportions. (NARA, Signal Corps photo)

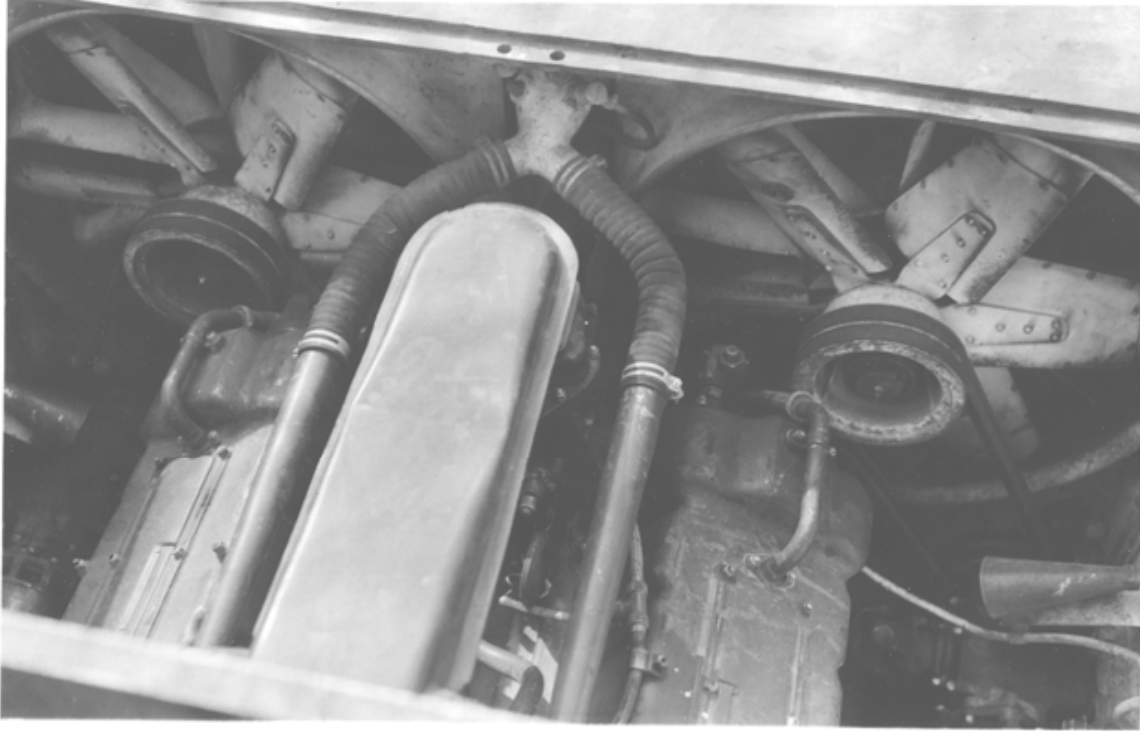
ARMORED FORCE BOARD 3908

Ford V-8 Engine Medium M4A3 showing Fan End.

AFB3908: The Ford V-8 engine became the preferred type in the Sherman and powered the M26 Pershing. (NARA, records of the Chief of Ordnance)

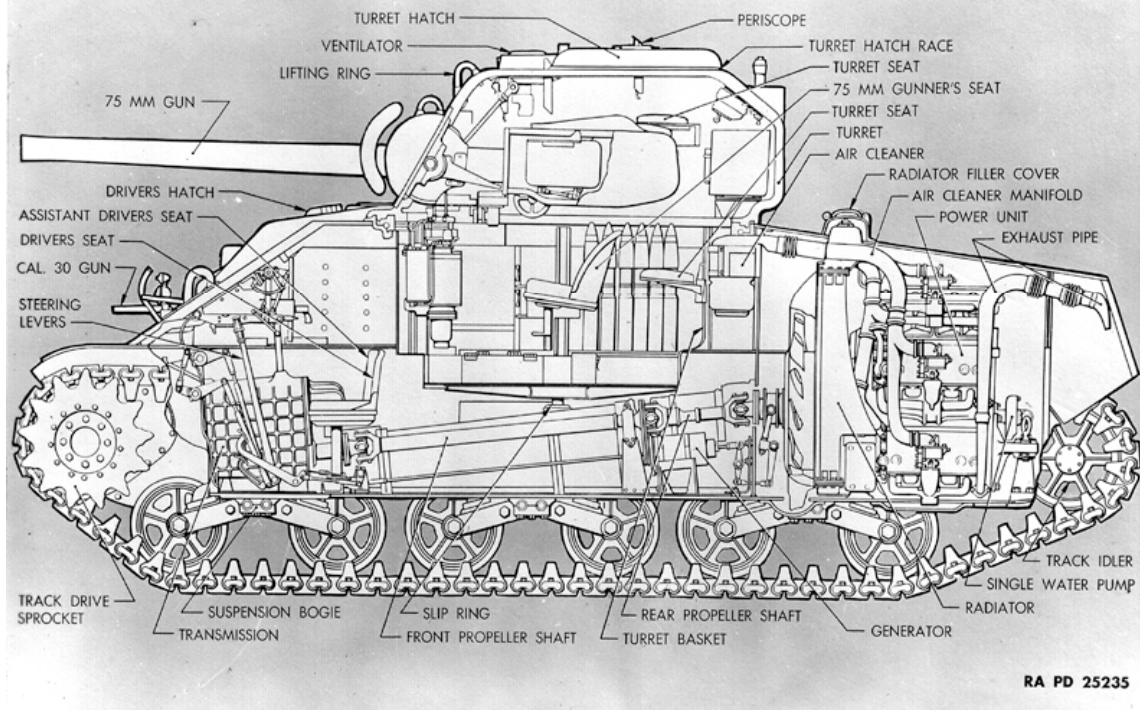
Army5: This diagram of the M4A4, which was used for training by some American battalions but was mainly supplied to the Allies under Lend-Lease, shows a typical internal Sherman layout. The M4A4 had five automobile engines welded together and a slightly longer hull to fit them. (NARA, records of the Chief of Ordnance)

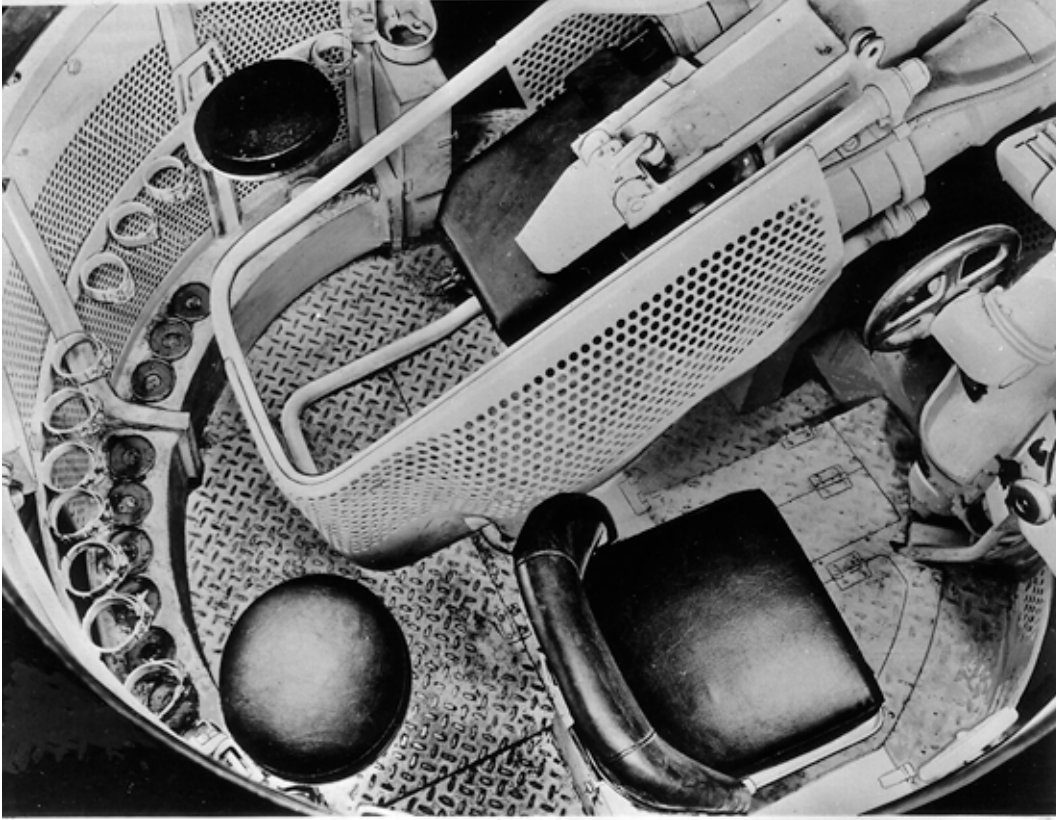
Army8: View of the turret interior in a 75mm Sherman. The seats, clockwise from the upper one, are the loader's, the gunner's and the commander's. The hoops on the turret basket are the ammunition ready racks. (NARA, records of the Chief of Ordnance)

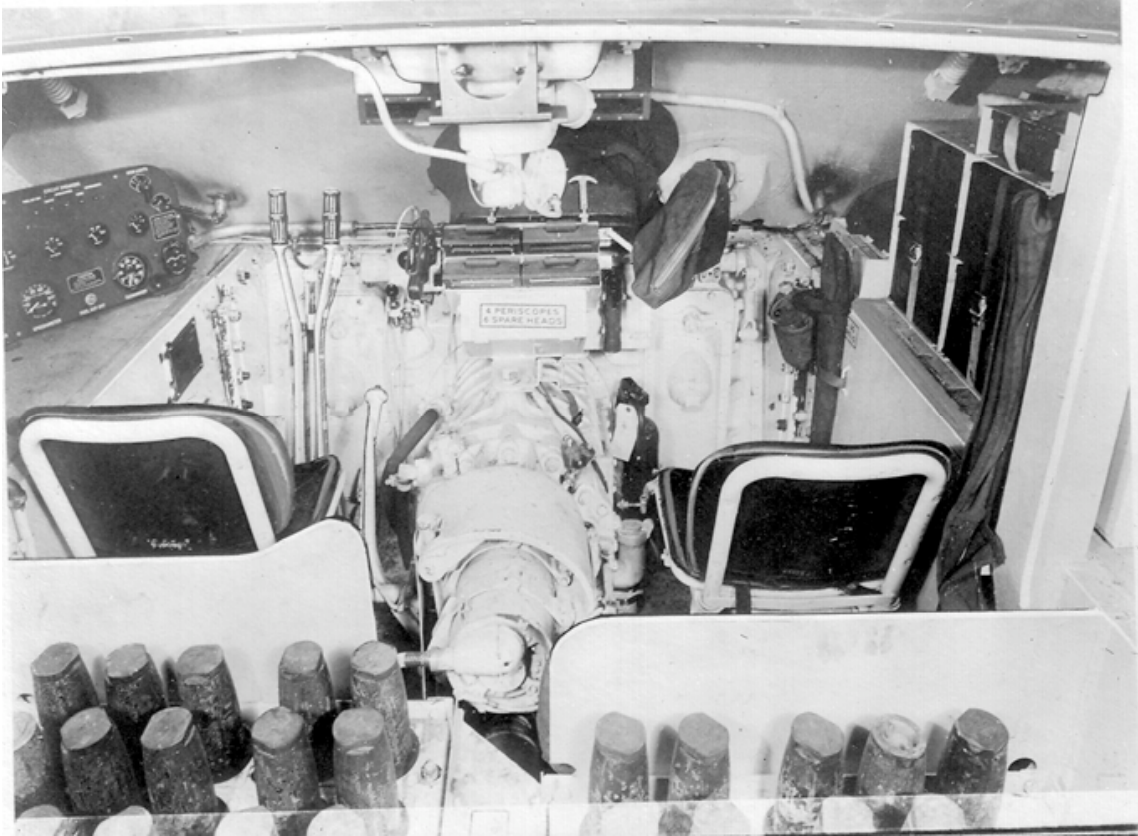
Army9: Interior of the M4 hull; the bow machine gun is covered. The transmission is between the two seats, and the driver's steering levers, which applied the brakes to the two tracks, are visible. Note the ammunition racks behind the seats; one of the bog's jobs was to pass shells up into the turret basket. (NARA, records of the Chief of Ordnance)

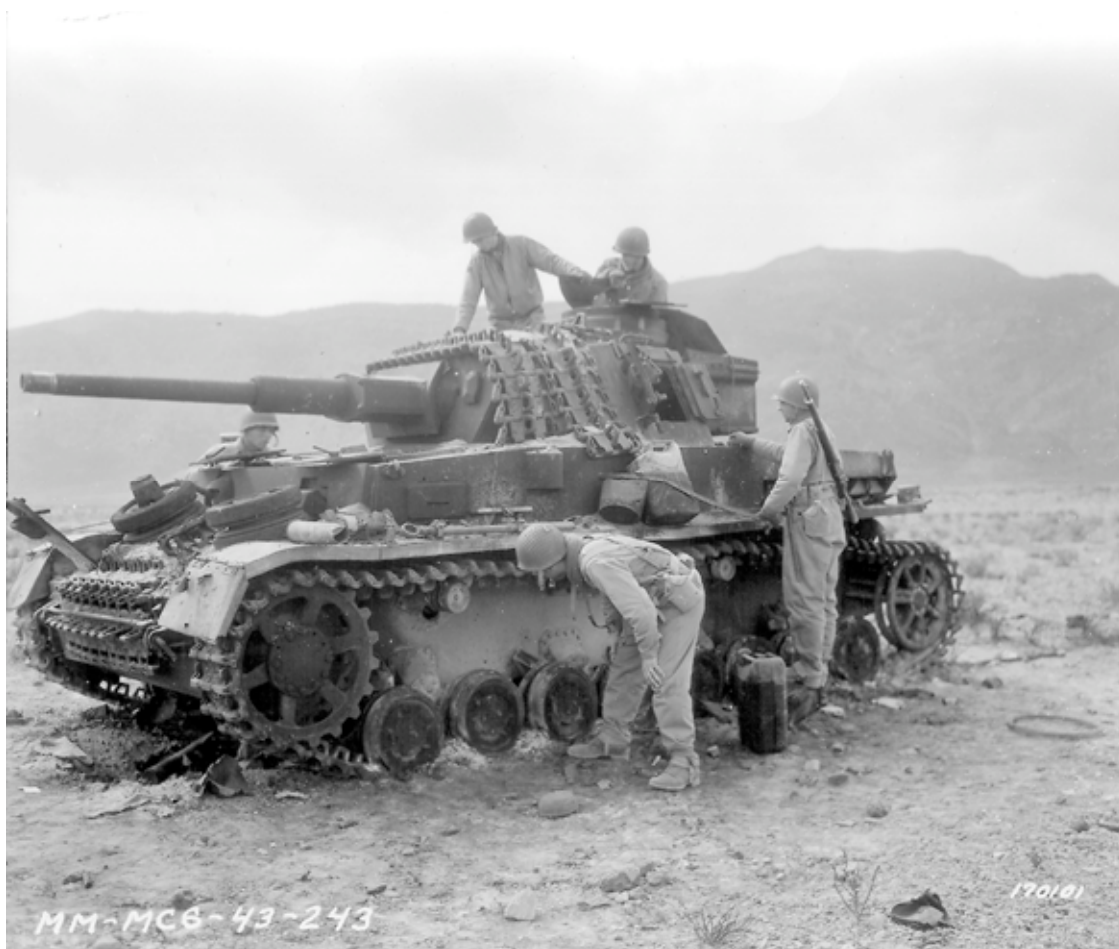
SC-170101: A German Mark IV knocked out by artillery fire at Kasserine Pass only days after Hightower's shootout. With the long 75mm gun, the panzer was a rough match for the Sherman. (NARA, Signal Corps photo)

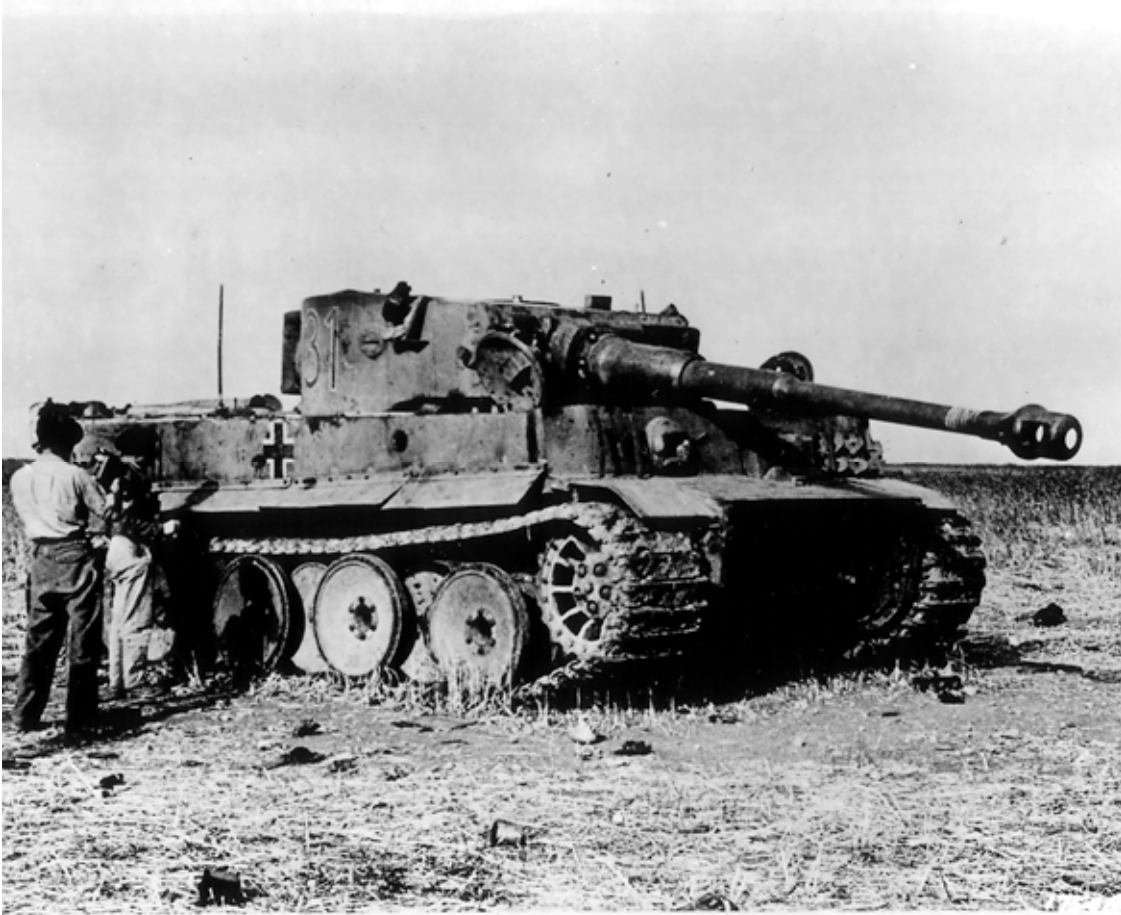
SC-175484: A Mark VI knocked out by a British Sherman in Tunisia in April 1943. An M4 gunner usually had to catch a Tiger with a shot from the flank, as in the case, or the rear in order to score a kill. (NARA, Signal Corps photo)

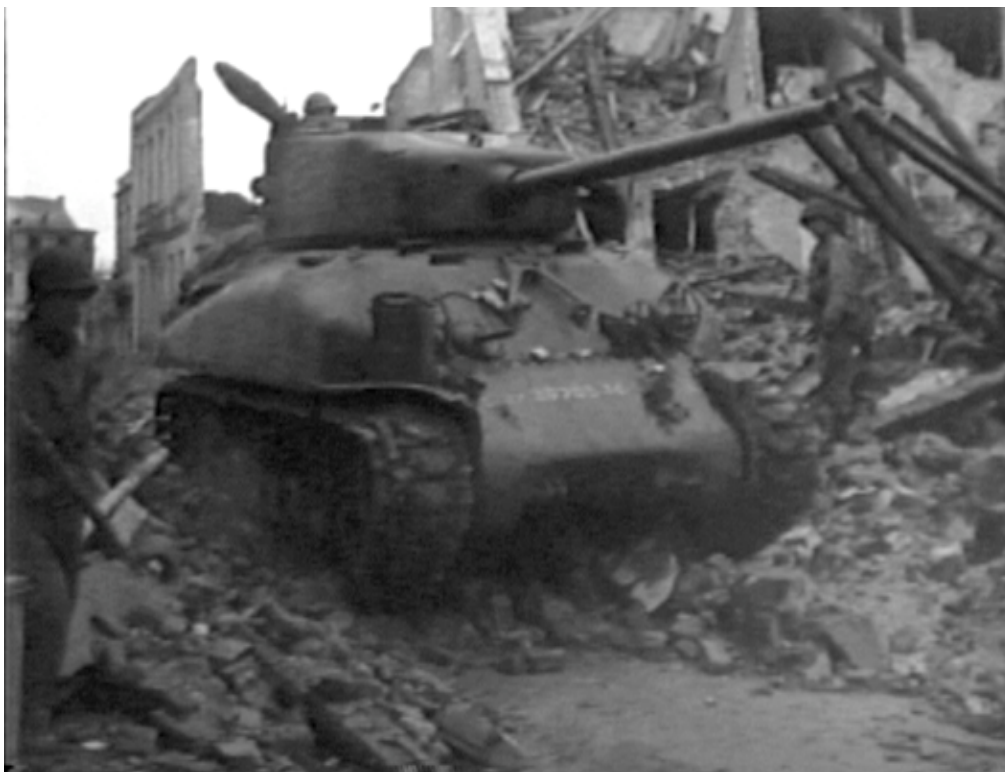
111-ADC-9704_2: A better view of the M4A1 (76mm), again belonging to the 3d Armored Division; this tank is part of the force that captured Cologne in March 1945. (NARA, Signal Corps film)

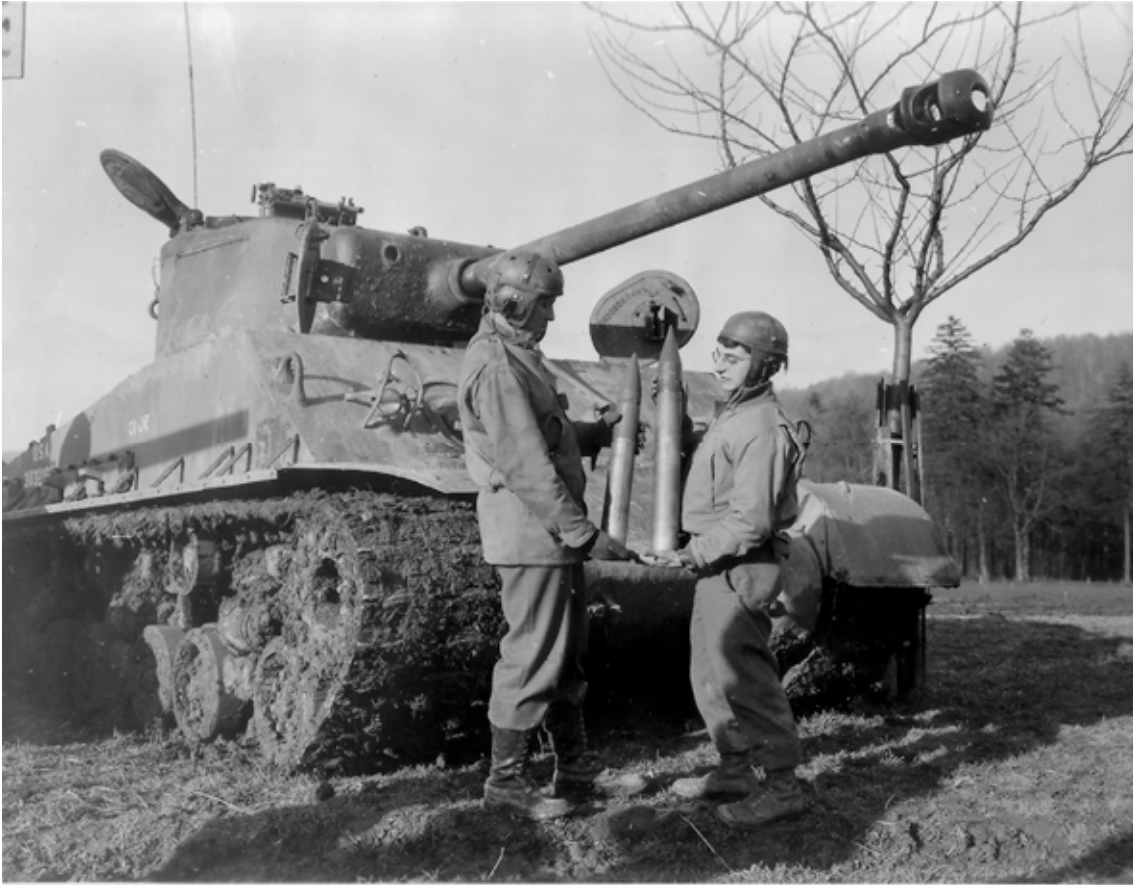
SC-208218: Second Armored Division tankers compare 76mm (right) and 75mm ammunition in front of an M4A3E8. (NARA, Signal Corps photo)

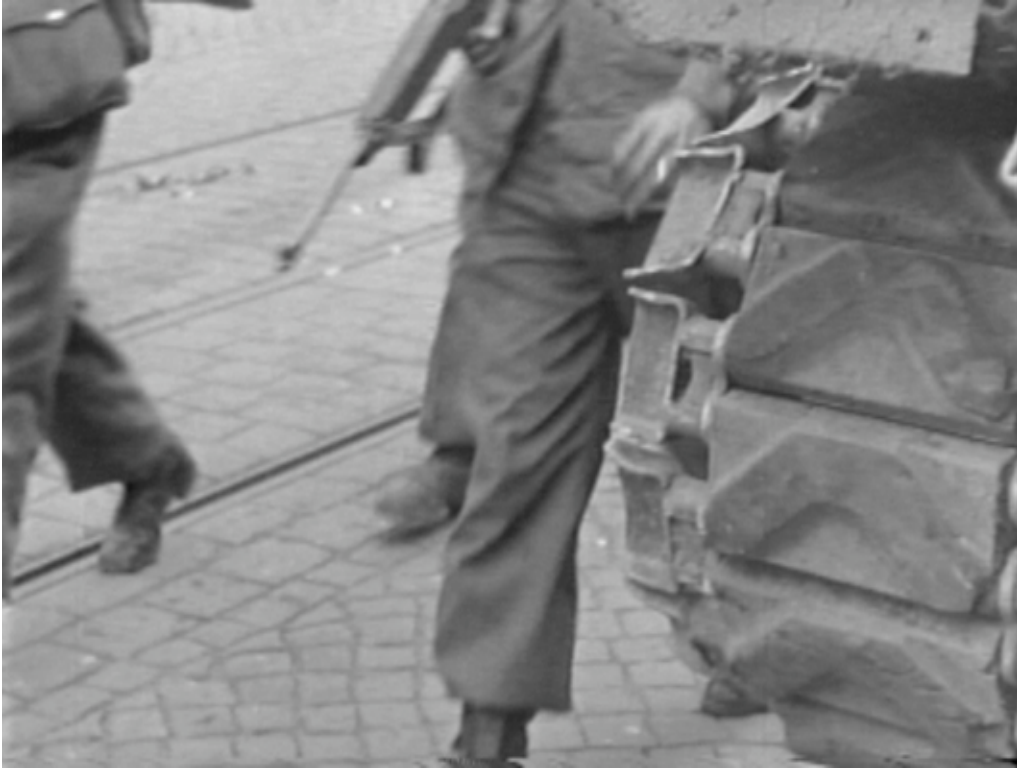
111-ADC-4025_1: A close-up view of track grousers, with their curved-edge construction that inspired the nickname "duckbills". (NARA, Signal Corps film)

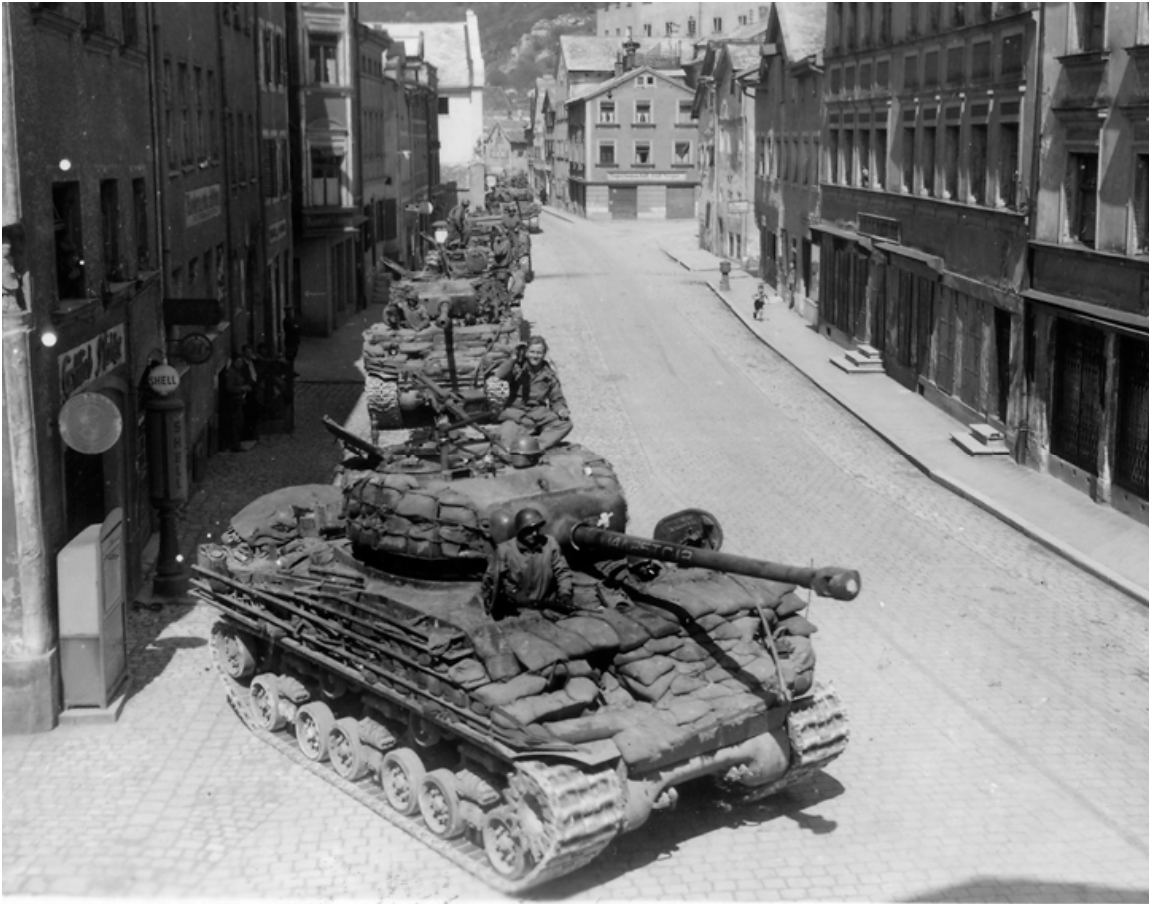
SC-205225: The 25th Tank Battalion, 14th Armored Division, enters Eichstatt on 25 April 1945. Though blessed with improvements to the gun and suspension, the Easy 8 had armor no thicker than that on earlier models, so crews continued to turn to sandbagging for extra protection. (NARA, Signal Corps photo)

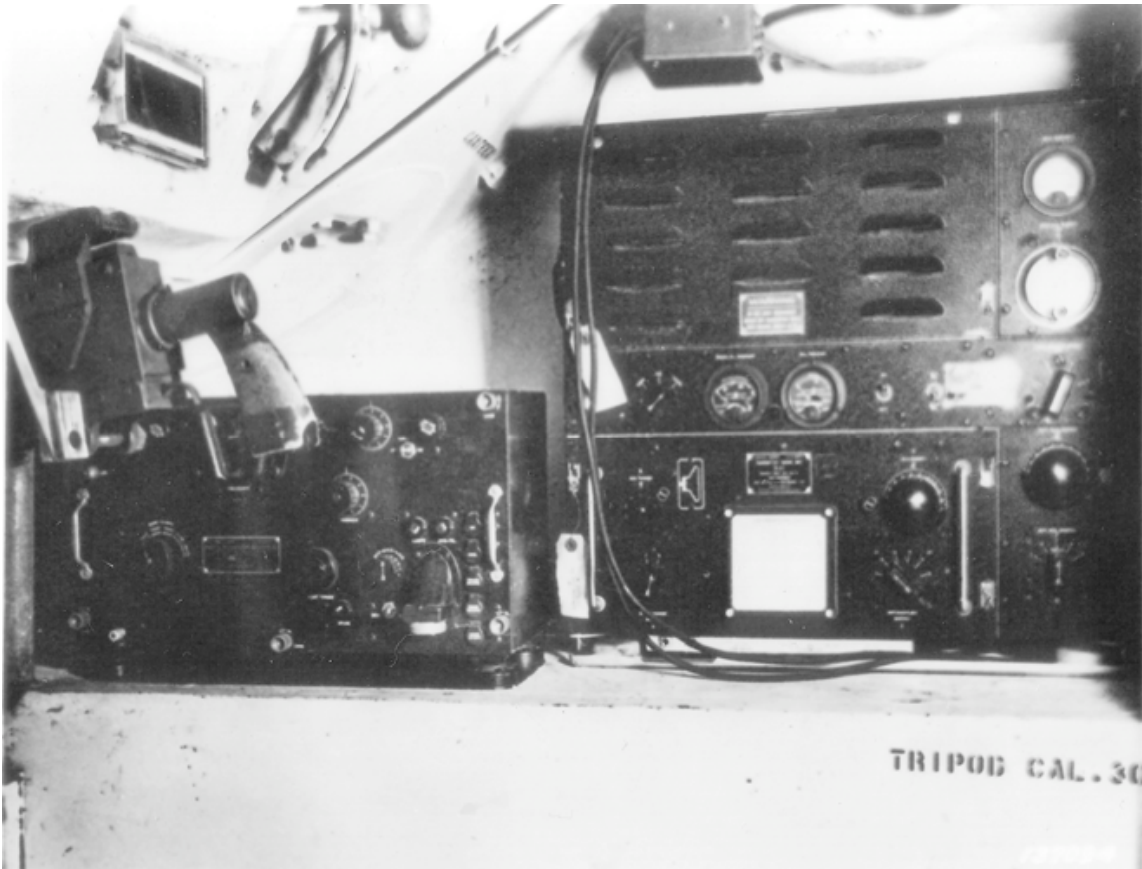
SC-137094-R: The bog's .30-caliber machine gun (left) in place in an M4A3 command tank. The bog had to aim his fire by watching where his tracer rounds hit; the fixed periscope that replaced early vision blocks is visible above the weapon. The Sherman carried a tripod so that the crew could use the weapon dismounted from the tank. (NARA, Signal Corps photo)

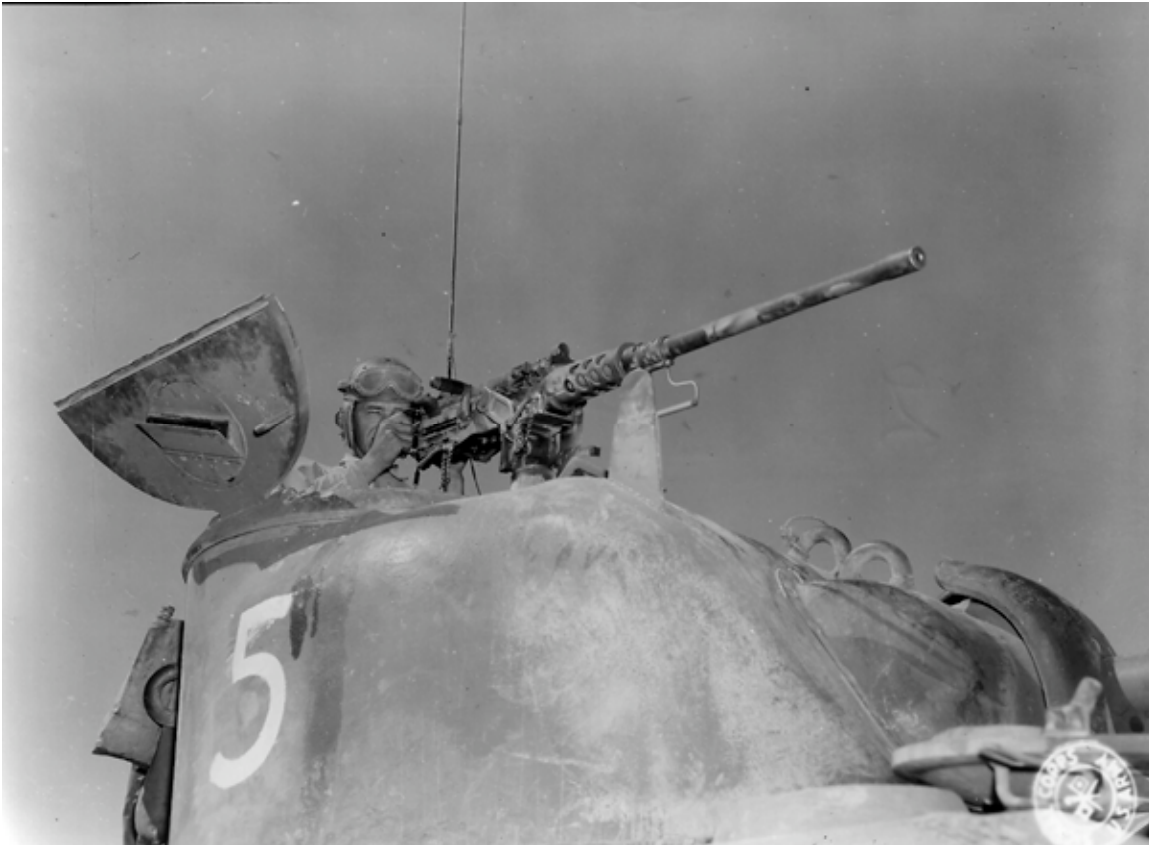
SC-239946: Firing the .50-caliber machine gun mounted beside the commander's hatch on an early model M4. This photo offers a clear view of the blade-style sighting vane the commander could use to roughly aim the main gun at a target. (NARA, Signal Corps photo)

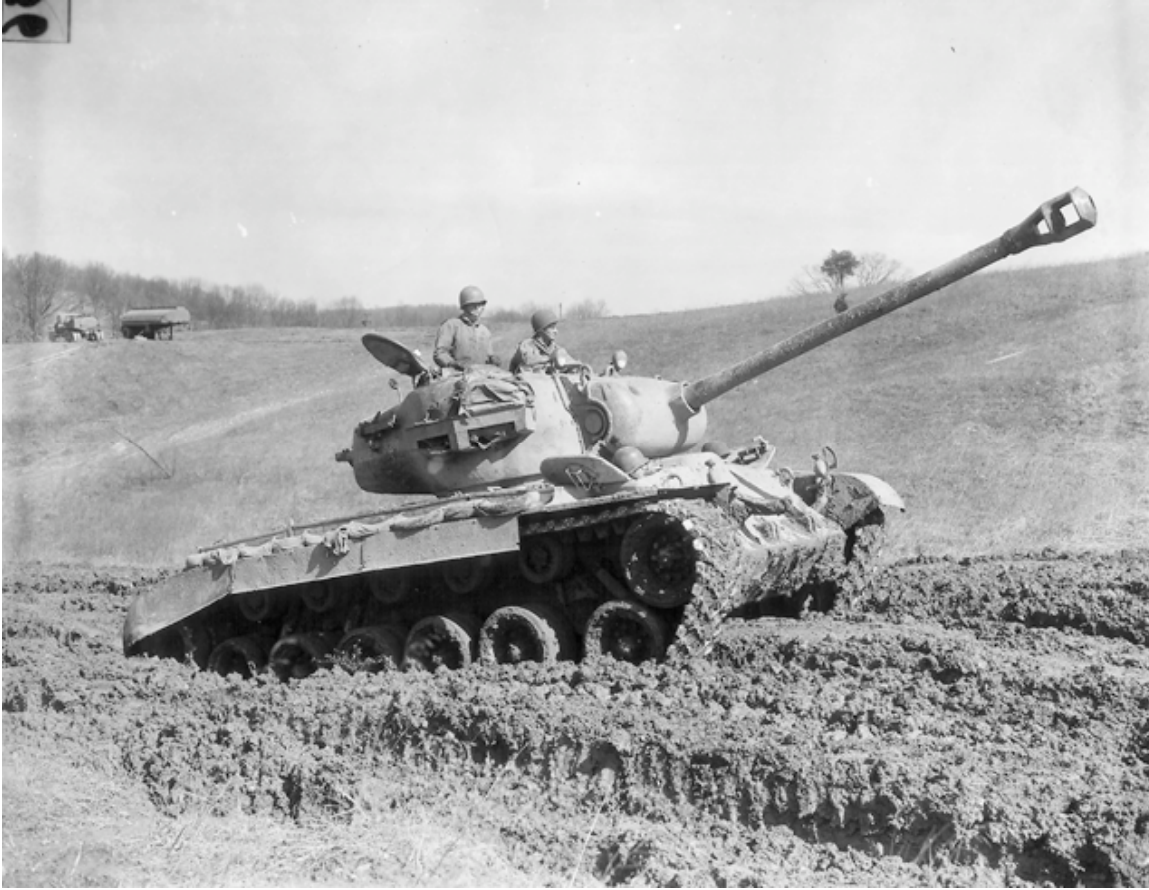
SC-204486: The new M26 heavy tank at Aberdeen Proving Grounds. The torsion-bar suspension system became standard on American tanks for decades to come. (NARA, Signal Corps photo)
