Weapons of Tank Battalions Illustrations

Chapter 3: Medium Tanks

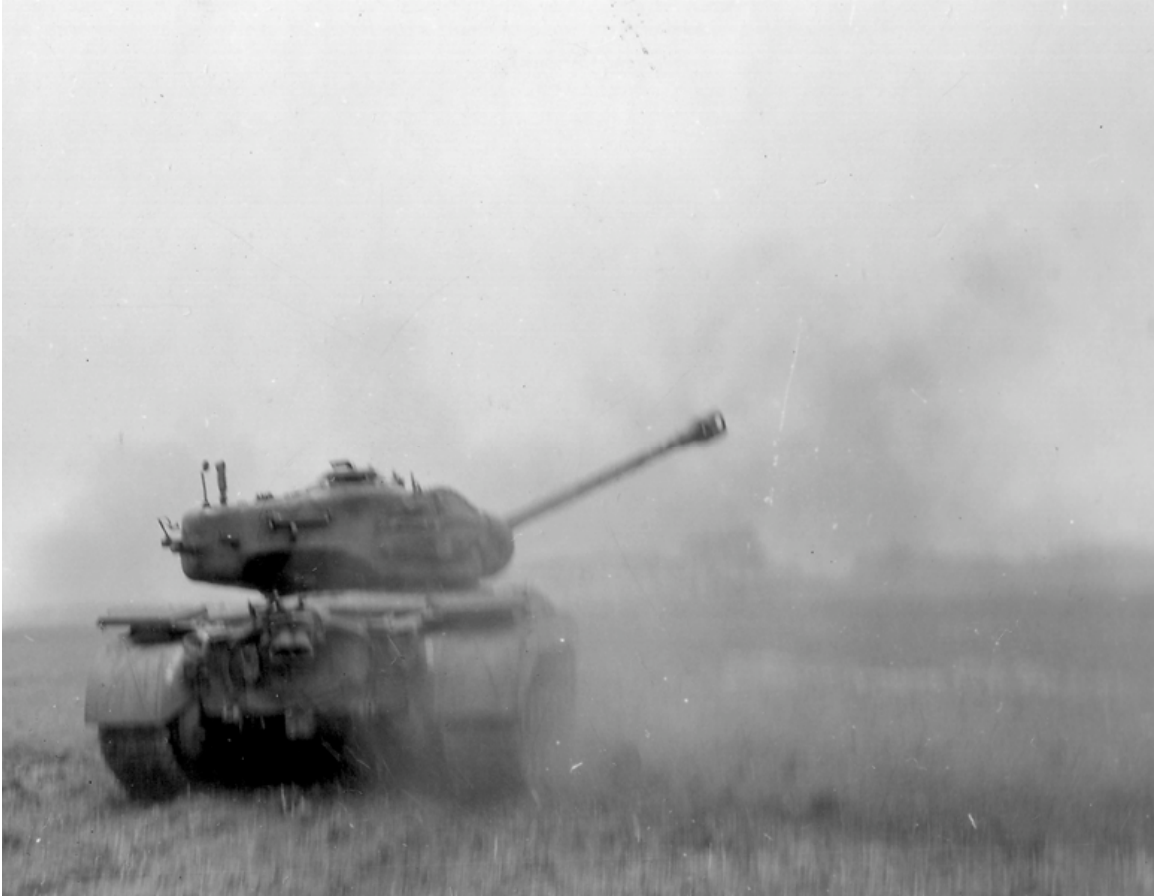
SC-210672: An M26 fires at German positions on the far side of the Rhine River in March 1945. (NARA, Signal Corps photo)

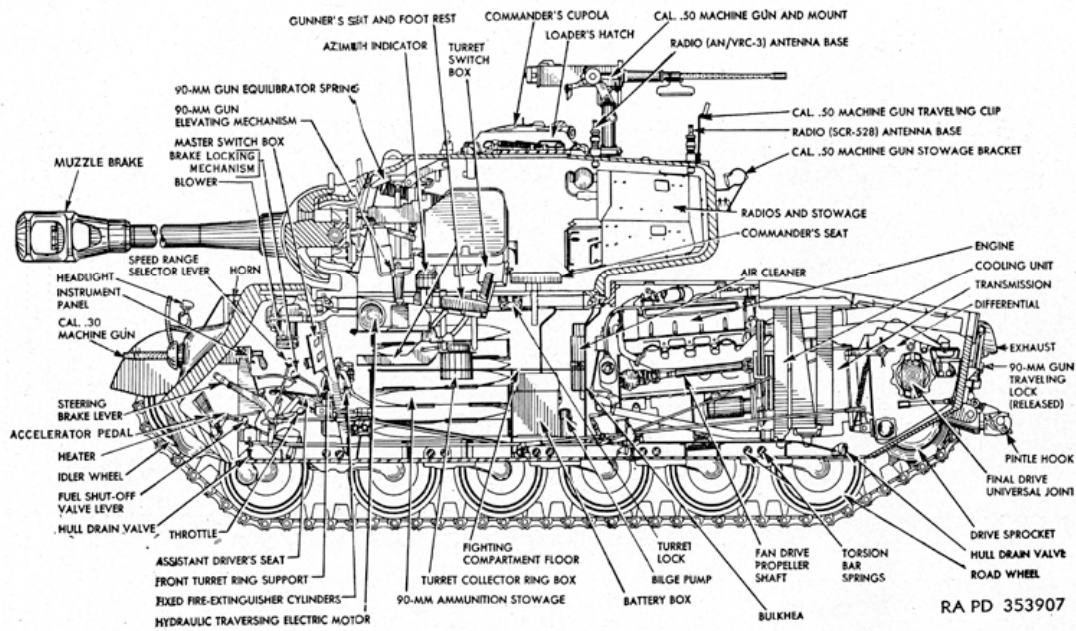
TM 9-735_1: Internal layout of the M26 Pershing. (NARA, records of the Government Printing Office)
