Weapons of Tank Battalions Illustrations

Chapter I: History

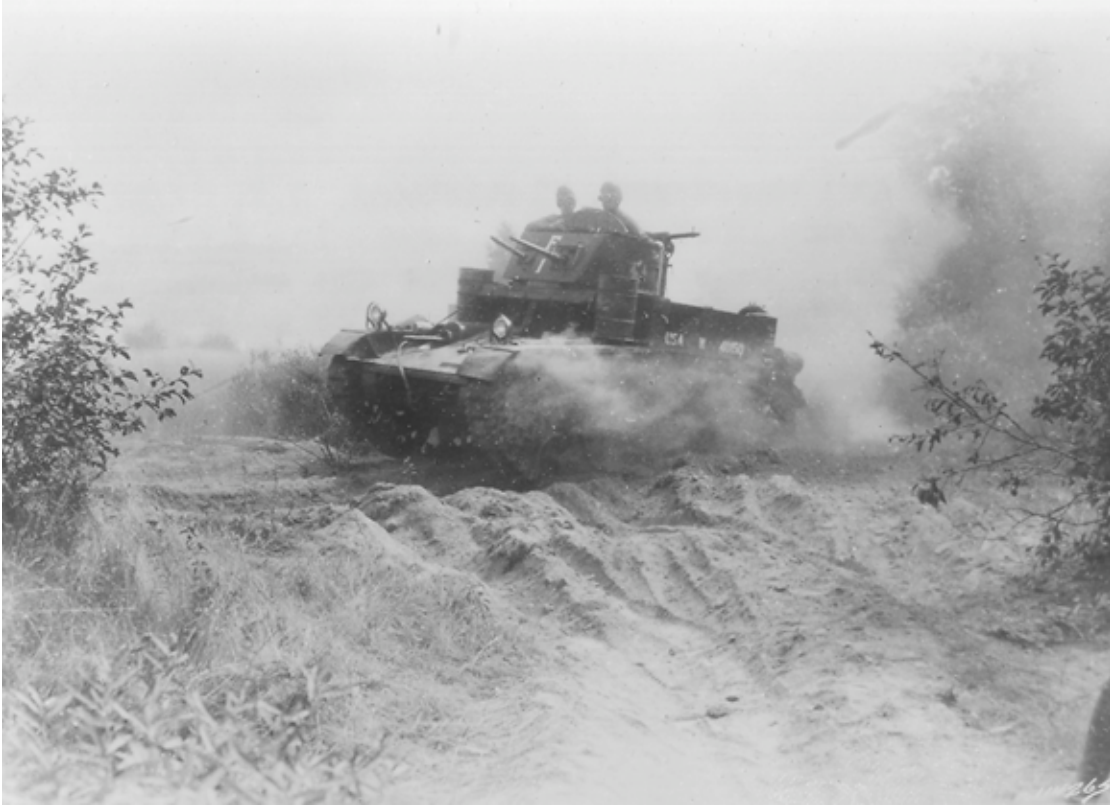
SC-114265: Armor-minded cavalry officers thought vehicles could replace horses in slashing maneuver. Here, an M1 combat car from the 1st Cavalry advances during maneuvers in August 1939. (NARA, Signal Corps photo)

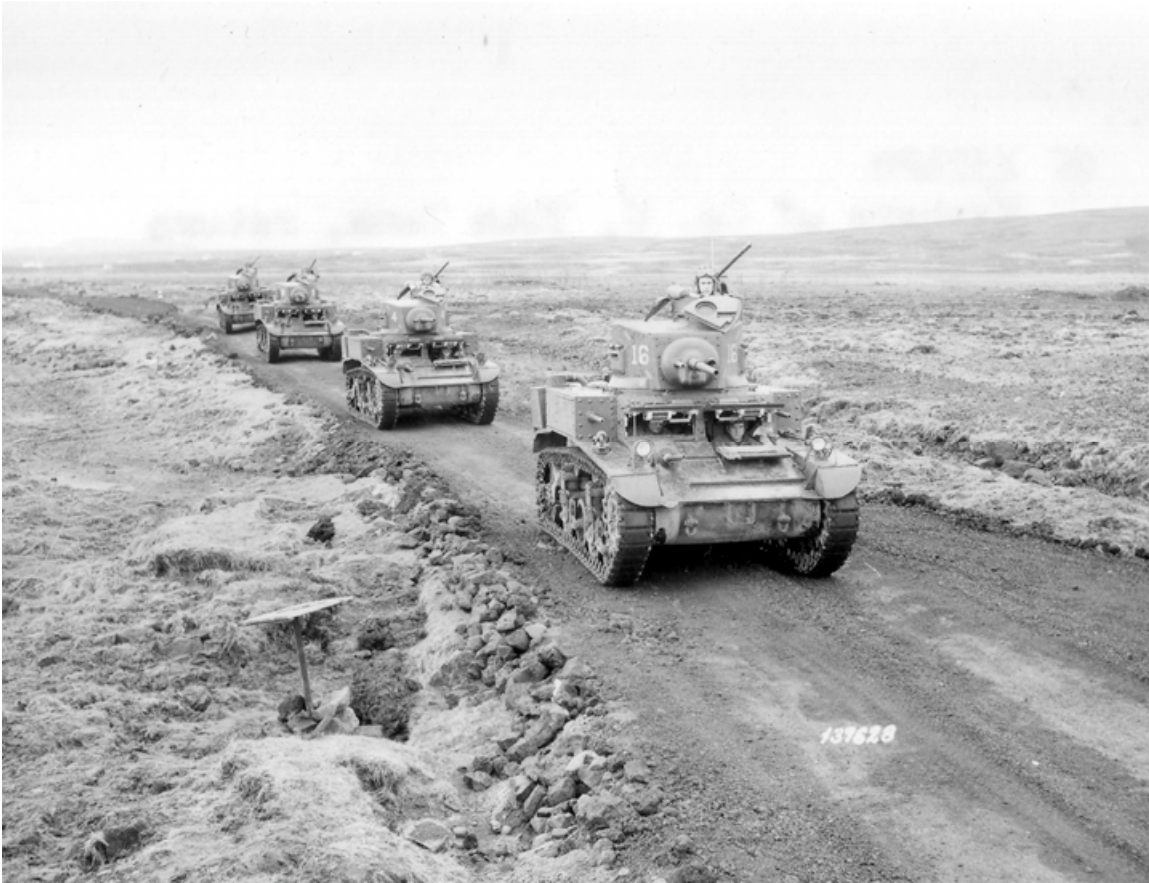
SC-137628: The first GHQ tank battalion, the 70th, was to have received medium tanks but did not because the armored divisions had first priority. The 70th reorganized as a light tank battalion. These M3 light tanks belong to Company C, which was sent to Iceland in March 1942 and later returned to the battalion as Company D. (NARA, Signal Corps photo)

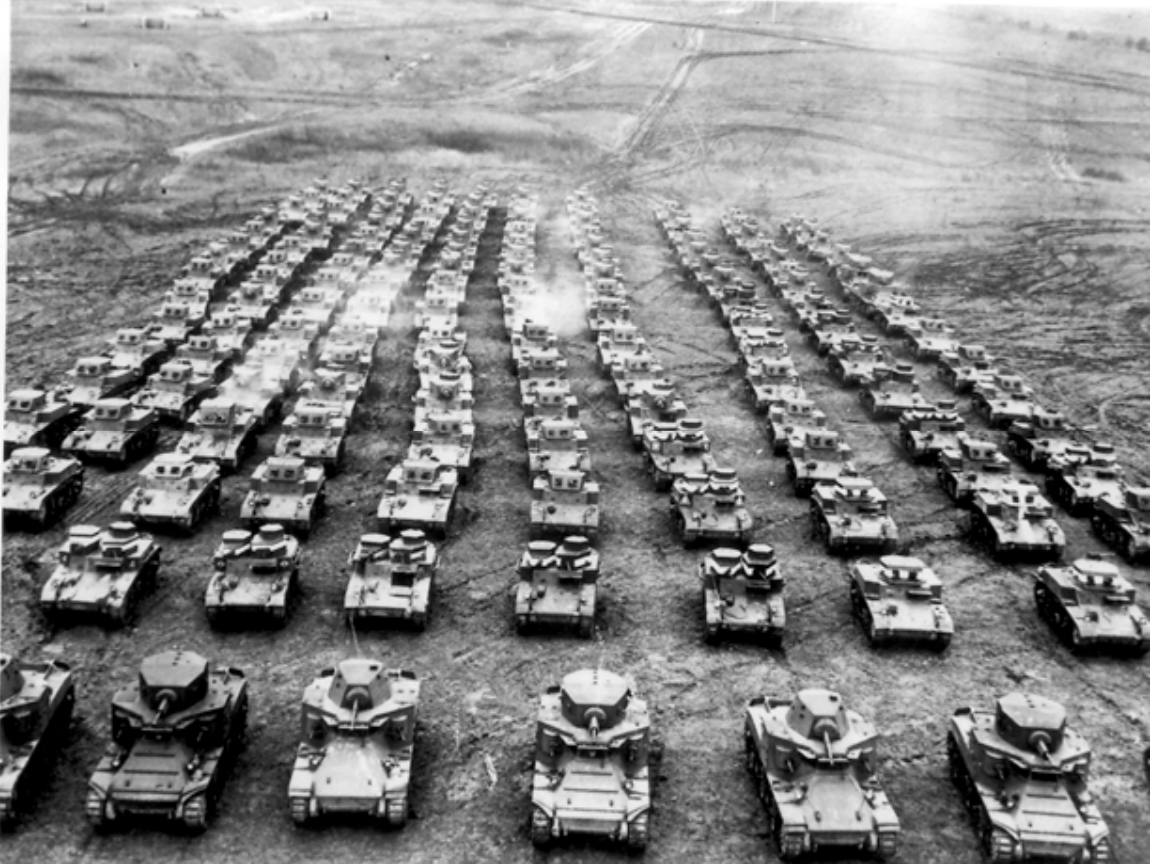
SC-118008: Part of the 1st Armored Division's tank brigade in formation at Fort Knox in March 1941. The tanks are a hodgepodge of prewar models. M2 and M2A1 medium tanks, the latter with larger turrets, form the front line. They carry a 37mm main gun and bristle with machine guns. The rest are light tanks and combat cars, the most modern being the M2 light tank with a 37mm gun. (NARA, Signal Corps photo)

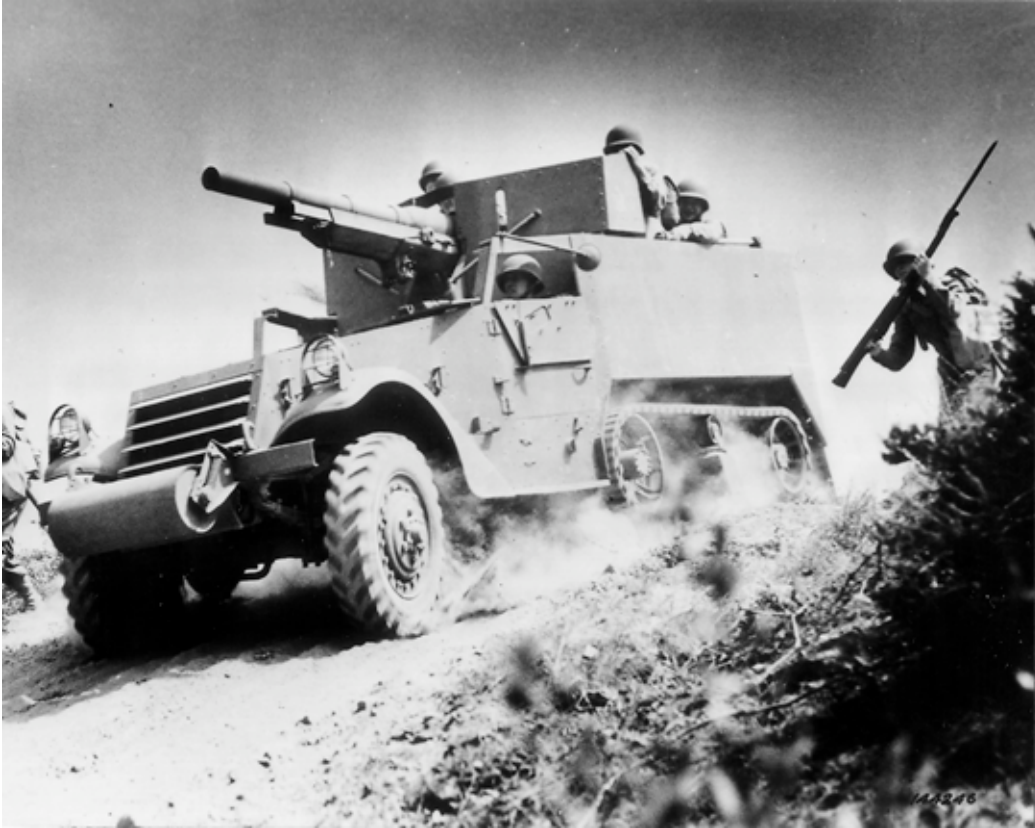
SC-144246: According to U.S. Army doctrine, the tank destroyer—here the stopgap M3 mounting a 75mm gun—was supposed to battle enemy tanks while friendly tanks dealt with other targets. (NARA, Signal Corps photo)

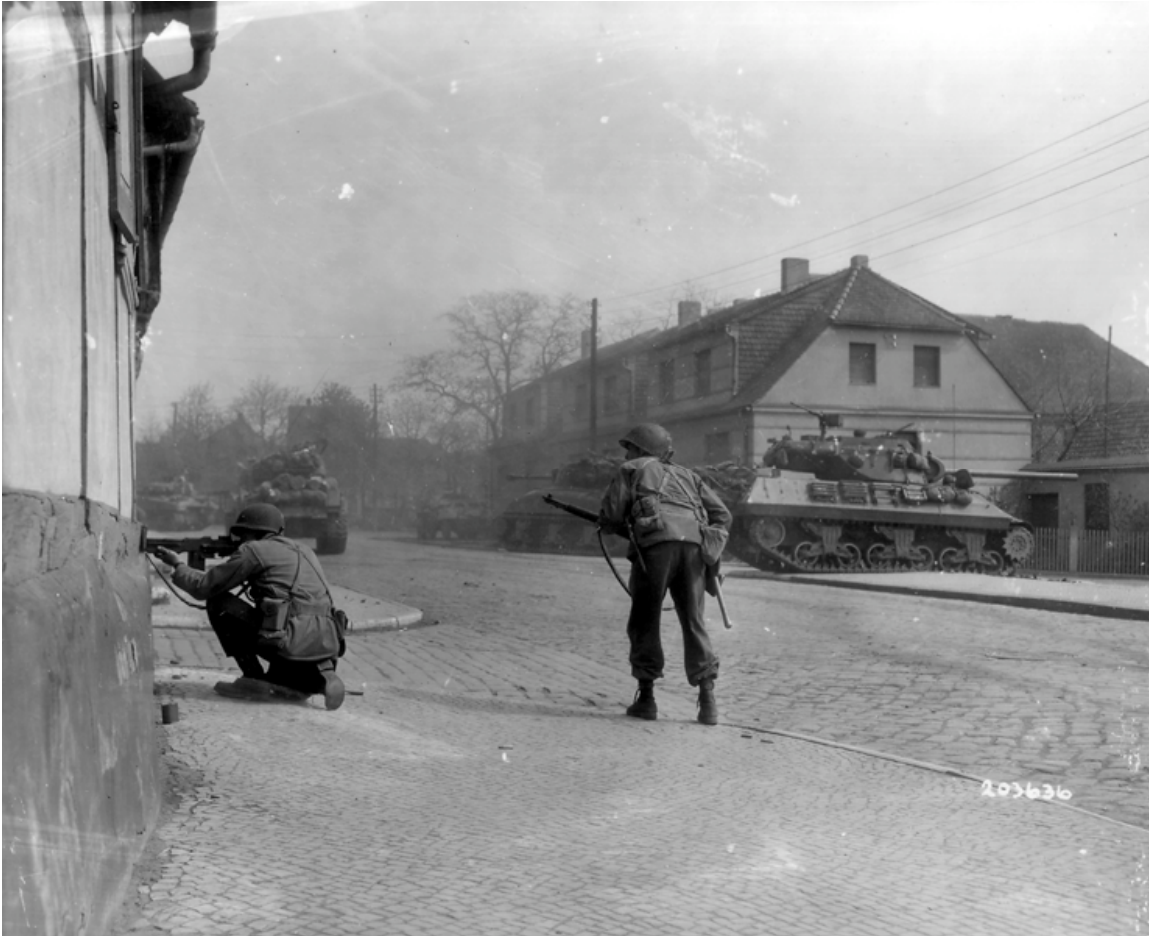
SC-203636: Tanks, TDs, and infantry from CCA, 5th Armored Division, work together to clear Tangermünde, Germany, on 12 April 1945. The tank destroyer is an M36, which carried a 90mm gun. The 740th Tank Battalion used several M36s in action after it had to equip itself with whatever was available from a repair depot during the Battle of the Bulge. (NARA, Signal Corps photo)

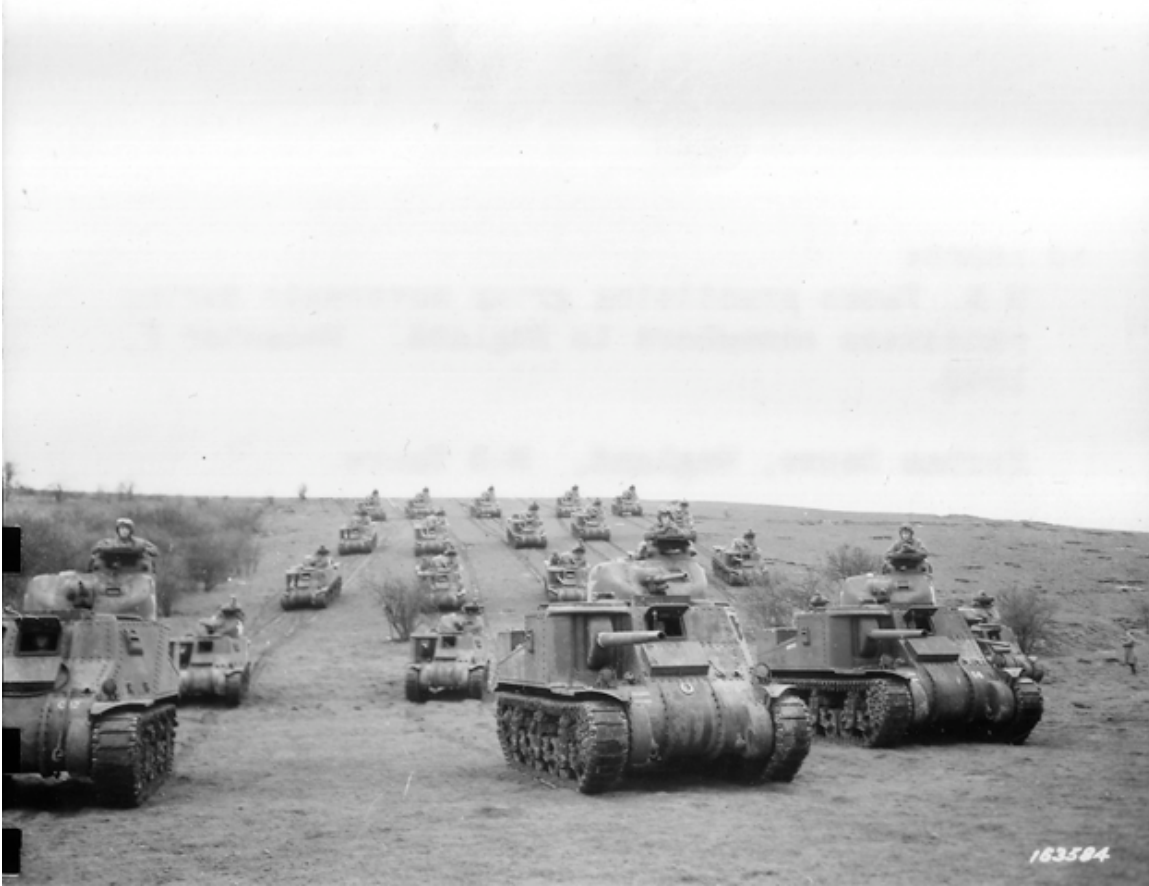
SC-163584: The look of a medium tank battalion under way in December 1942, with more than a company of vehicles visible in this shot. This unidentified separate tank battalion is part of the 1st Tank Group. These are late production M3s, on which the side access doors were eliminated because they weakened the armor protection. (NARA, Signal Corps photo)

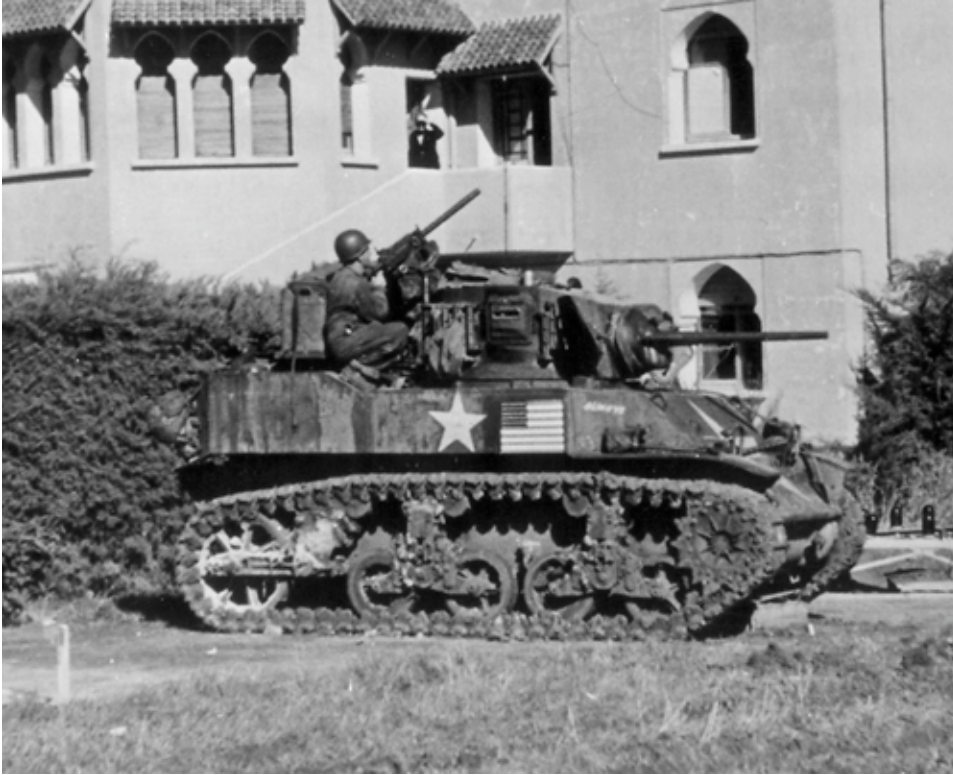
SC-172606: A 70th Tank Battalion M5 crewmember mans the anti-aircraft .30-caliber at Casablanca Airport in November 1942. The new M5 had sloped armor that offered better ballistic protection and twin Cadillac engines, but it retained the M3 Stuart's 37mm main gun. (NARA, Signal Corps photo)

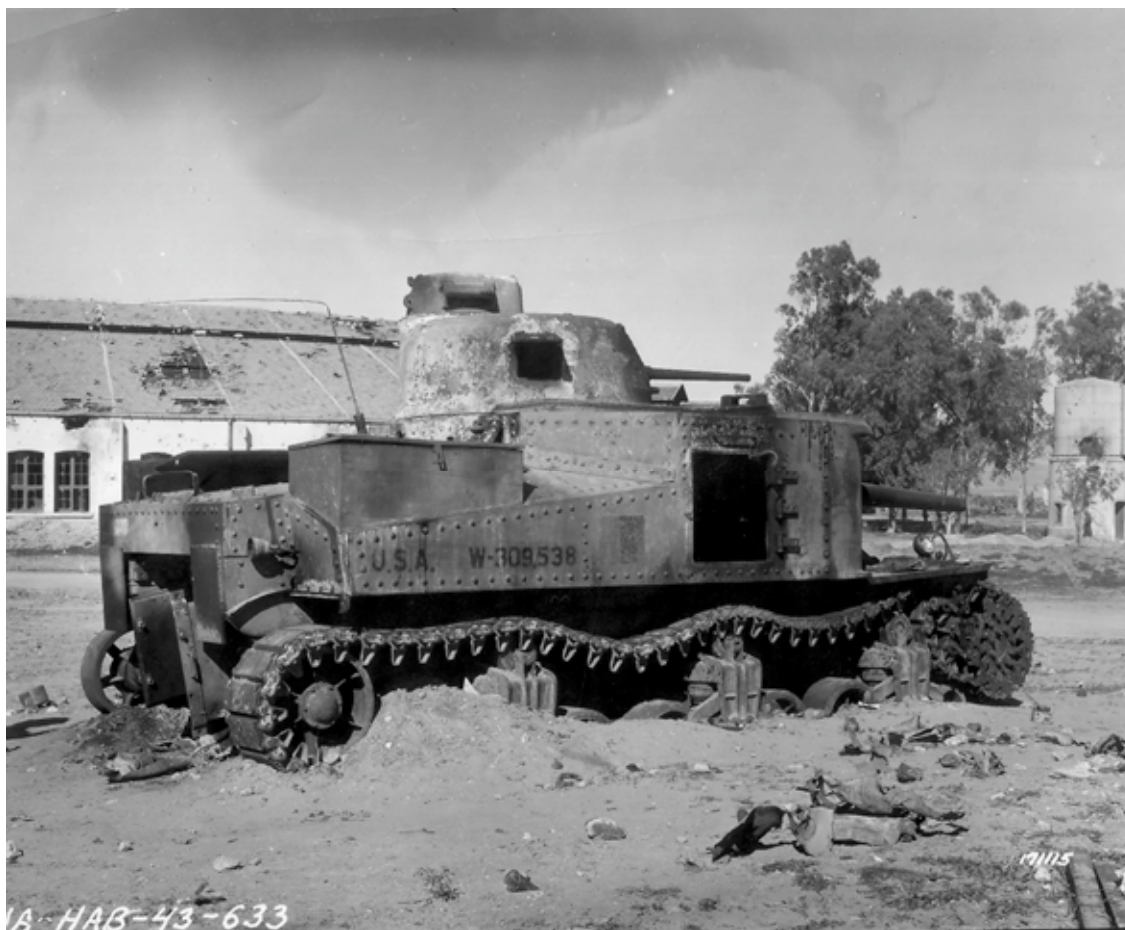
SC-171115: Results of an 88mm gun hit on an M3 Lee. (NARA, Signal Corps photo)

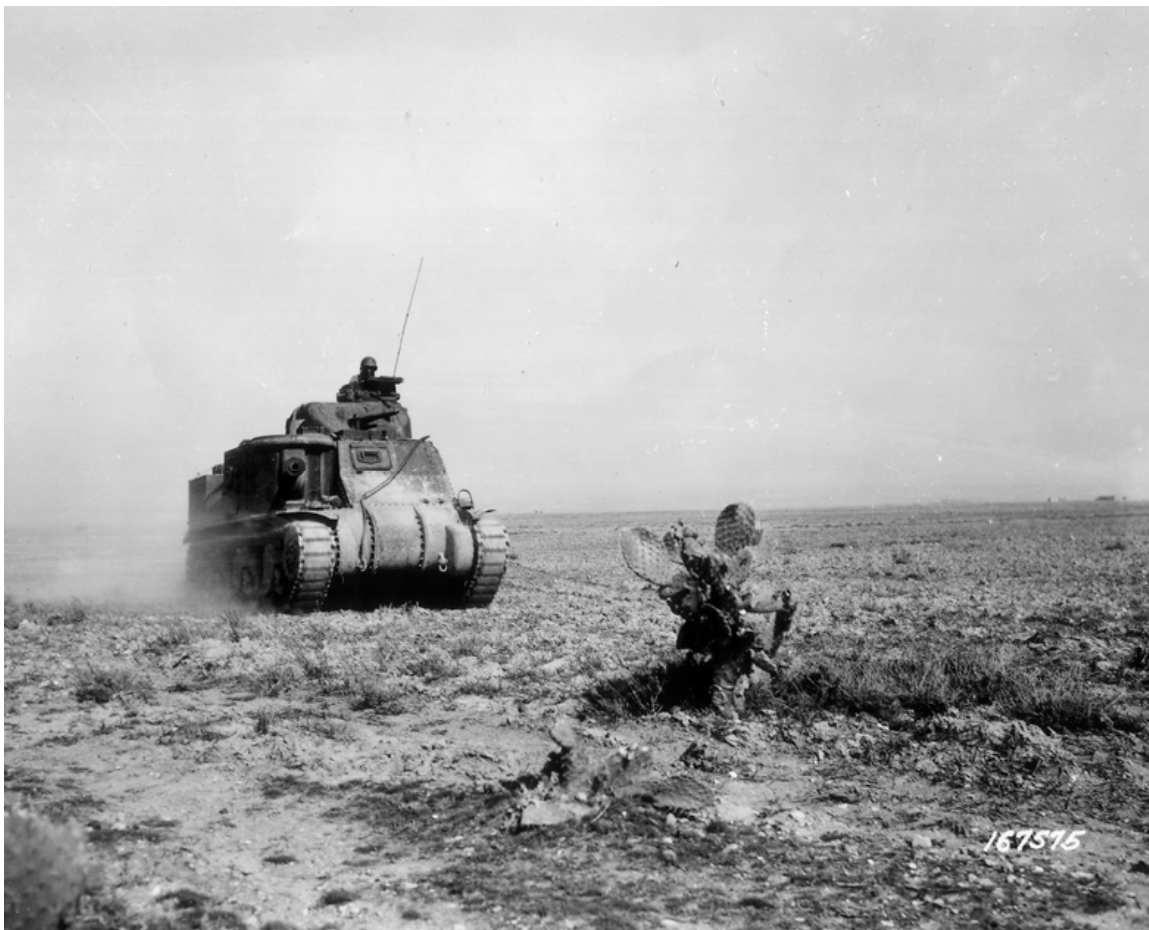
SC-167575: A 13th Armored Regiment M3 Lee on 20 February 1943 rolls toward the enemy near Kasserine Pass. This photo illustrates the M3's potentially dangerous high silhouette. (NARA, Signal Corps photo)

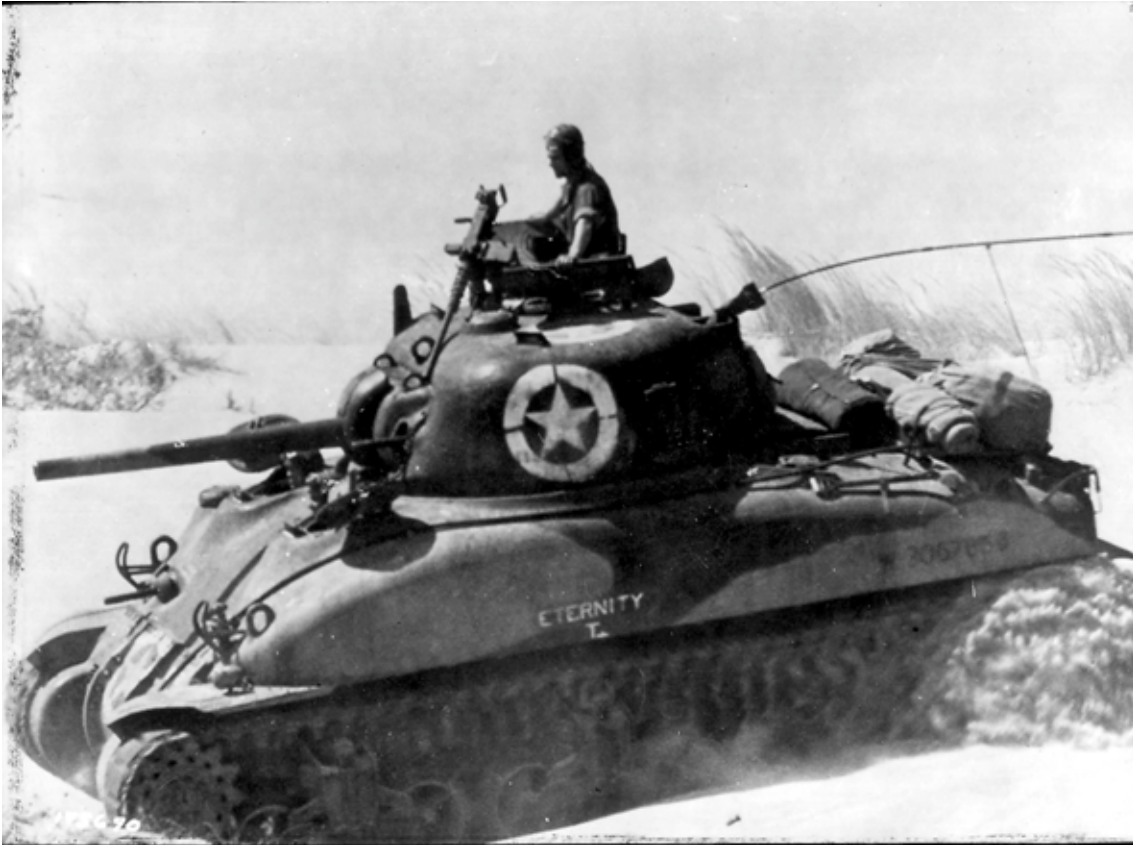
SC-175690: An early production M4A1—almost certainly from the 753d Tank Battalion—plows its way up a Sicilian beach on D-day, 10 July 1943, just after leaving an LCT. The tank has a riveted three-piece final drive housing, the narrow main gun mantlet and simple slit for the coaxial machine gun, and M3 Lee-pattern bogies with the return rollers directly over the center of the assemblies. The driver and bog, however, have fixed periscopes in front of their hatches rather than the very early vision blocks. (NARA, Signal Corps photo)

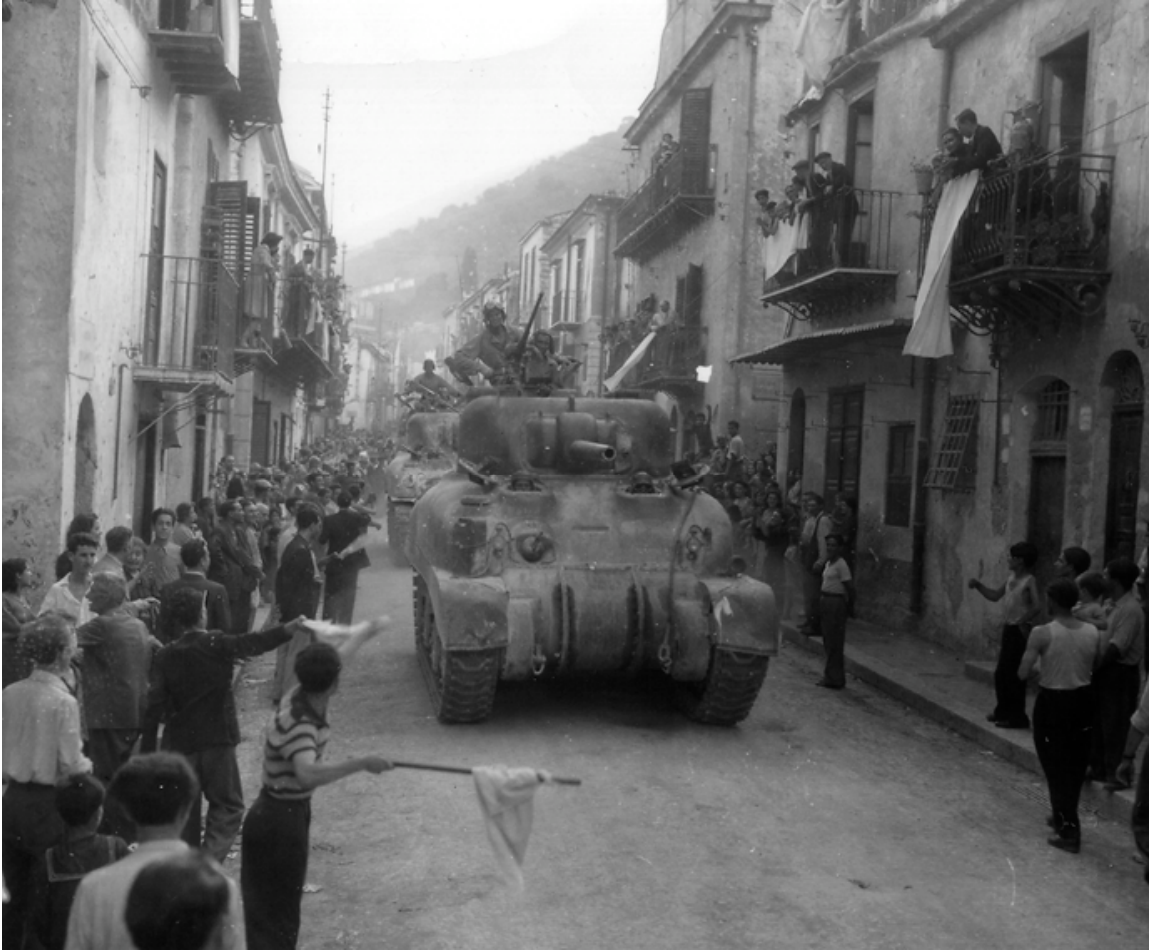
SC-179709: Second Armored Division tanks on 22 July 1943 enter Palermo, Sicily, as residents waive white flags. The lead M4A1 has an add-on armor piece that was often affixed around the coaxial machine gun to prevent shrapnel or bullets from entering the turret. The lead tank has sand shields on the sides. (NARA, Signal Corps photo)

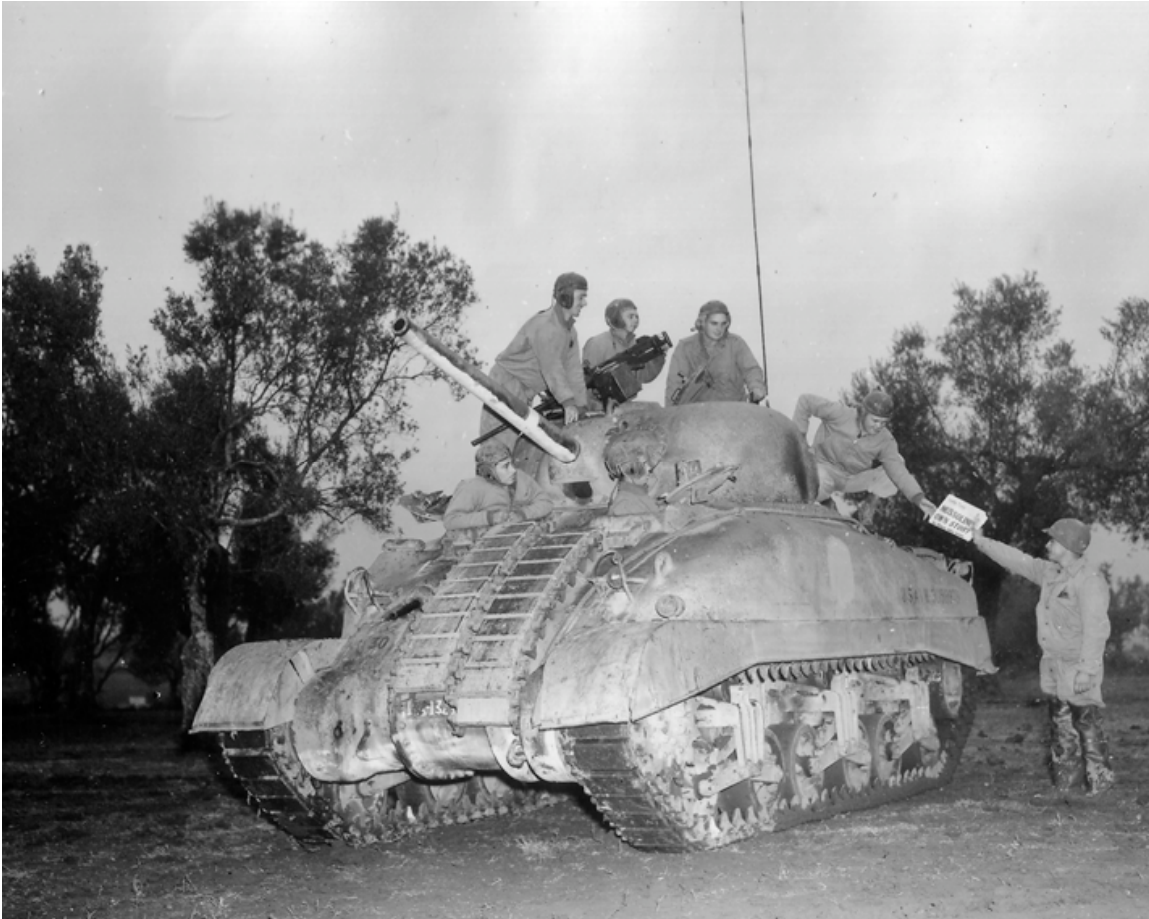
SC-182608: The 1st Armored Division's "look" in November 1943. This M4A1 near Capua, Italy, still has sand shields, and the crew has added track sections to increase the frontal armor protection. (NARA, Signal Corps photo)

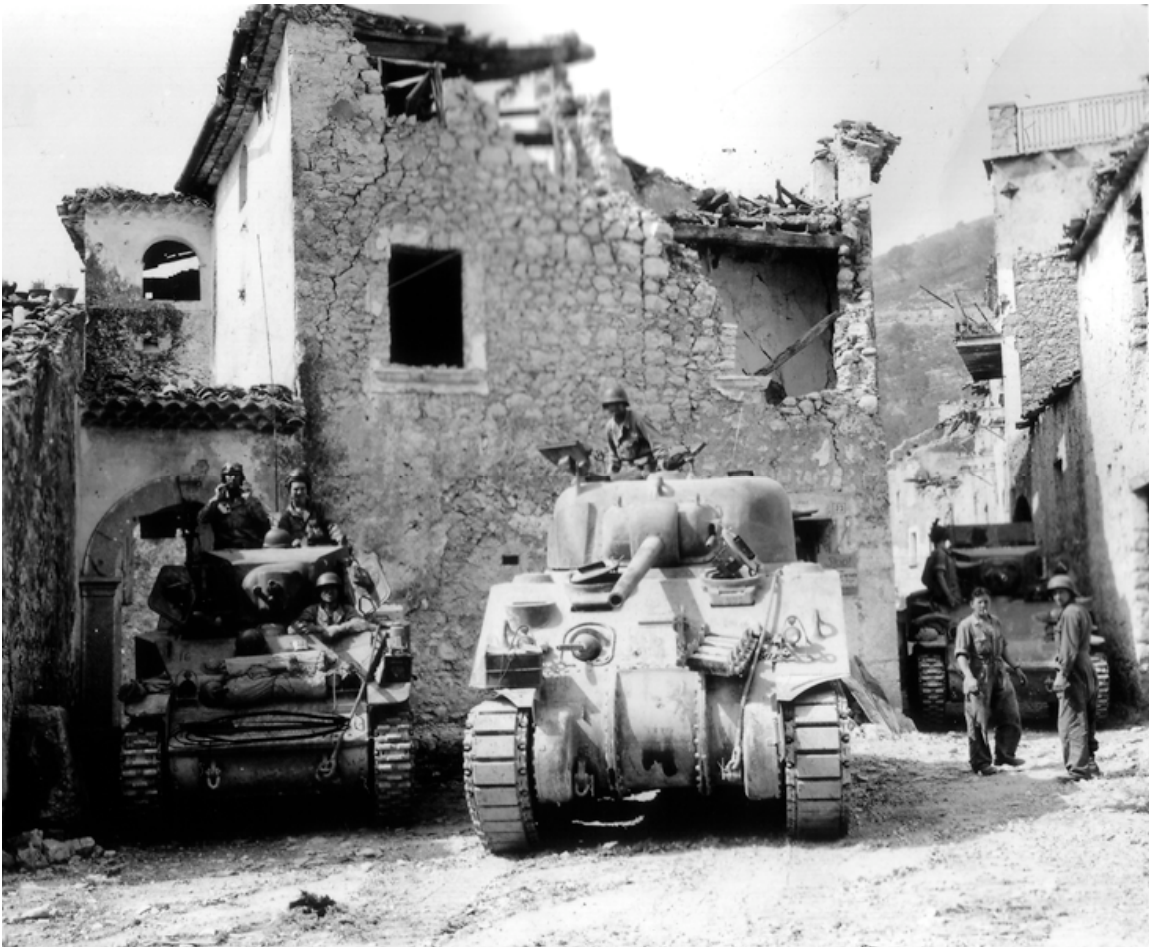
SC-190082: 755th Tank Battalion medium and light tanks in Coreno, Italy, just after its capture on 14 May 1944. The M4 exhibits first-generation characteristics in nearly every respect, although it has appliqué armor over the gunner's position. (NARA, Signal Corps photo)

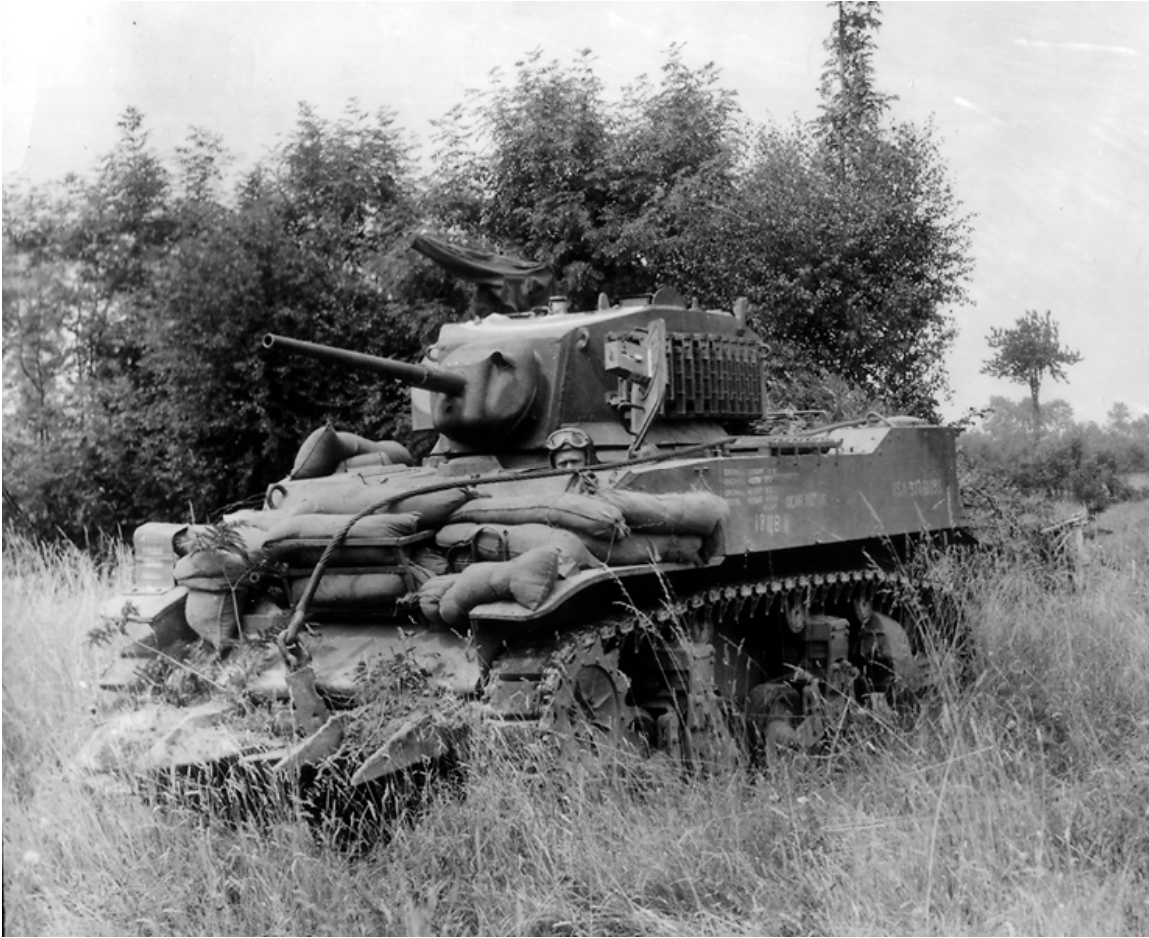
SC-192066: Tank battalions adopted new techniques in the hedgerows. A 709th Tank Battalion M5A1 in July 1944 has sandbags for extra armor protection and the Culin hedgerow-busting device that allowed tanks to plow through the obstructions. (NARA, Signal Corps photo)

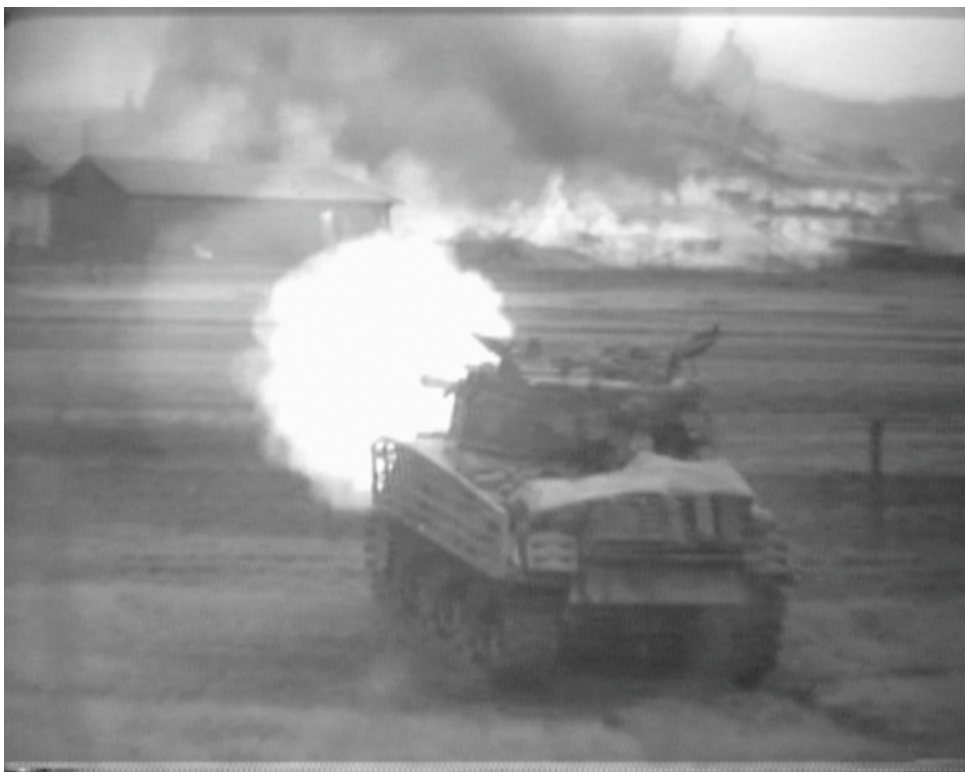
111-ADC-3960_1: A 707th Tank Battalion M4A3 (76mm) fires at a building outside Bamberg in support of the 89th Infantry Division's advance on the city in April 1945. The steel frame visible on the hull was added by Service Company to hold sandbags but is now empty. (NARA, Signal Corps film)

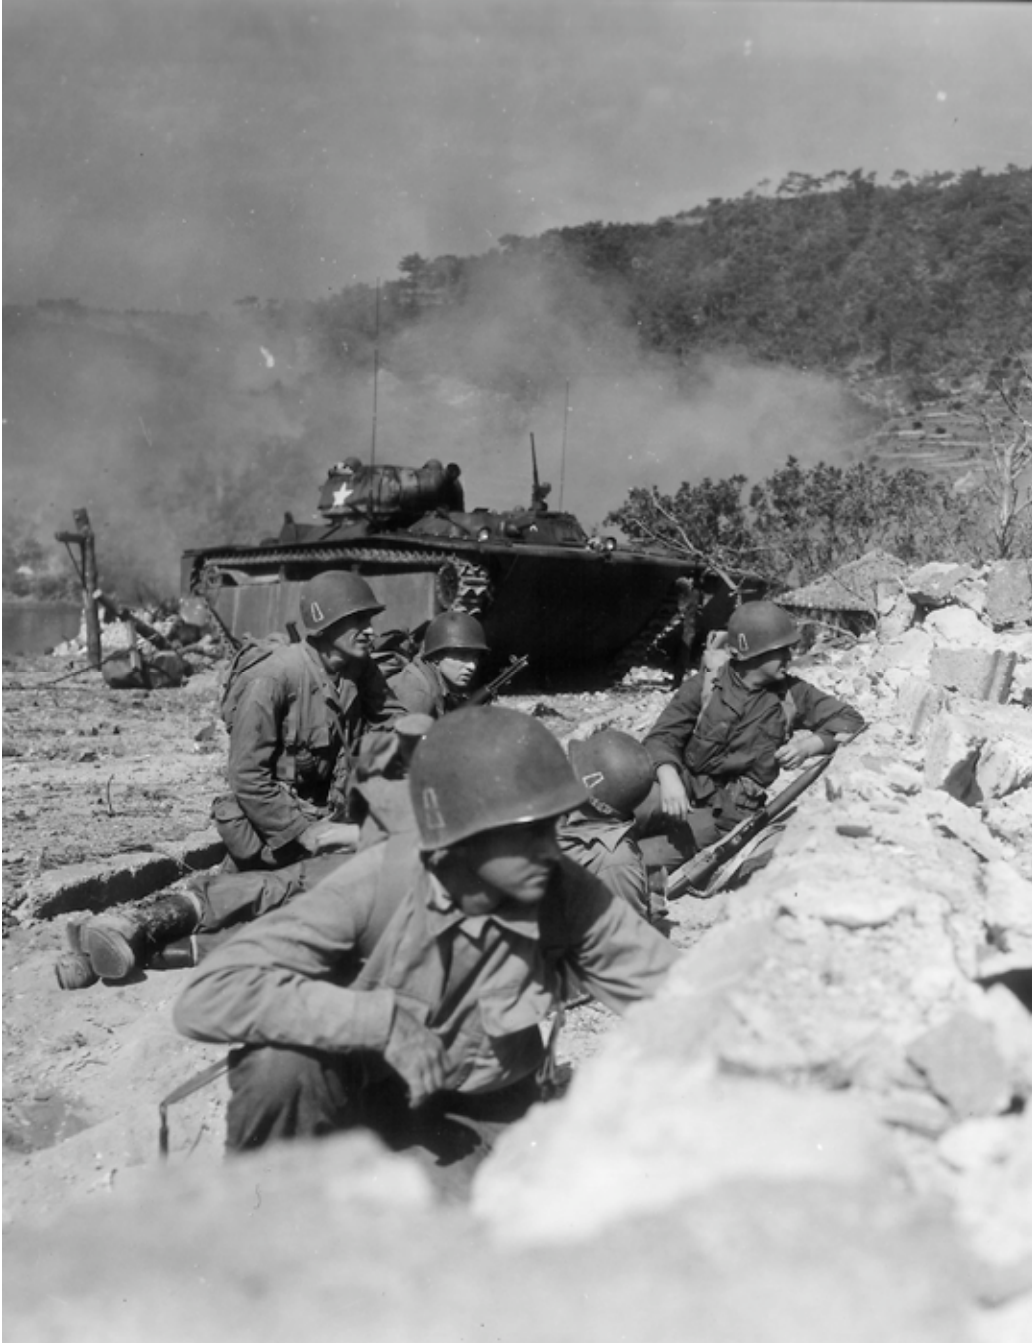
SC-206879: An LVT(A)(4) from the 708th Amphibian Tank Battalion supports Tenth Army troops taking cover from heavy fire before advancing into Zamami Shima in the Ryukyu Islands on 26 March 1945. (NARA, Signal Corps photo)

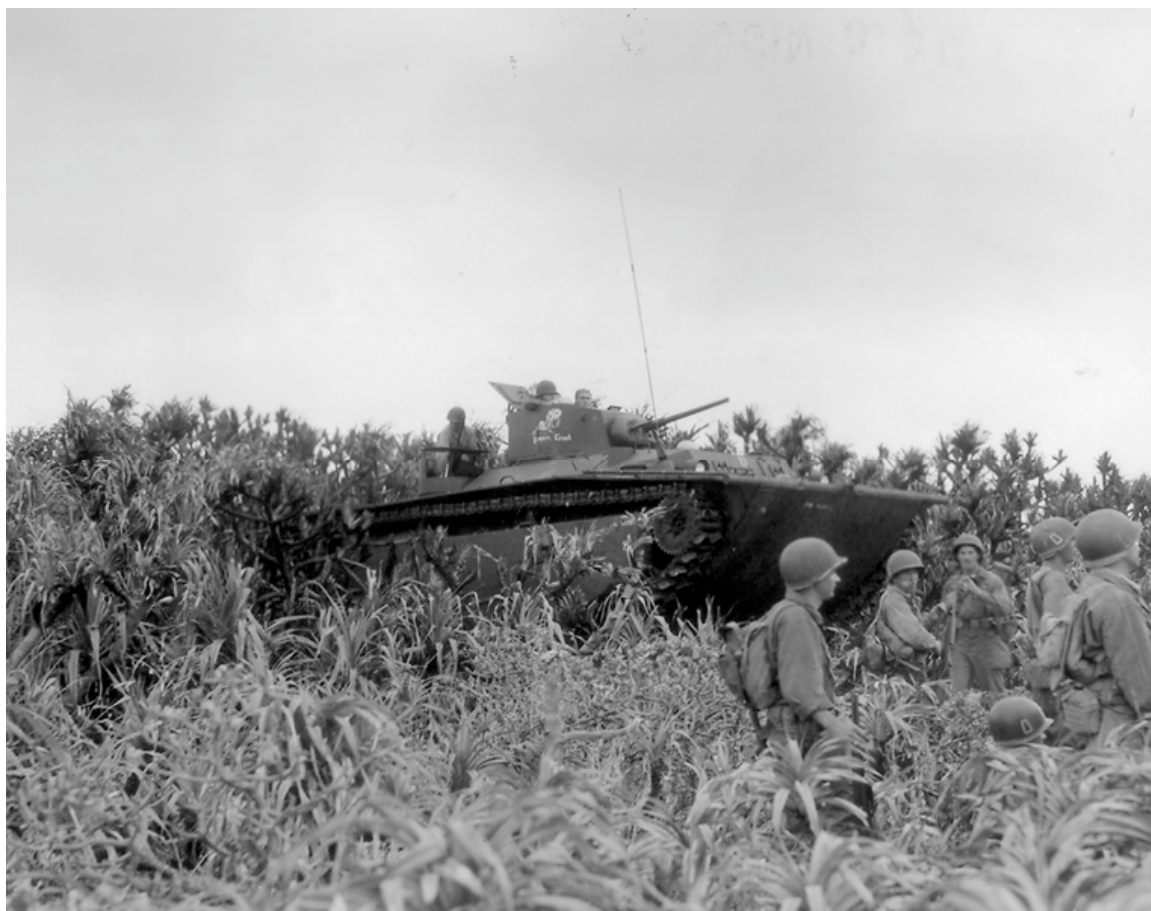
SC-206493: A 708th Amphibian Tank Battalion LVT(A)(1), which was the first type of amtank produced, works inland with the 77th Infantry Division on Keise Shima on 31 March 1945. (NARA, Signal Corps photo)

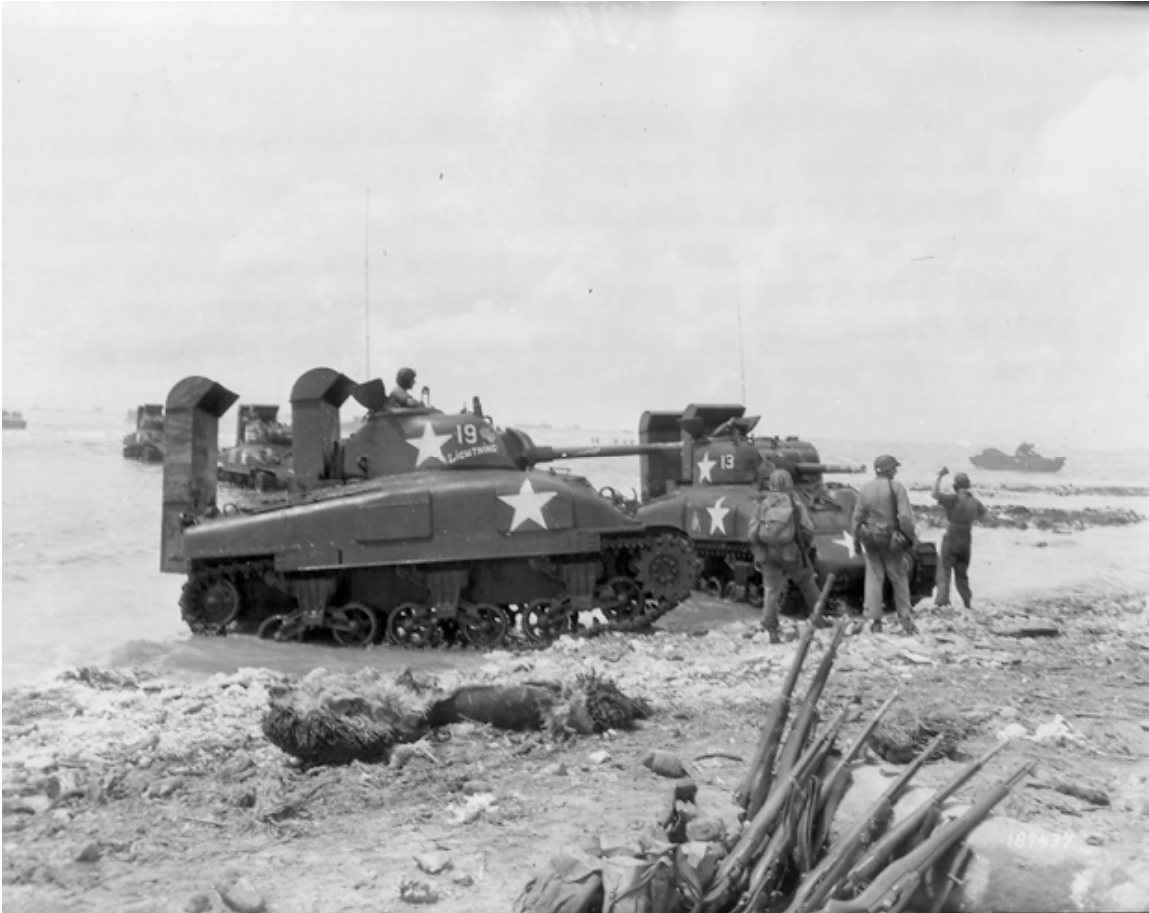
SC-187437: Water-proofed 767th Tank Battalion M4A1s with wading gear land with the 7th Infantry Division on Kwajalein on 2 February 1944. The forward stack was for the air intake, and the rear one handled exhaust. (NARA, Signal Corps photo)
