Weapons of Tank Battalions Illustrations

Chapter 6: Assault Guns and Mortars

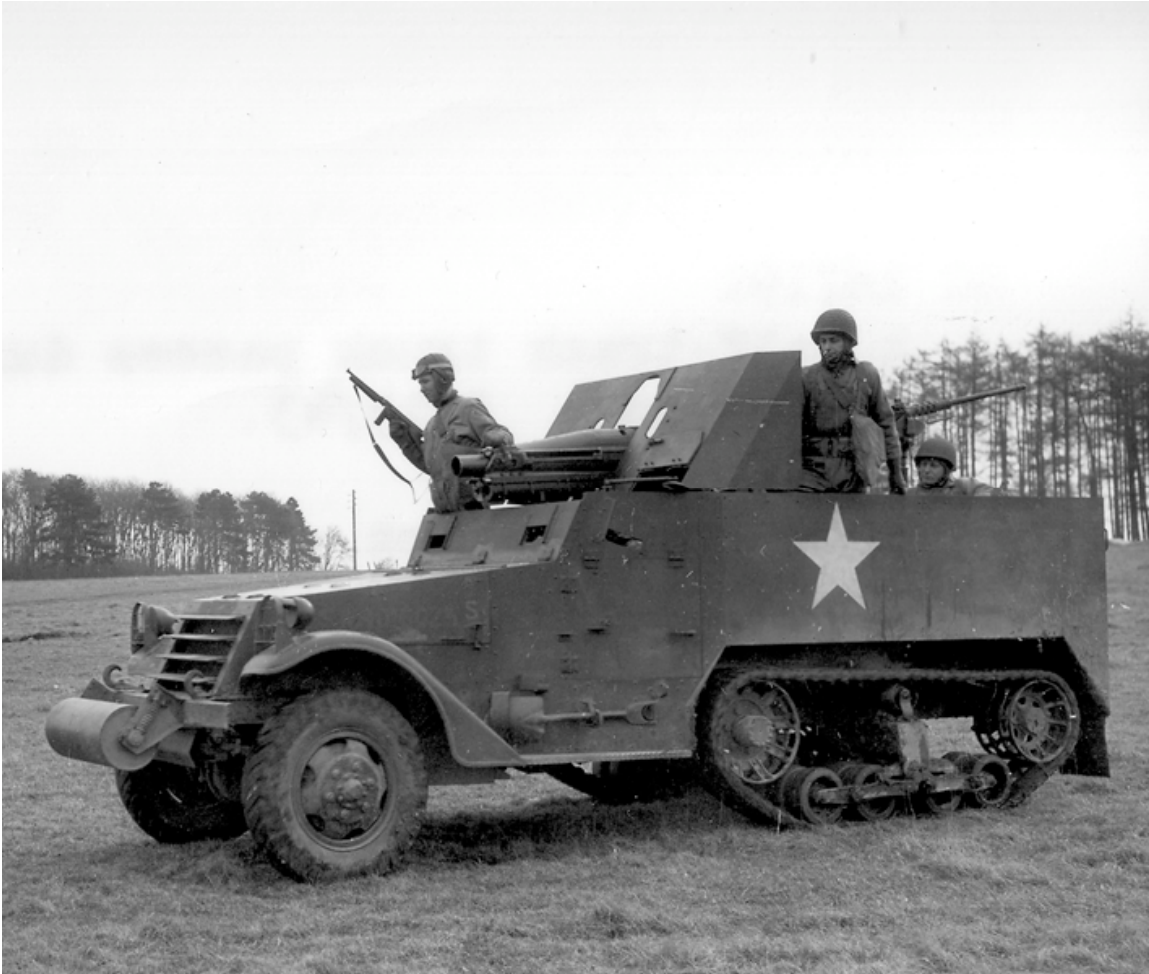
SC-167191: A T30 assault gun displays the distinctive hump atop the 75mm pack howitzer barrel. The pedestal-mounted .50-caliber machine gun is visible behind the howitzer. (NARA, Signal Corps photo)

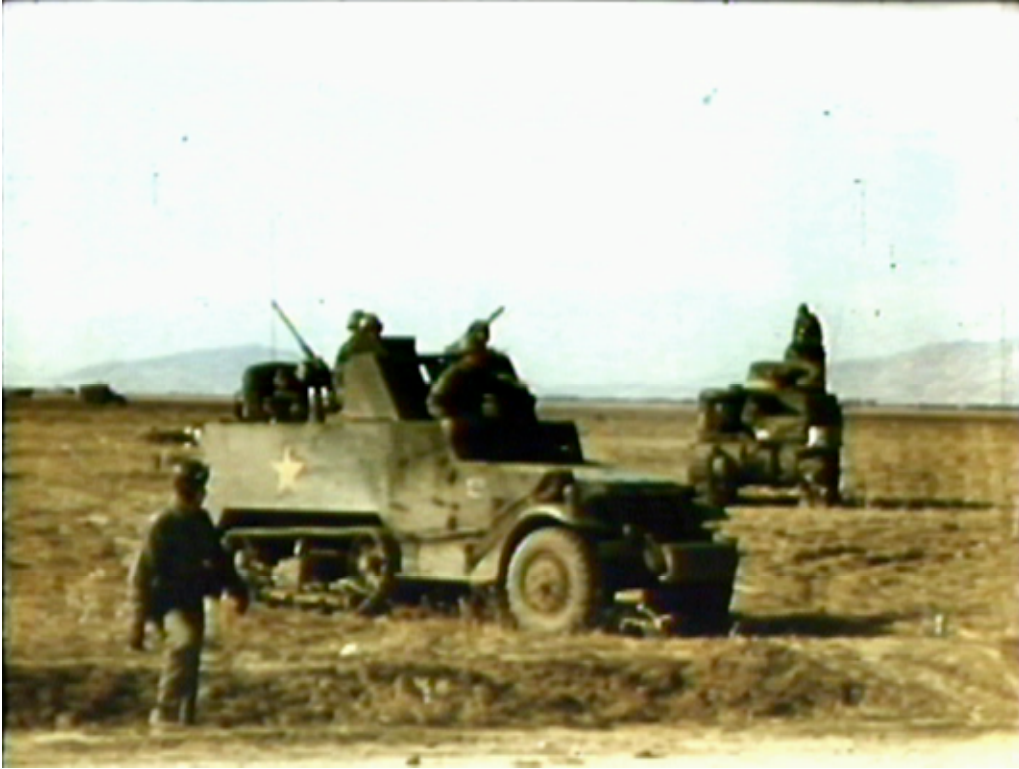
111-M-1001_15: A T30 assault gun advances into Tunisia with 2/13th Armored Regiment in November 1942. (NARA, Signal Corps film) [color photo]

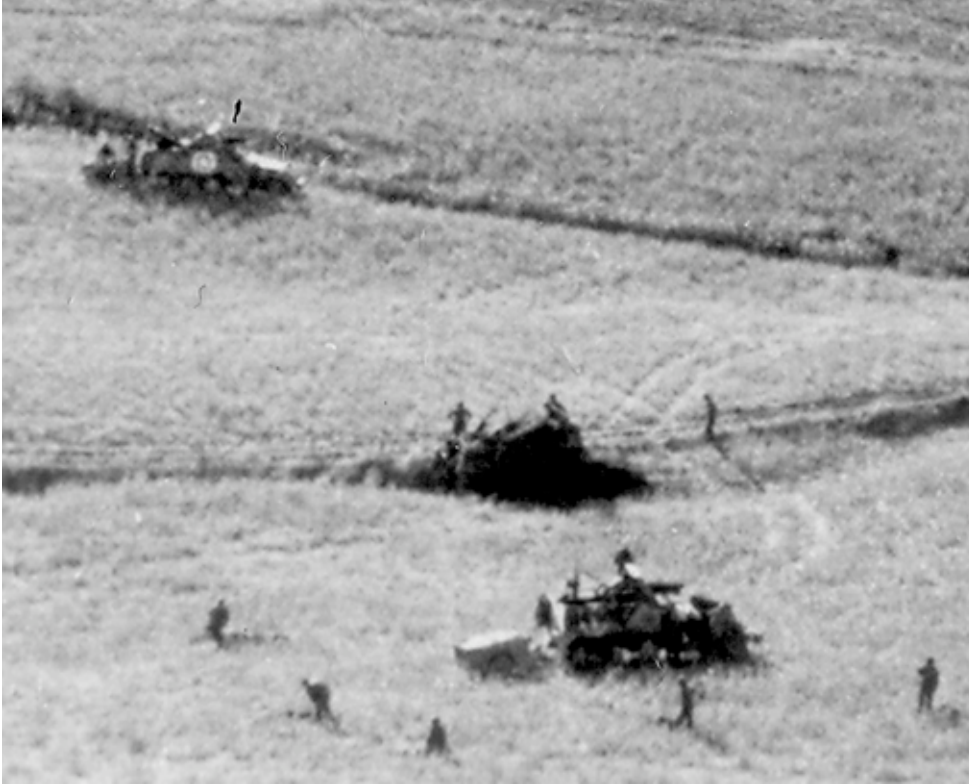
SC-177883: T30 assault guns operate near Montechiaro, Sicily, on 14 July 1943. Two are pulling ammunition trailers. (NARA, Signal Corps photo)

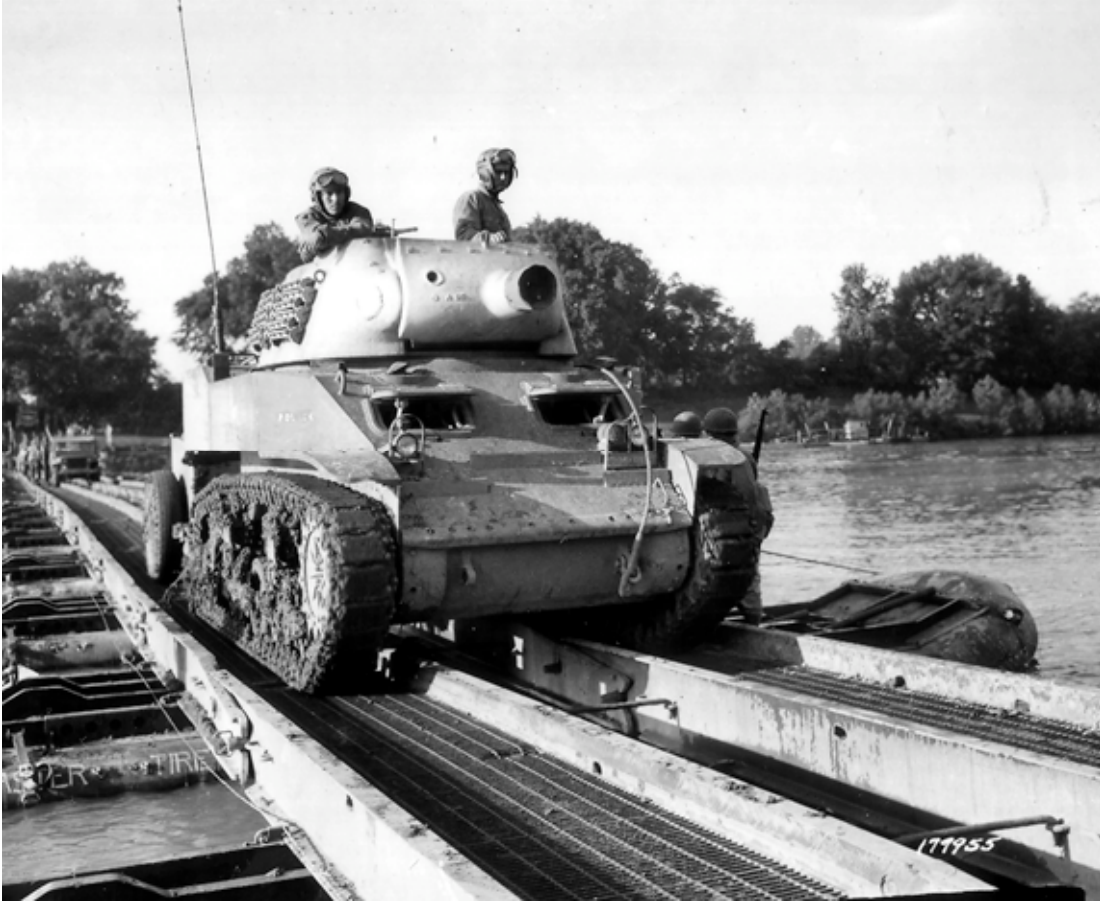
SC-179955: An M8 HMC pulls an ammunition trailer during maneuvers in Tennessee in May 1943. The vehicle had very limited ammunition stowage. (NARA, Signal Corps photo)

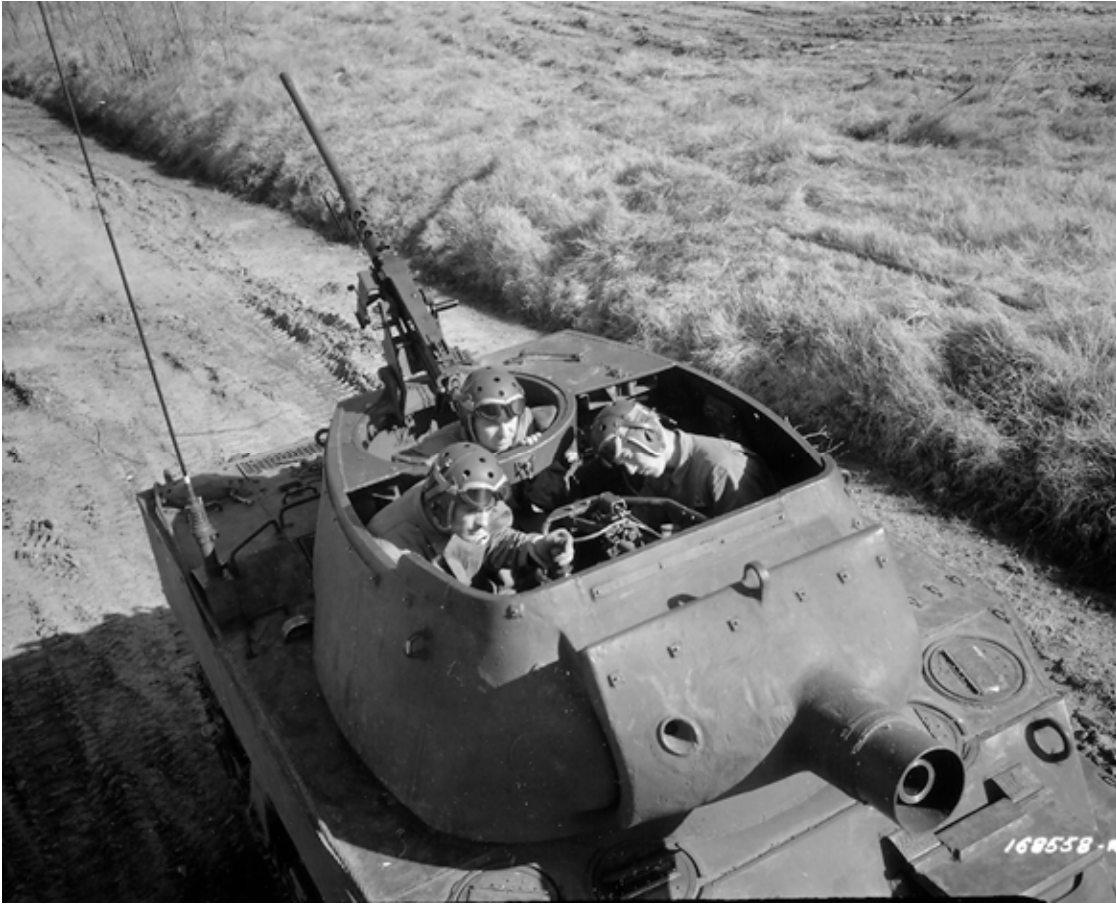
SC-168558-R: Layout of the M8 turret, which was also installed on the LVT(A)(4) amtank. (NARA, Signal Corps photo)

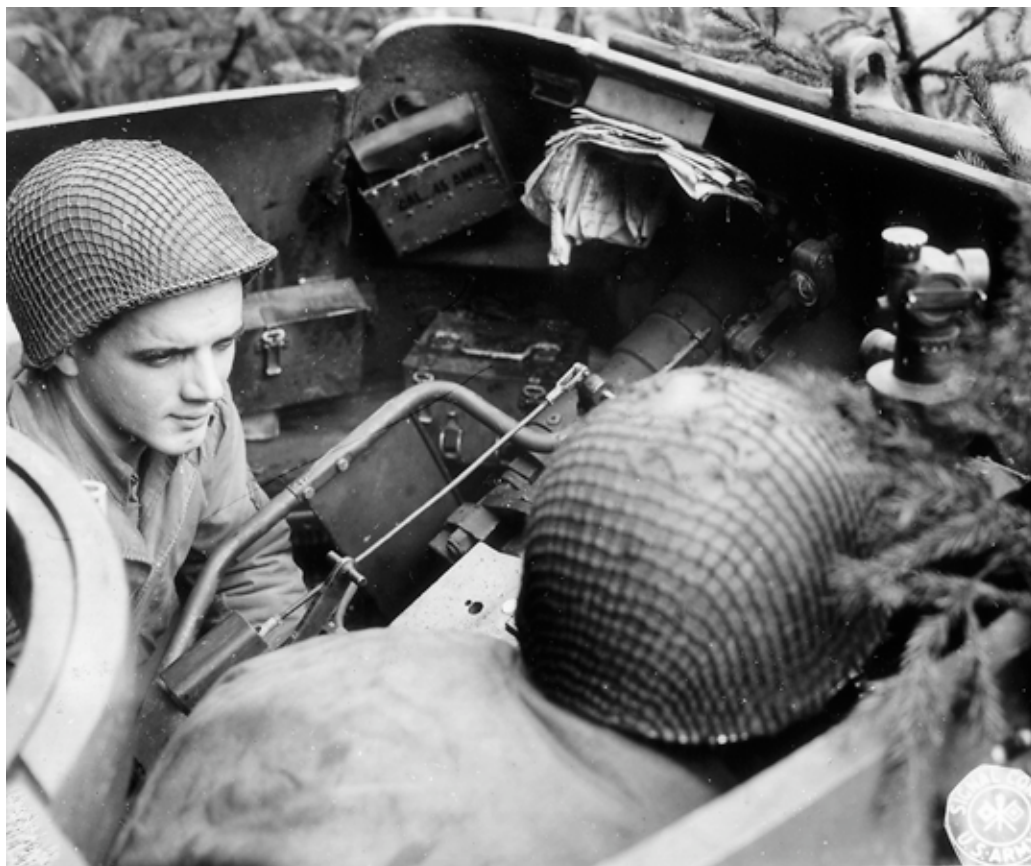
SC-195753: The commander/gunner and loader worked in tight spaces in the open-topped turret. (NARA, Signal Corps photo)

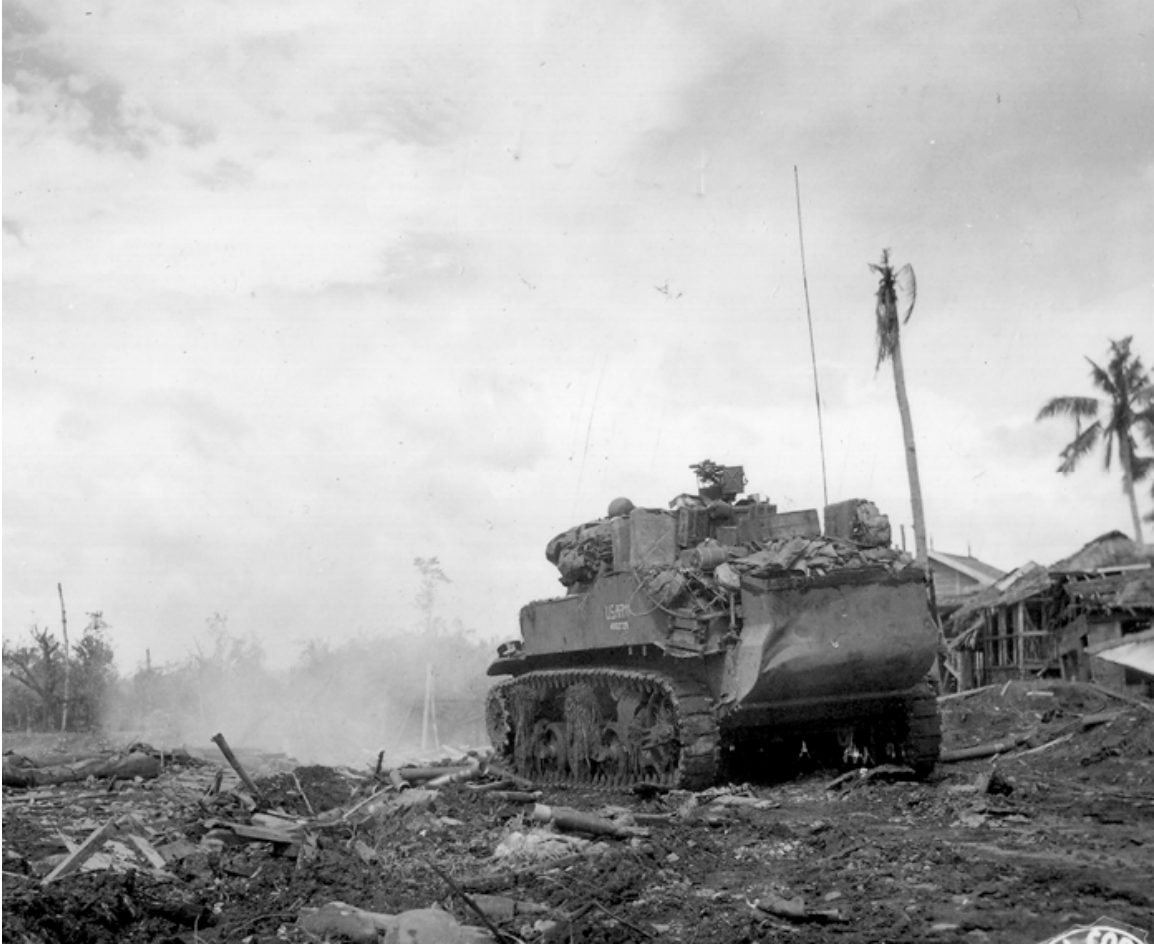
SC-199172: An M8 fires at a Japanese pillbox on Leyte Island, the Philippines, in December 1944. Close-quarters shooting was common in the Pacific Theater. This assault gun still has part of its wading gear attached. (NARA, Signal Corps photo)

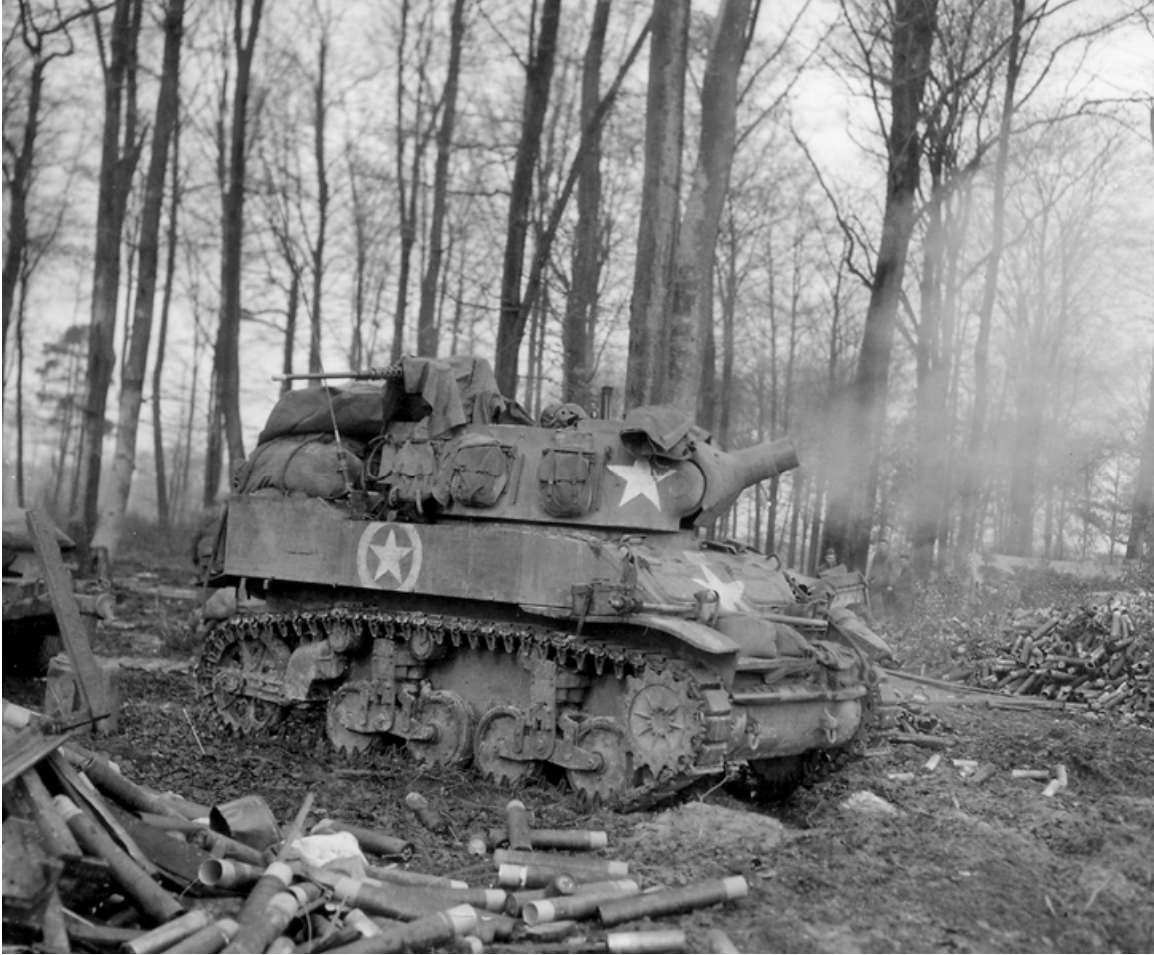
SC-200259: An M8 shells the Germans near Karlsbrun, Germany, in February 1945. Indirect-fire missions were fairly common for assault guns when they could be tied into an artillery unit's fire-control center. (NARA, Signal Corps photo)

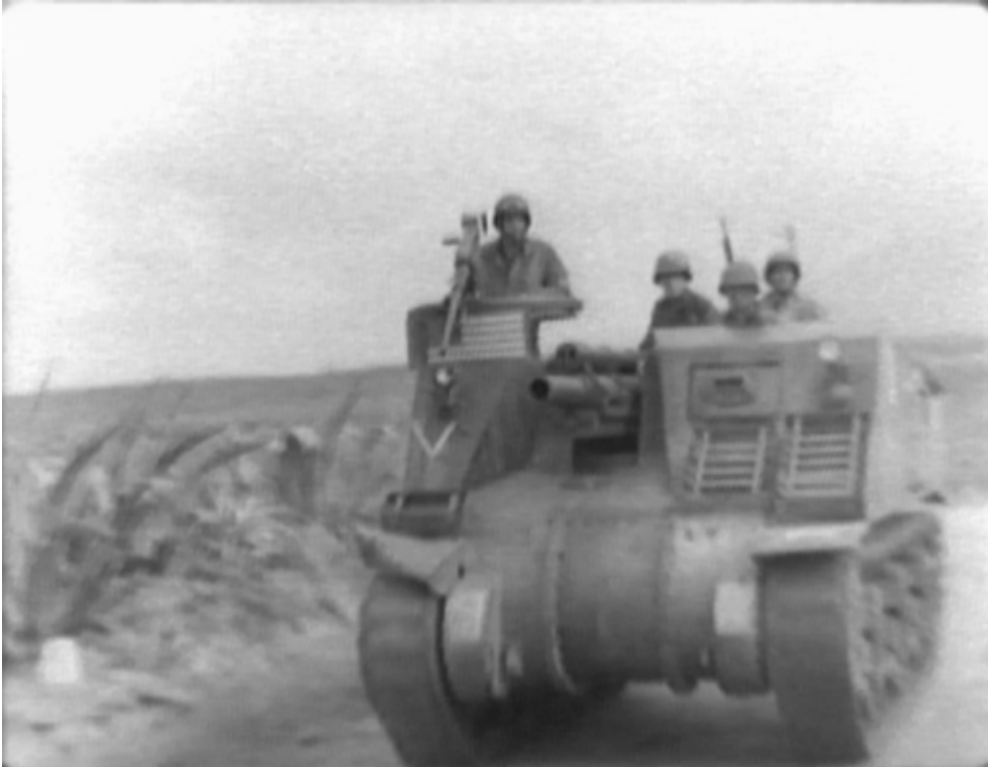
111-FB-51_1: The 1st Armored Division, while still in North Africa in November 1943, assigned M7 Priest self-propelled 105mm howitzers to its medium tank battalions as stop-gap assault guns, because it found the 75mm howitzer underpowered in combat. The 751st substituted M7s for its M8s when it reorganized as a standard tank battalion in December 1943 while in Italy. (NARA, Signal Corps film)

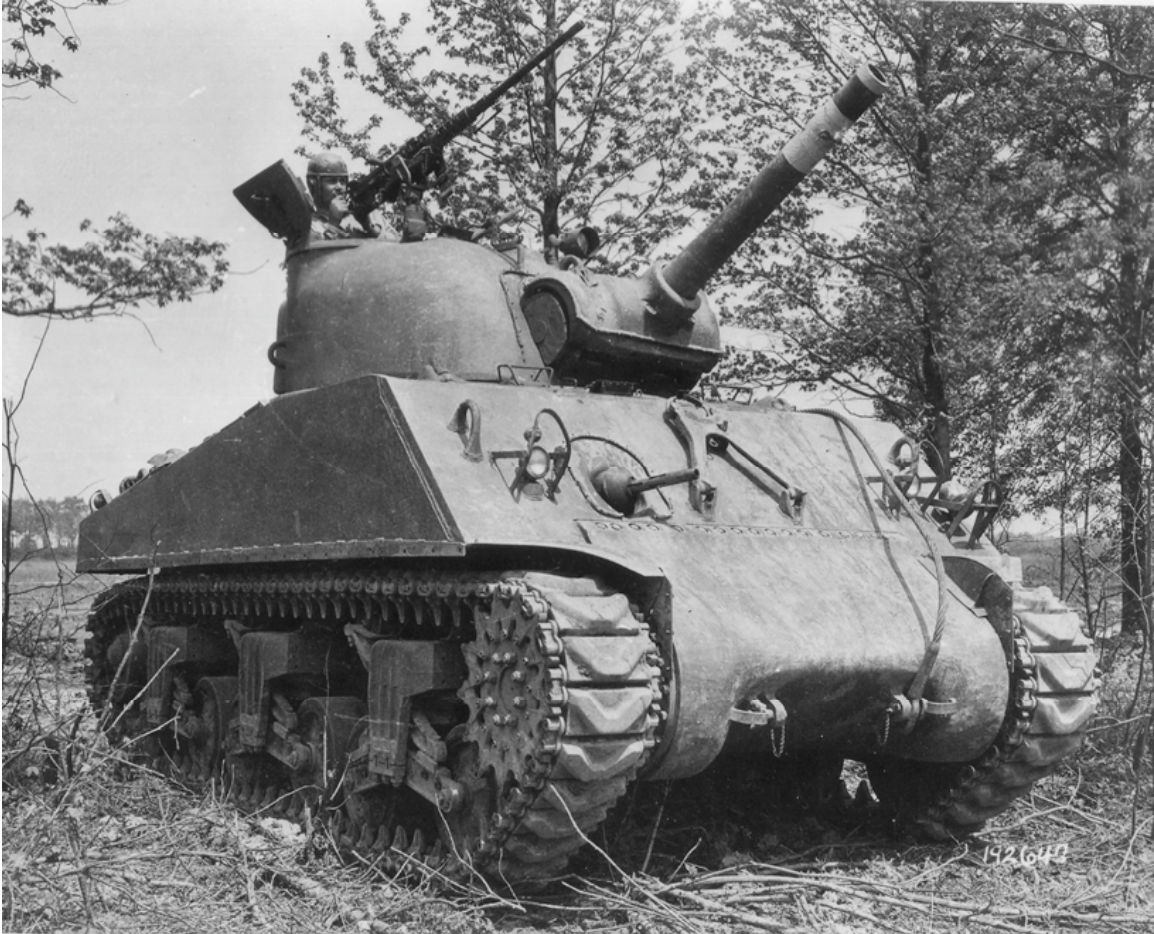
SC-192647: An early M4 Sherman with 105mm howitzer. This vehicle has a standard commander's hatch. (NARA, Signal Corps photo)

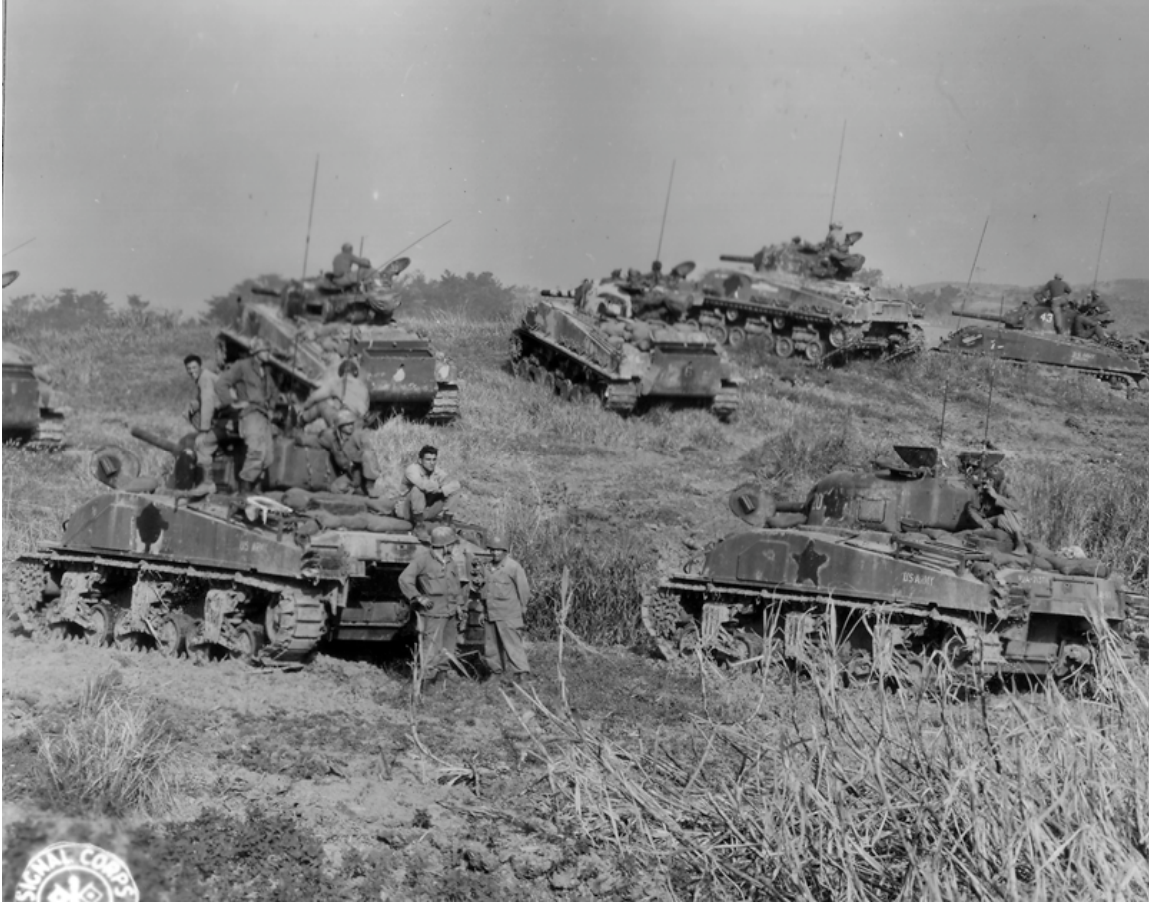
SC-206511: This group of tanks on Okinawa includes very late-production assault guns equipped with HVSS suspension (center rear). The crews have all blotted out the white stars on the hull sides as they provided aiming points for Japanese gunners. Note the sandbags on the rear decks, which was standard practice in the Pacific because satchel charges and magnetic mines delivered by suicide squads rather than bazookas constituted the main close-range threat. (NARA, Signal Corps photo)

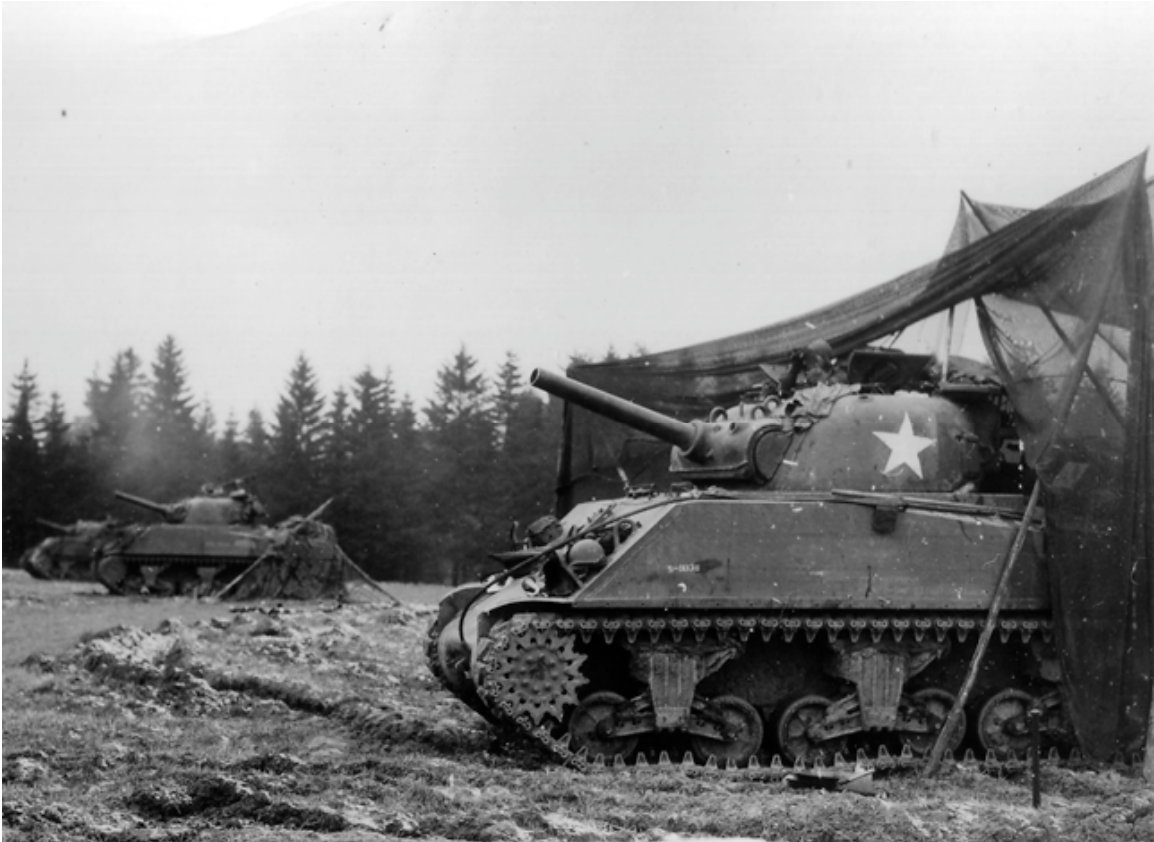
SC-198396: Assault guns from the 750th Tank Battalion fire indirectly at Manhay, Belgium, on 30 December 1944. (NARA, Signal Corps photo)

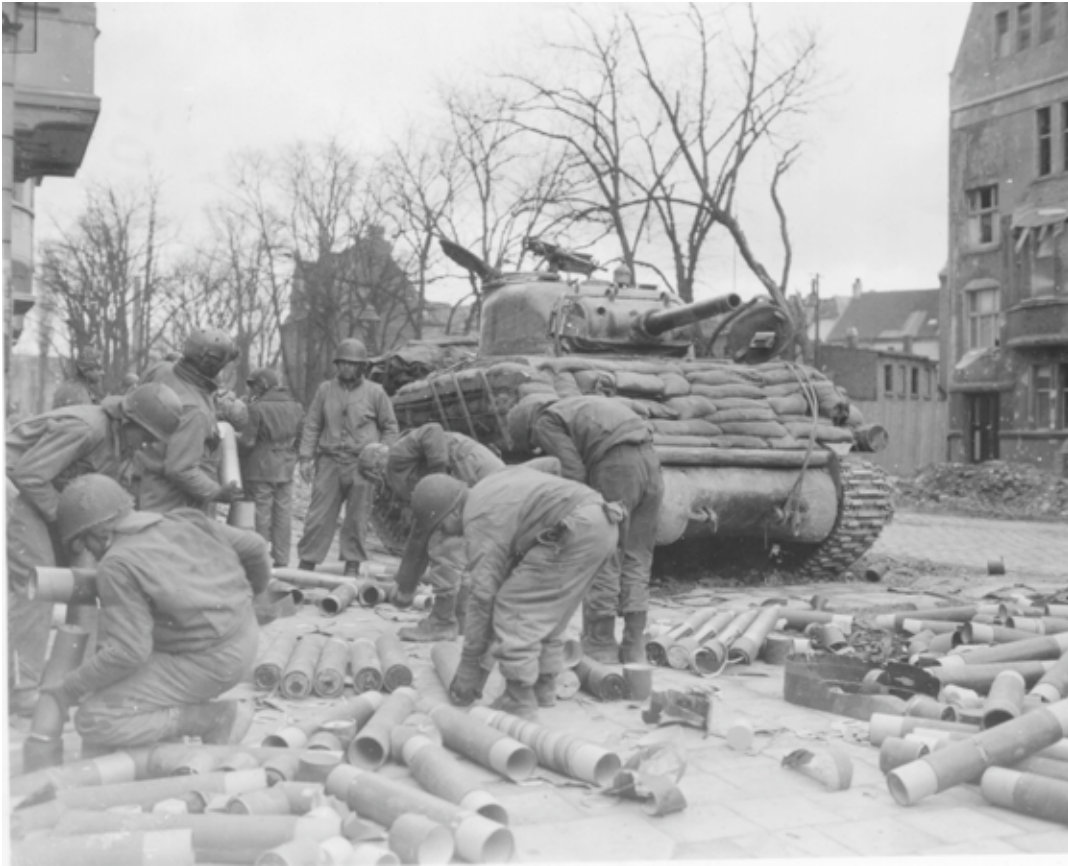
SC-201841: A litter of empty shell containers surrounds a 736th Tank Battalion assault gun firing in support of the 83d Infantry Division in Neuss, Germany, on 3 March 1945. The gun's elevation suggests it has been shooting in direct support of the doughs, as does the heavy sandbagging. This tank has the commander's vision cupola with the single hatch. (NARA, Signal Corps photo)

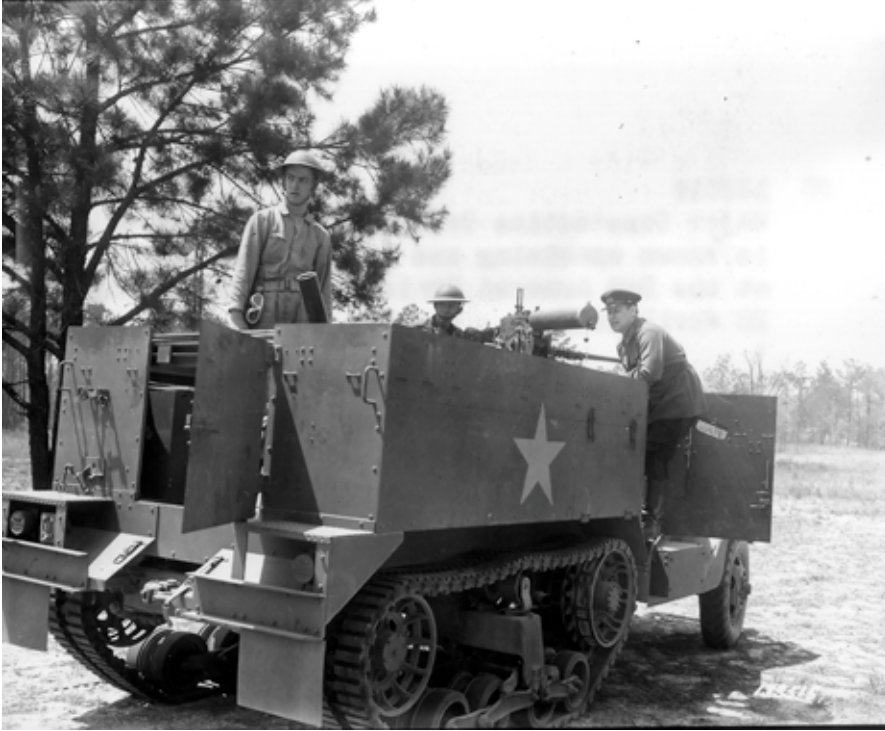
SC-133515: A Soviet officer in April 1942 examines a 2d Armored Division Halftrack 81mm Mortar Carrier M4, based on the M2 halftrack. The shorter rear compartment and twin back steps are the easiest way to distinguish the M2 from the M3 halftrack. (NARA, Signal Corps photo)

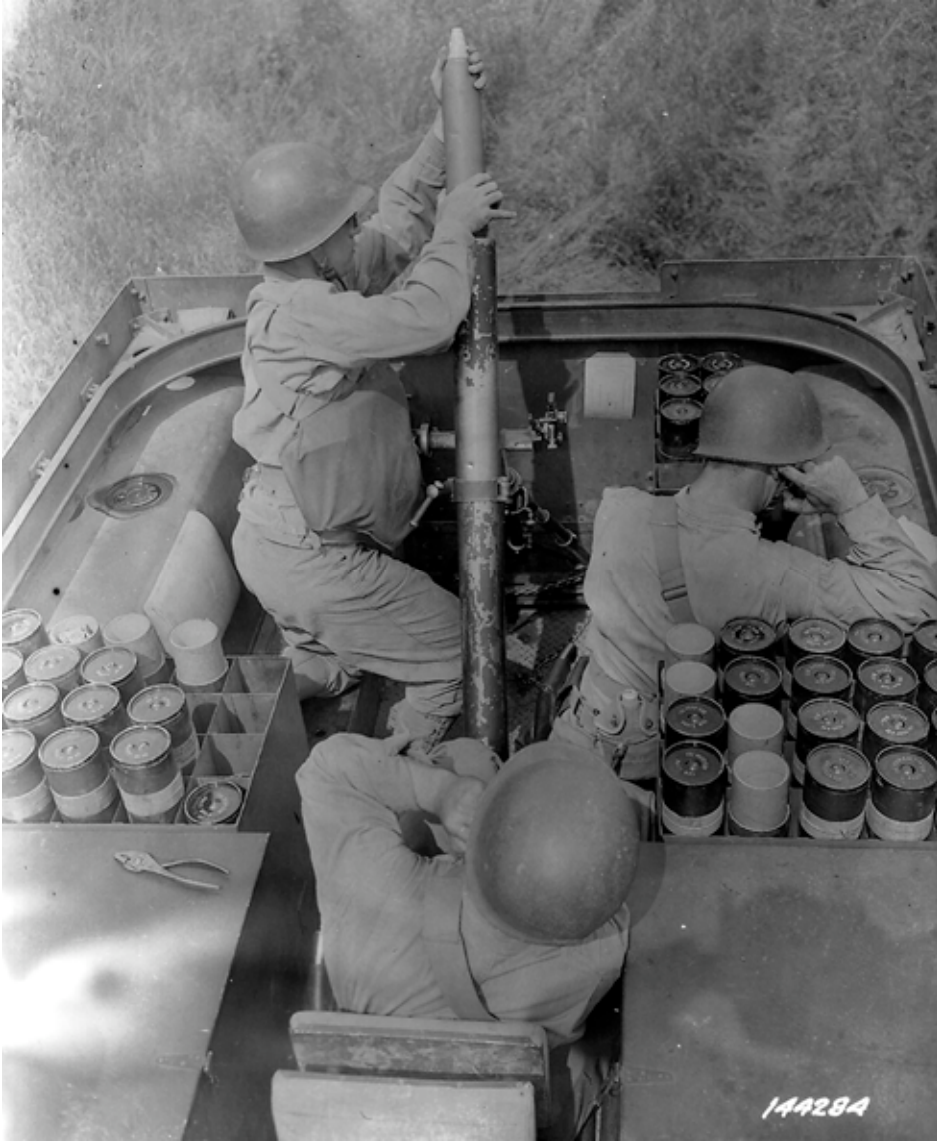
SC-144284: Firing the weapon mounted in the Halftrack 81mm Mortar Carrier M4A1, which had a raised and strengthened floor mount. (NARA, Signal Corps photo)

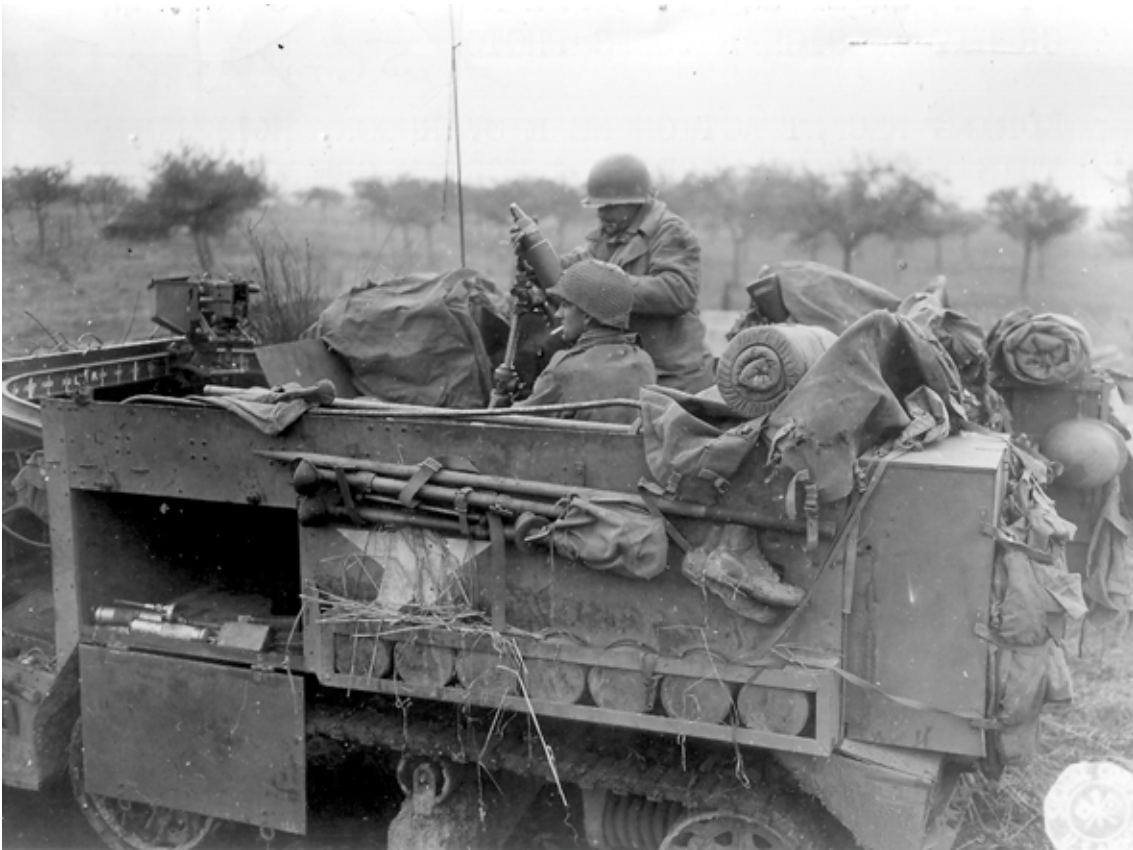
SC-195079: An M4A1 mortar crew in action near Overloon, Holland, in October 1944. Crews often turned the mortar to face forward. (NARA, Signal Corps photo)

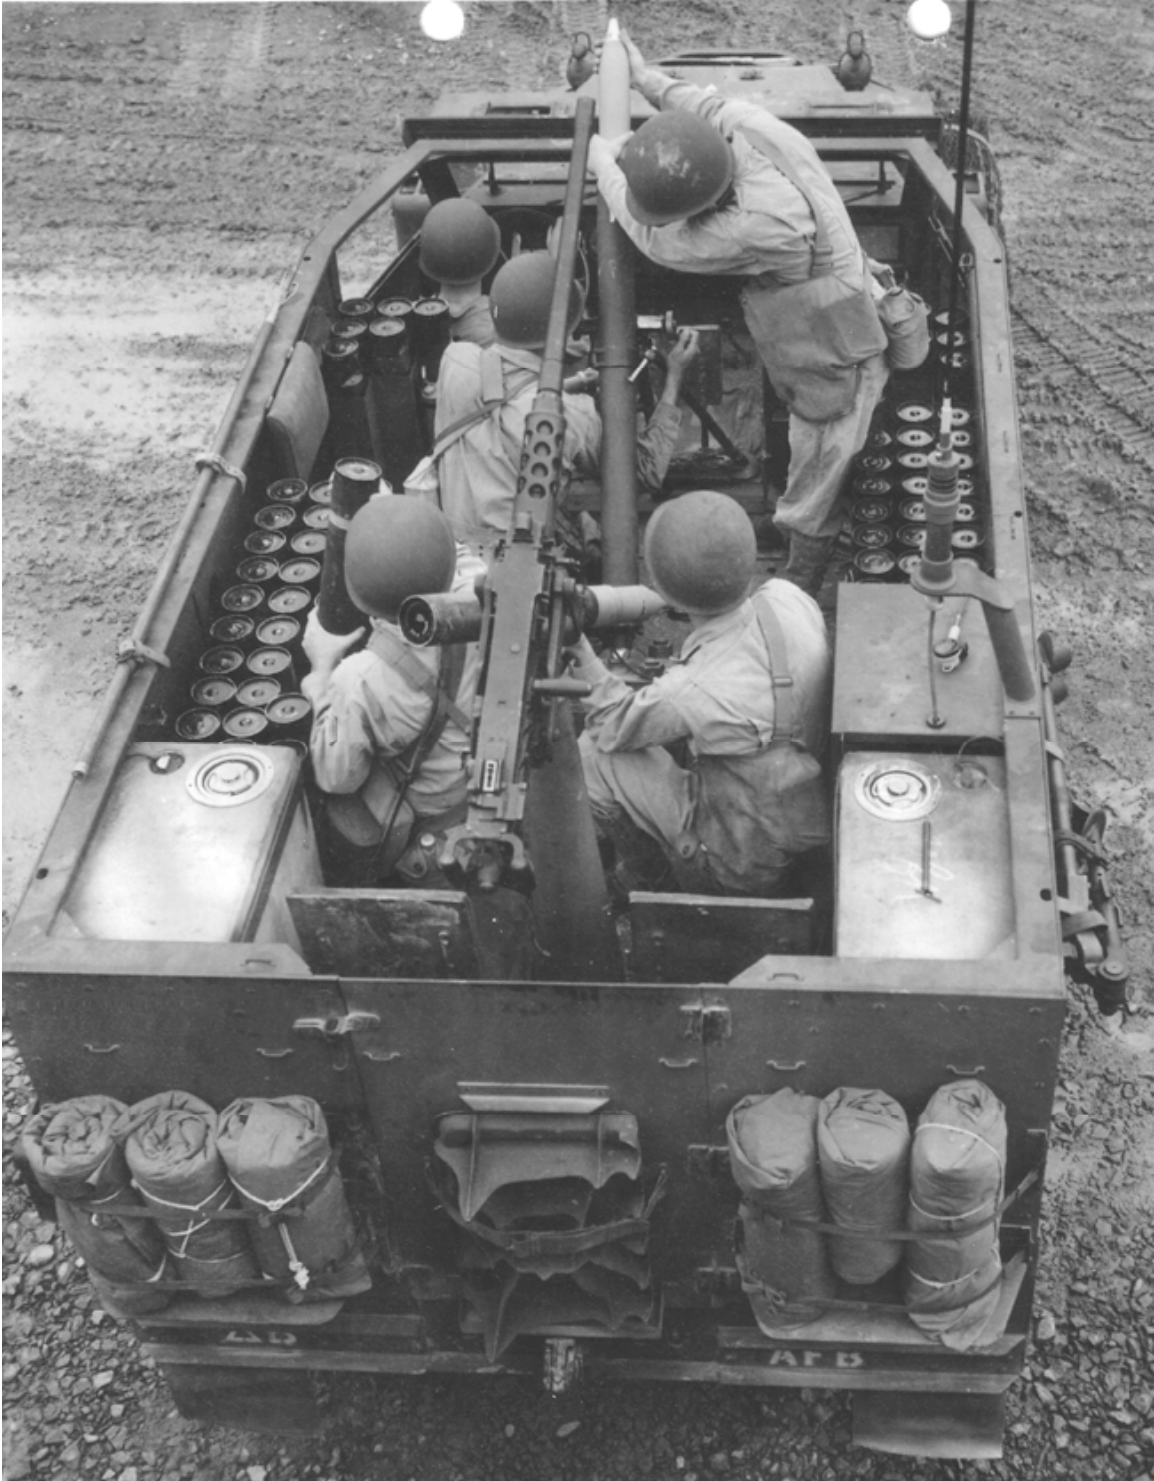
AFB6100: The crew of an 81mm Mortar Carrier T19, prototype for the M21, serves the weapon, which was designed to fire forward. (NARA, records of the Chief of Ordnance)
