Weapons of Tank Battalions Illustrations

Chapter 8: Supporting Elements

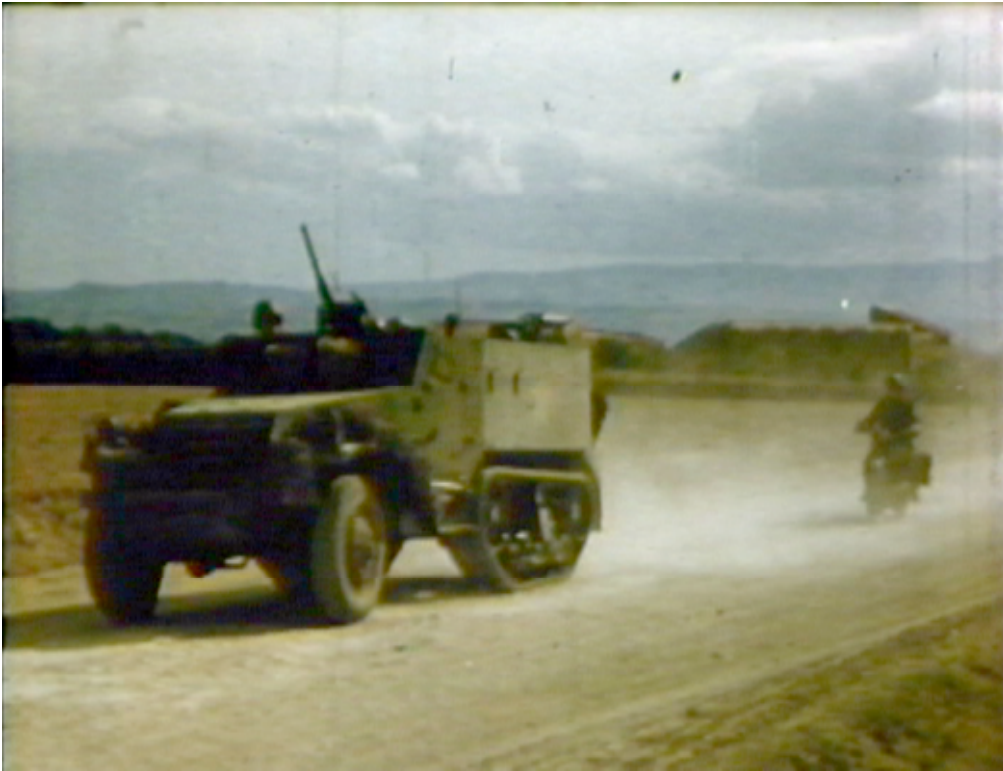
111-M-1001_10: A halftrack and dispatch rider from 2/13th Armored Regiment in North Africa in November 1942. (NARA, Signal Corps film) [color photo]

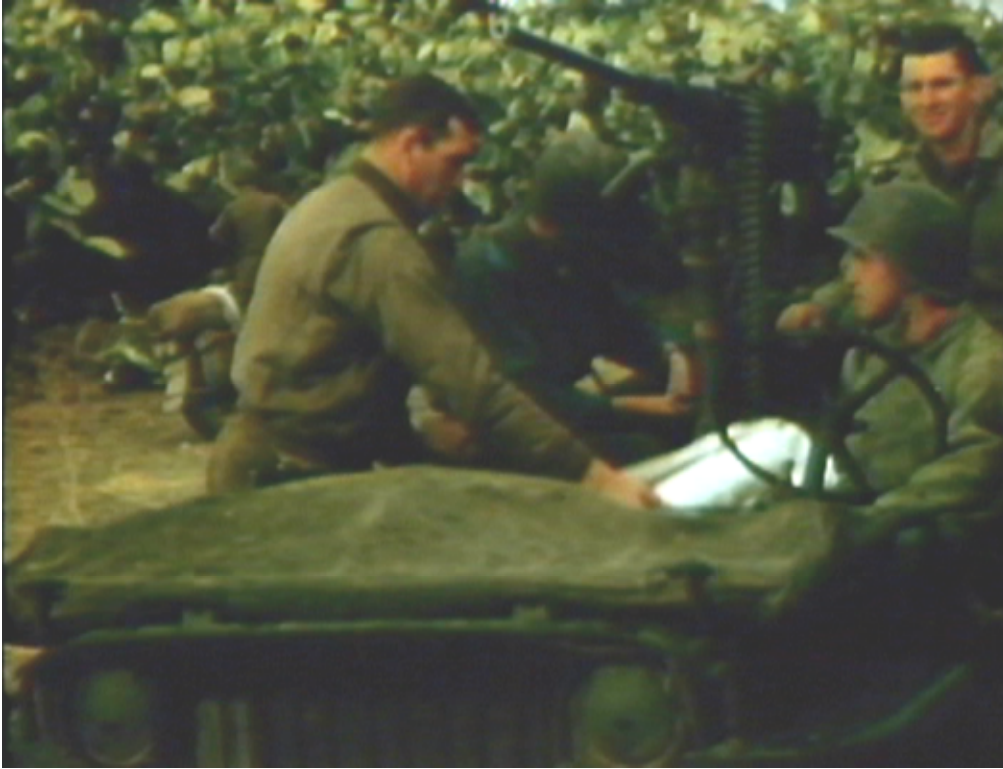
111-M-1001_3: Storing maps in a reconnaissance jeep in North Africa in November 1942. (NARA, Signal Corps film)
[color photo]

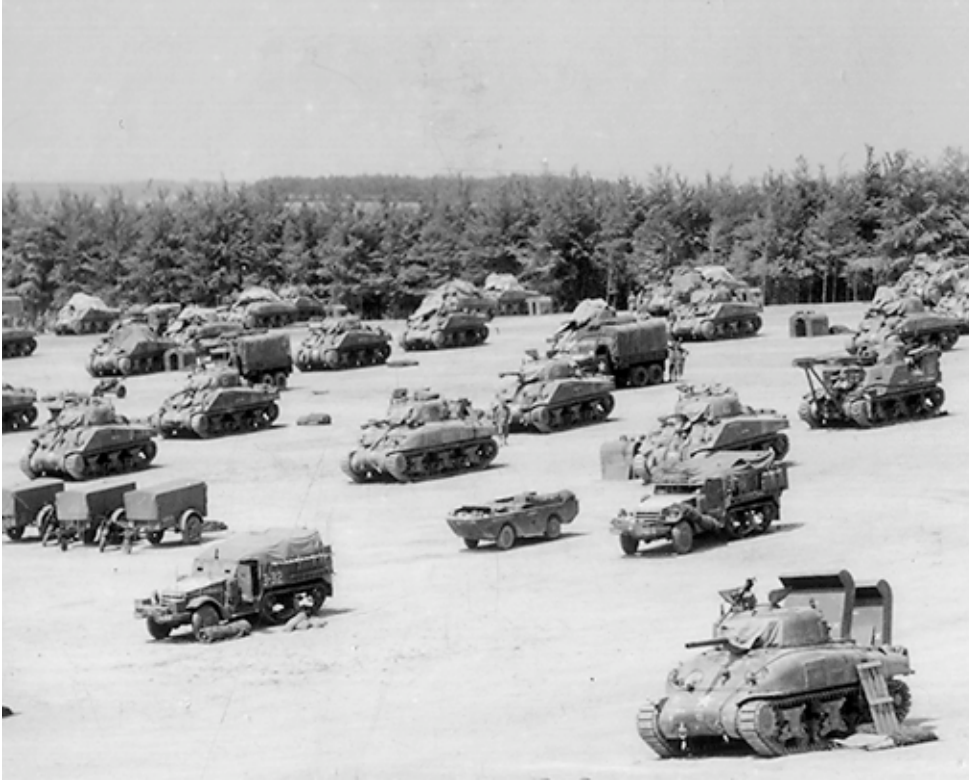
SC-186584: This tank battalion from the 66th Armored Regiment, 2d Armored Division, is gathered at a marshalling area on 29 May 1944. The photo shows tanks with and without wading gear, halftracks, deuce-and-a-half cargo trucks, a T2 tank recovery vehicle, and a non-standard-issue 1/4-ton amphibian truck. (NARA, Signal Corps photo)

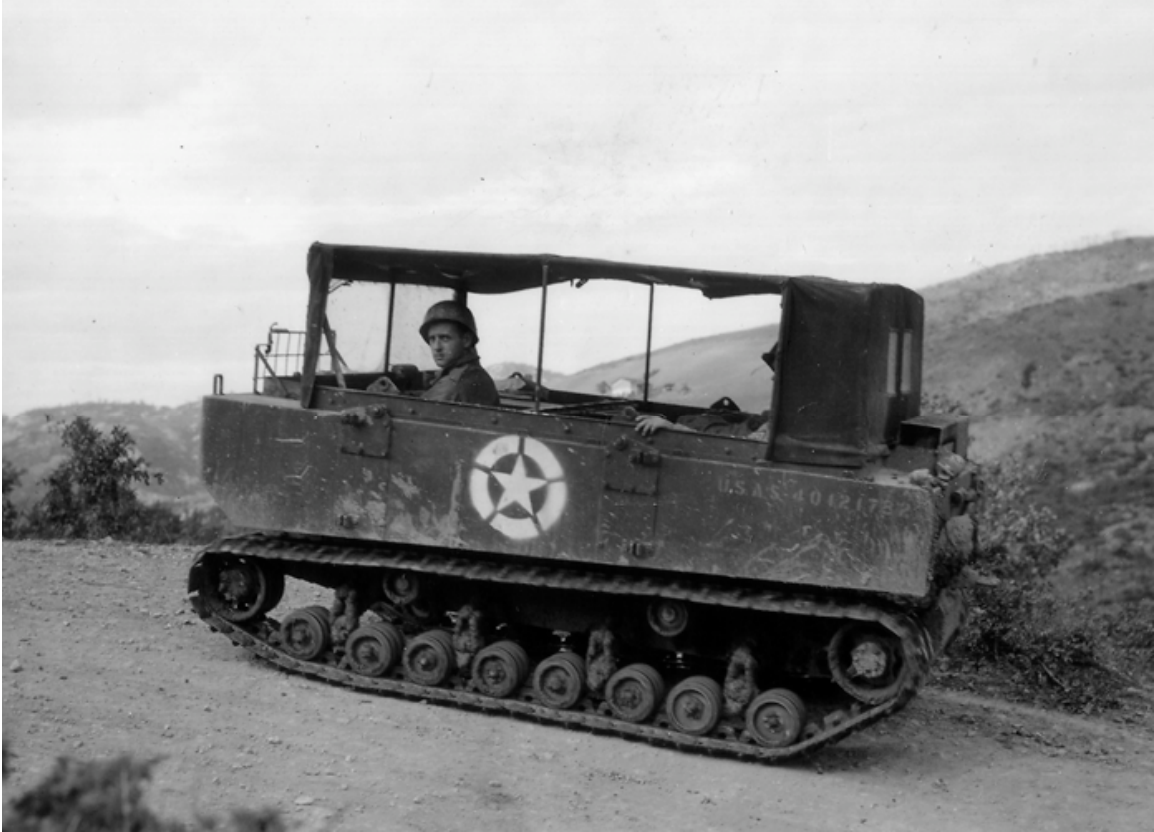
SC-196135-S: The M29 light cargo carrier, known as the Weasel, was not standard issue but served with some battalions in the Pacific Theater. (NARA, Signal Corps photo)

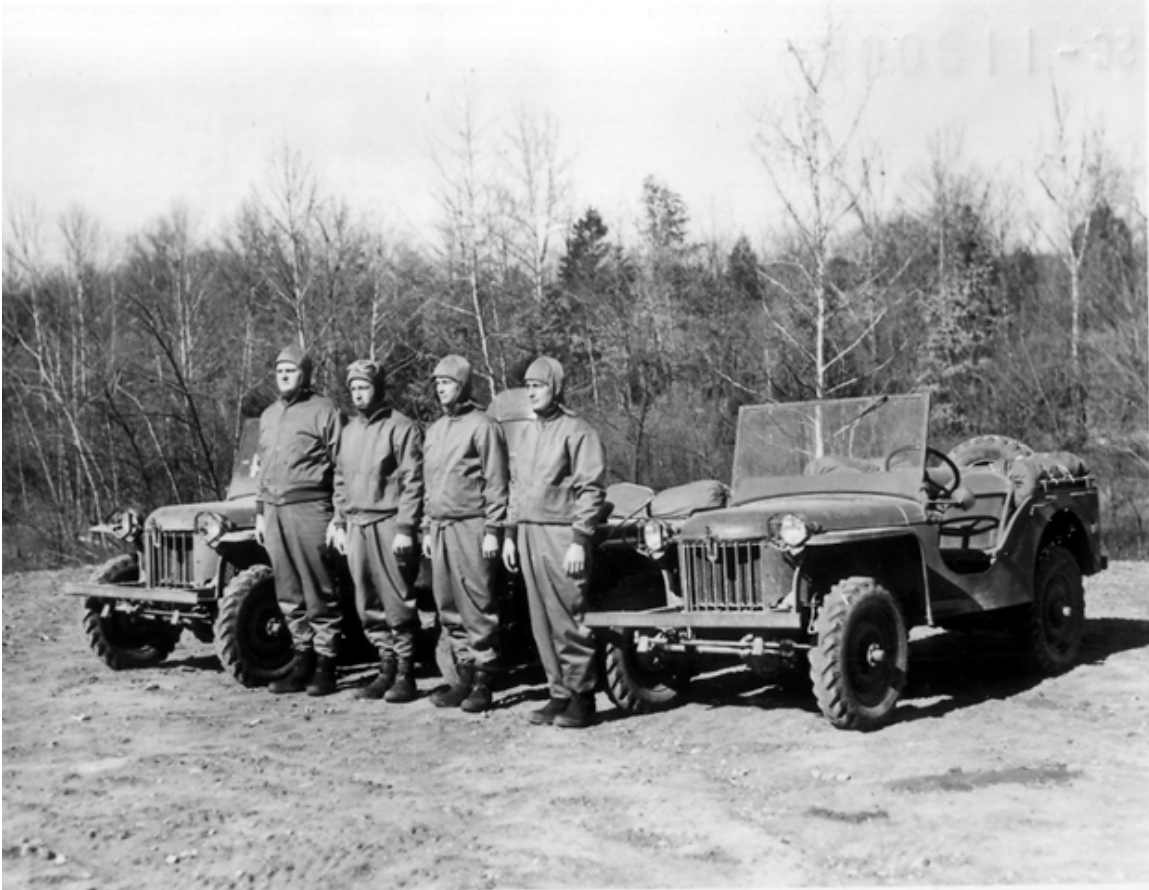
SC-118005: 1st Armored Division men in winter uniforms stand next to "Bantam cars" in early 1941. (NARA, Signal Corps photo)

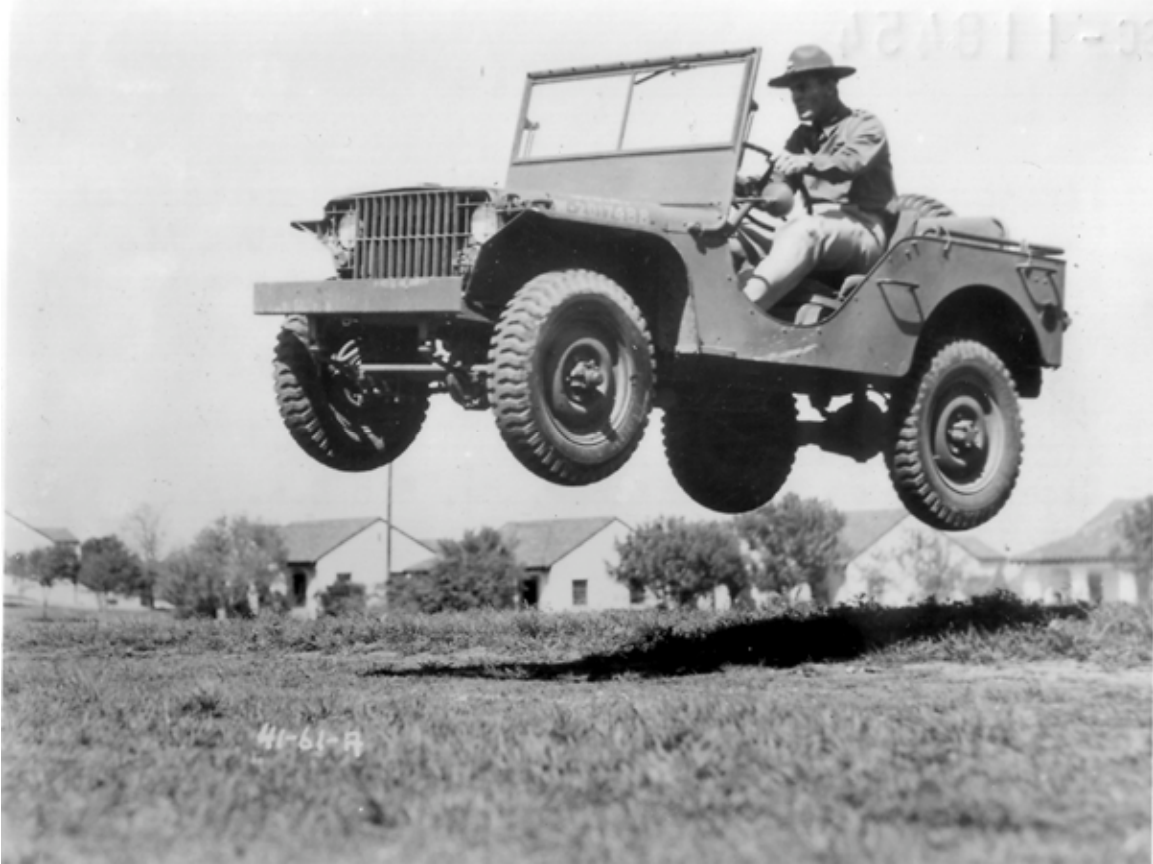
SC-118454: The new 1/4-ton truck in March 1941. (NARA, Signal Corps photo)

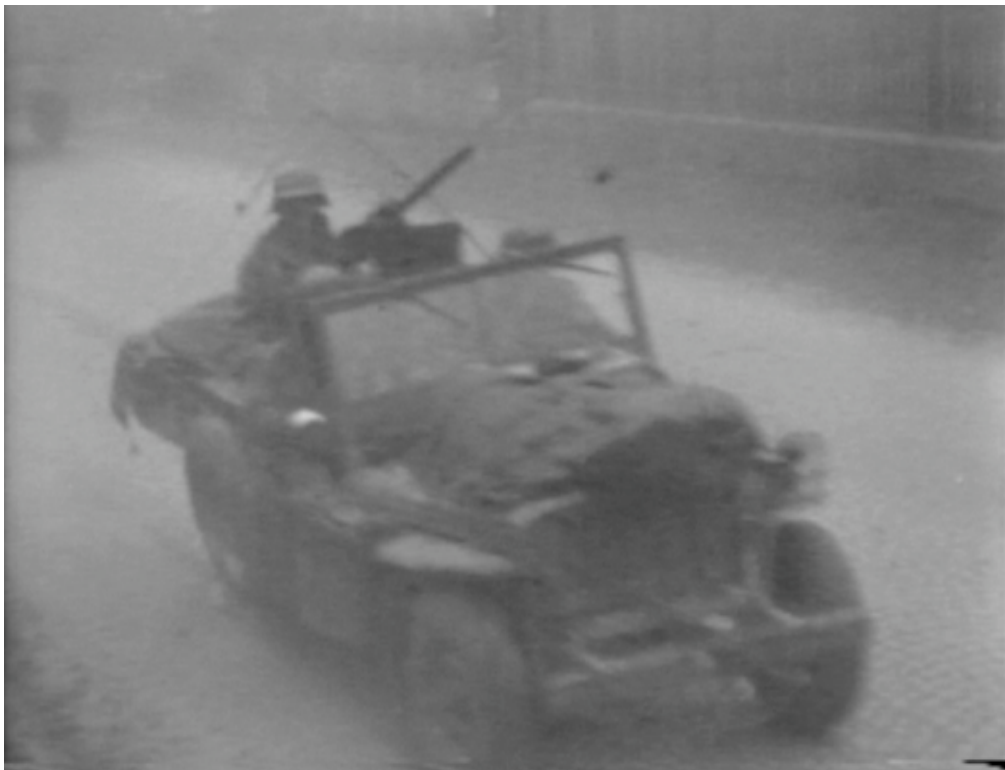
111-ADC-3802_1: An armored unit jeep fitted out for reconnaissance in early 1945 carries a pedestal-mounted .30-caliber machine gun. (NARA, Signal Corps film)

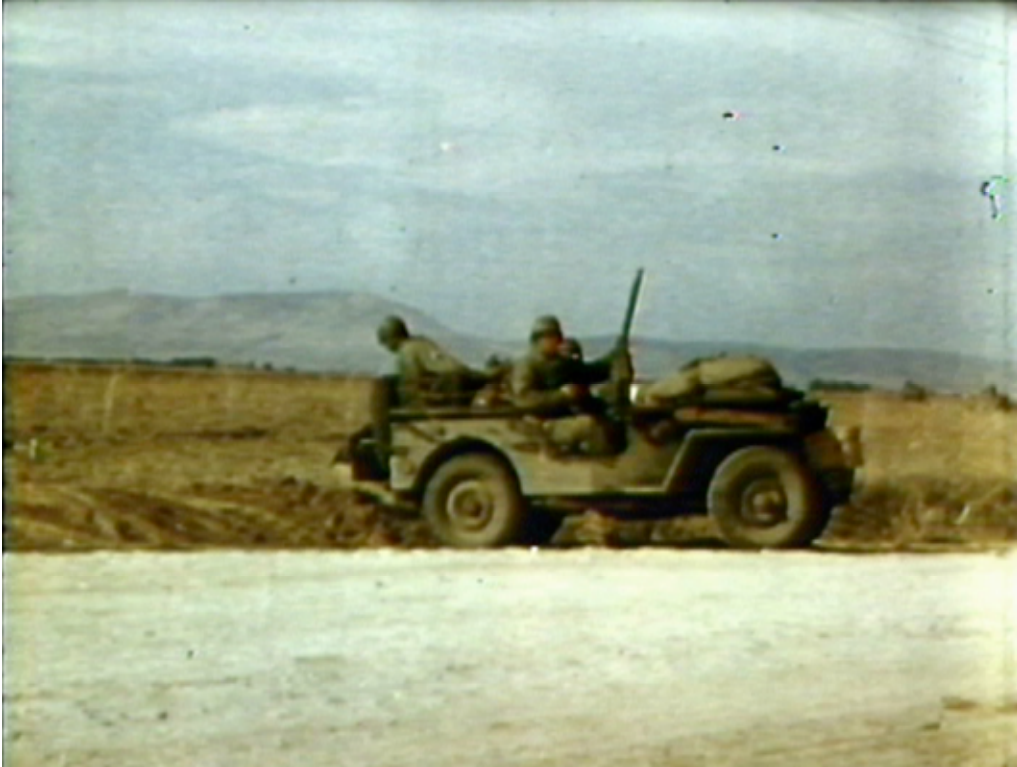
111-M-1001_17: A jeep, probably from the battalion headquarters of 2/13th Armored Regiment, in North Africa. The machine gun is mounted forward. (NARA, Signal Corps film) [color photo]

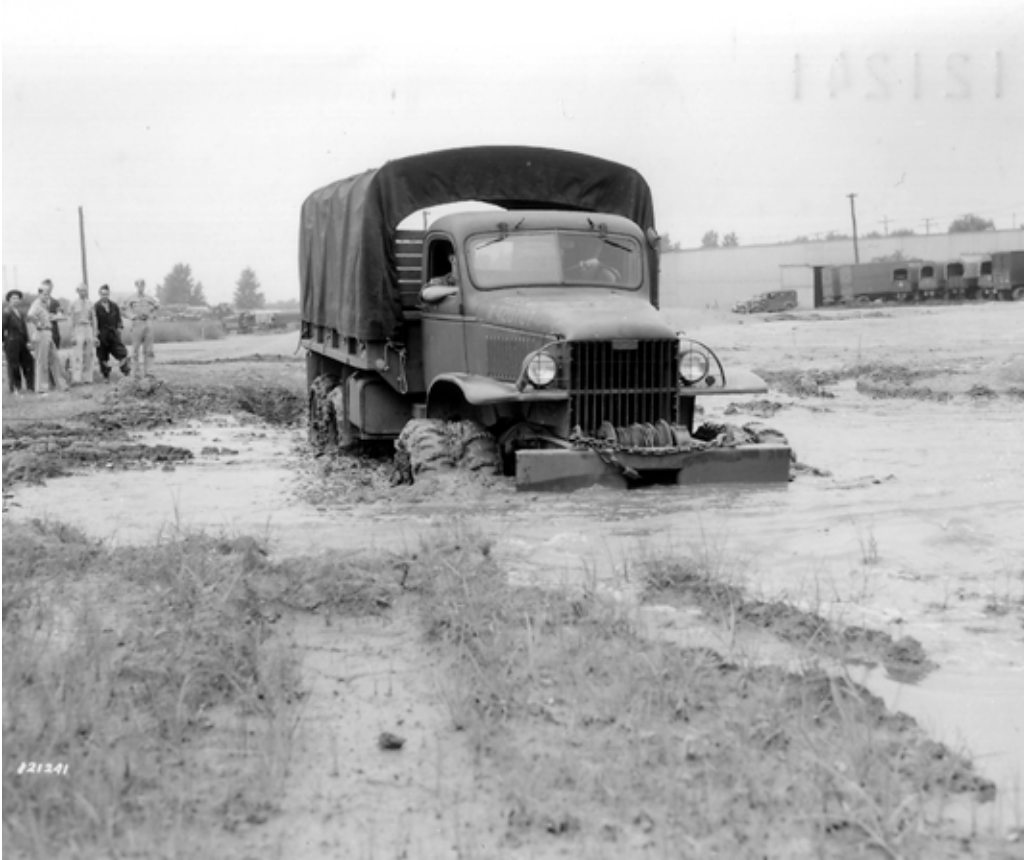
SC-121241: Testing the 2-1/2-ton truck at Aberdeen Proving Grounds in July 1941. (NARA, Signal Corps photo)

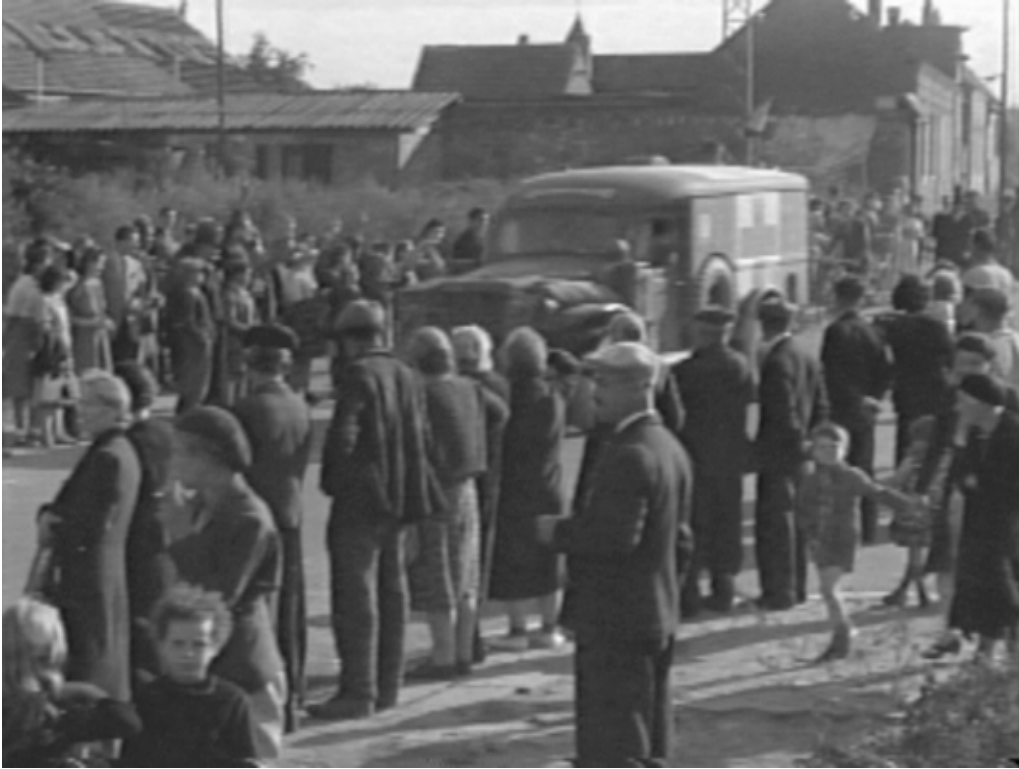
111-ADC-2278_2: A 2d Armored Division 3/4-ton ambulance on a road in France in September 1944. (NARA, Signal Corps photo)

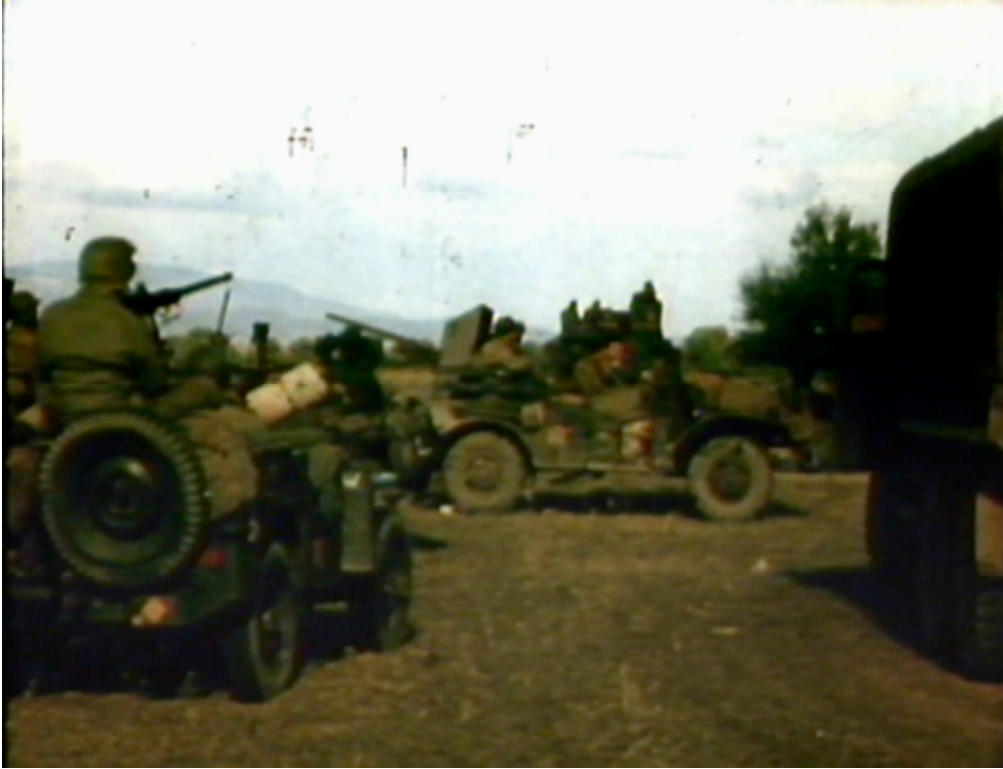
111-M-1001_4: A 3/4-ton weapon carrier mounting a 37mm gun (center), probably belonging to the battalion headquarters of 2/13th Armored Regiment in North Africa. A reconnaissance jeep is to the left, a deuce-and-a-half to the right, and an M3 medium tank behind the Dodge. (NARA, Signal Corps film) [color photo]

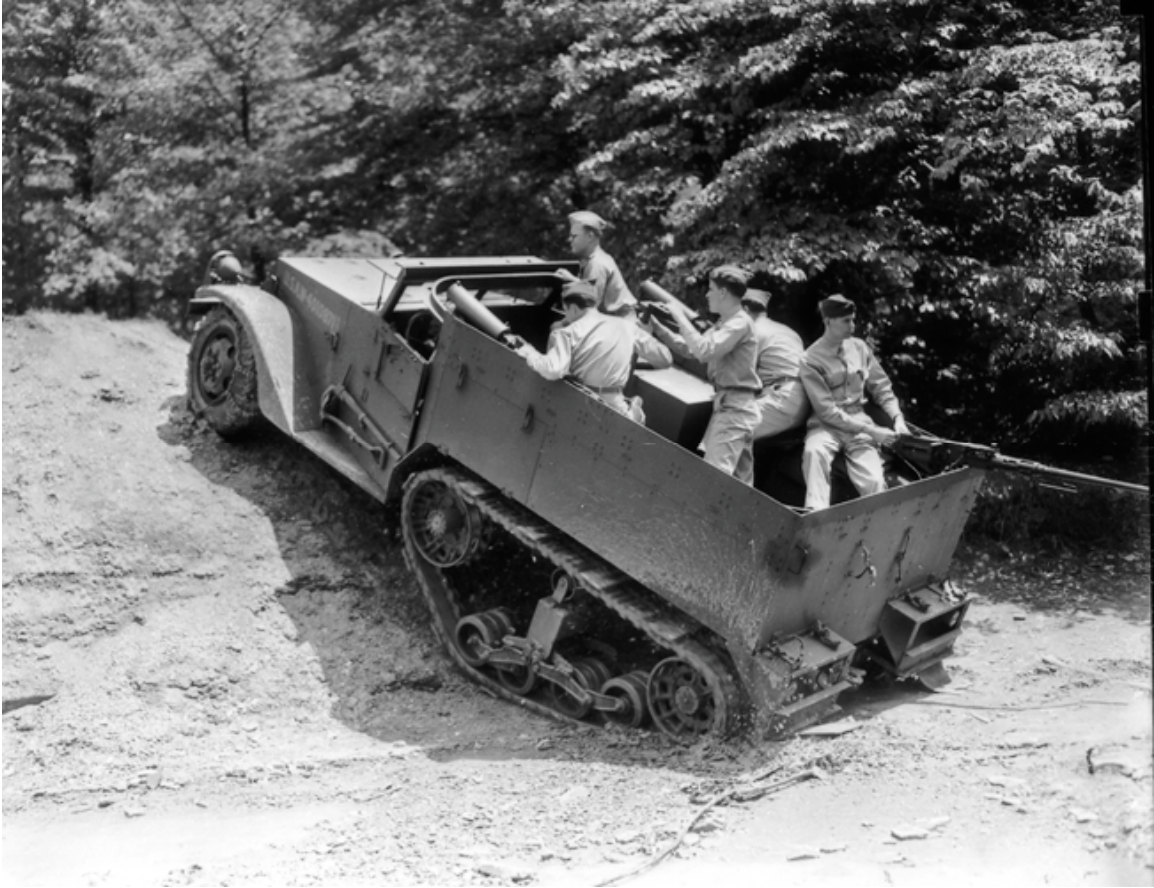
SC-120410: The M2 had a rail around the rear compartment to which several machine guns could be fixed, in this case one .50-caliber pointing to the rear and two water-cooled .30-calibers facing forward. (NARA, Signal Corps photo)

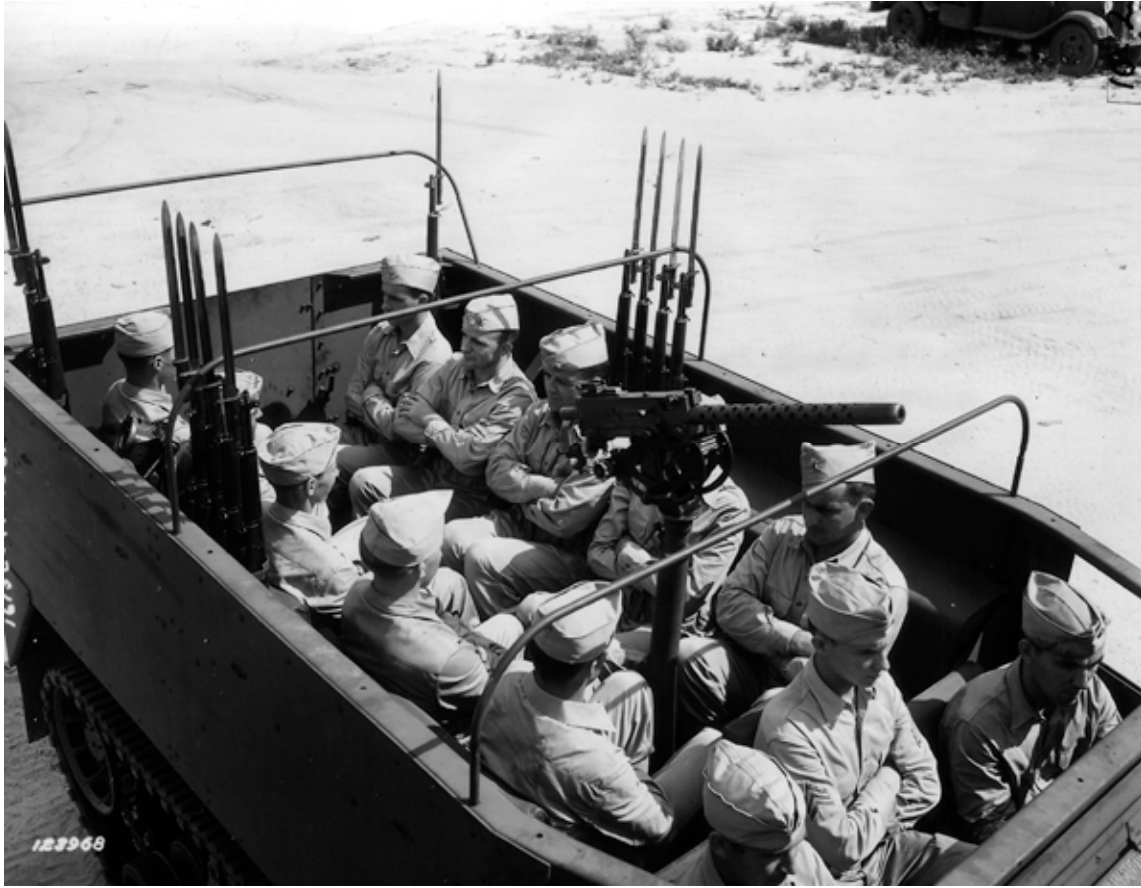
SC-123968: The M3 had a slightly longer rear compartment and a pedestal-mounted machine gun. (NARA, Signal Corps photo)

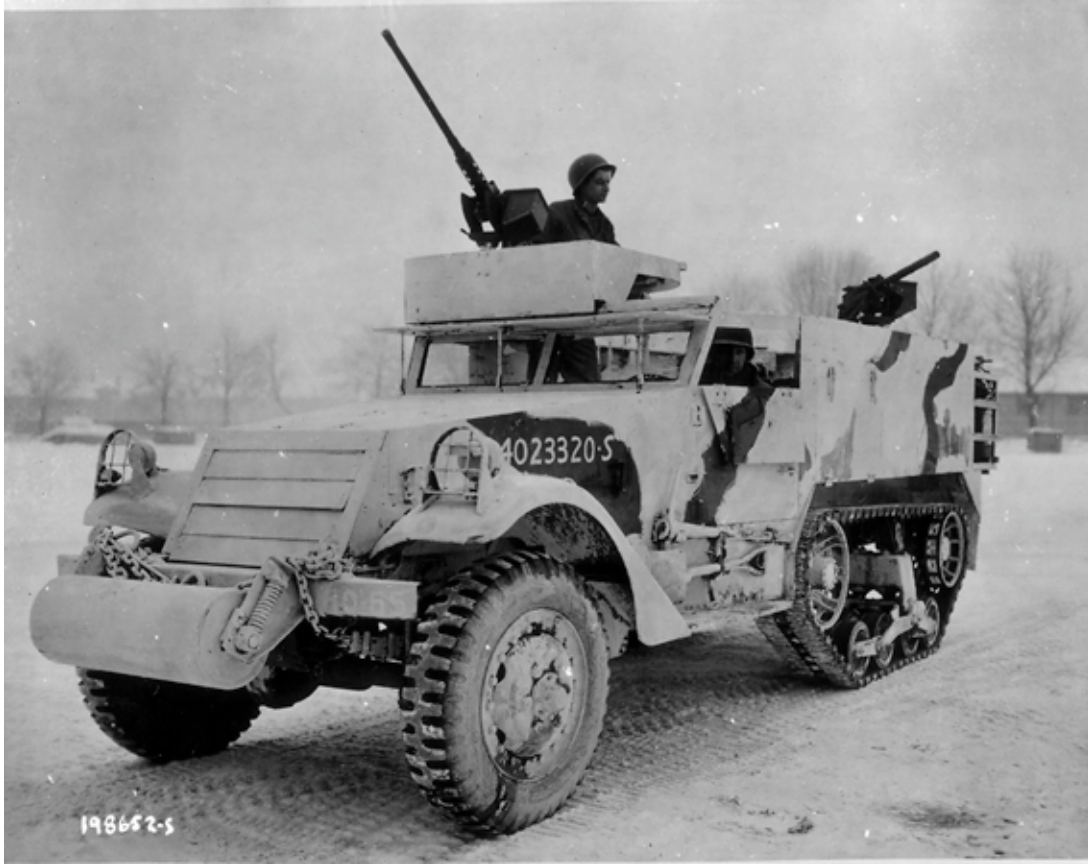
SC-198652-S: M2A1 and M3A1 halftracks added a ring mount for a .50-caliber machine gun. (NARA, Signal Corps photo)

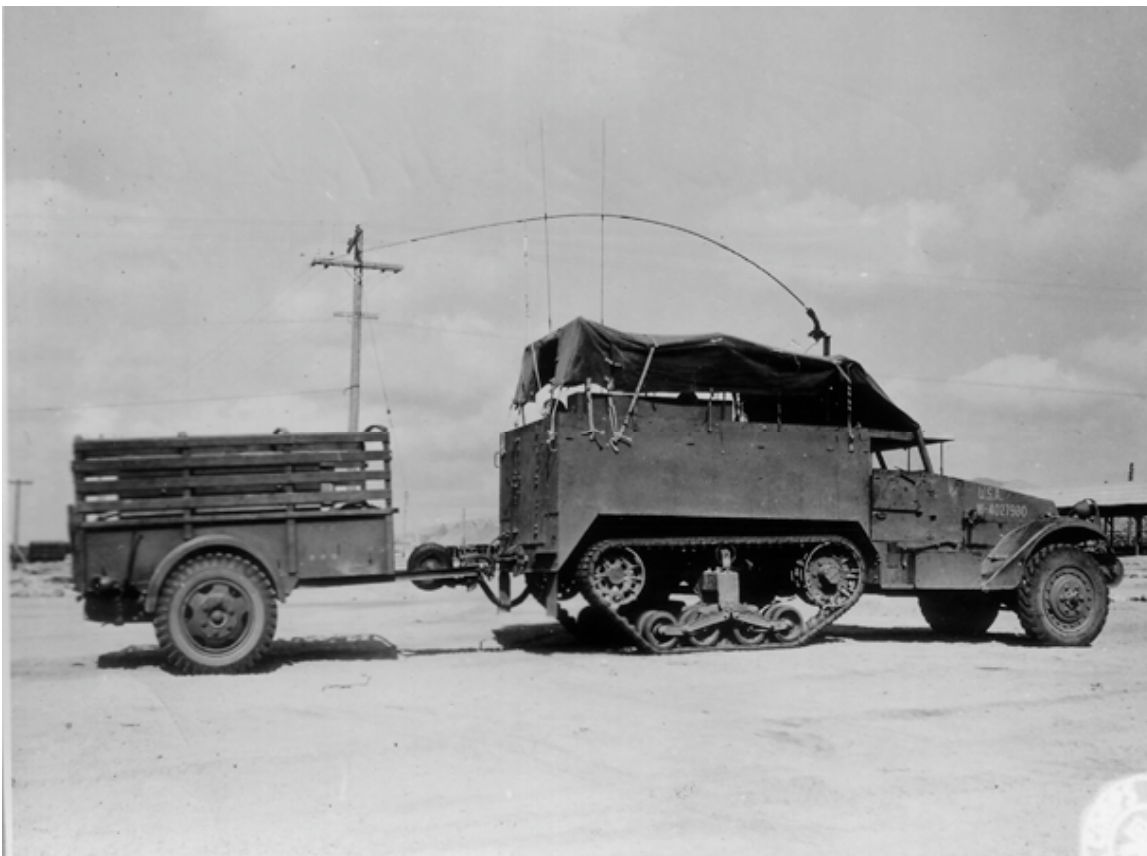
SC-239840: An M3 command halftrack at the Desert Training Center in November 1942. (NARA, Signal Corps photo)

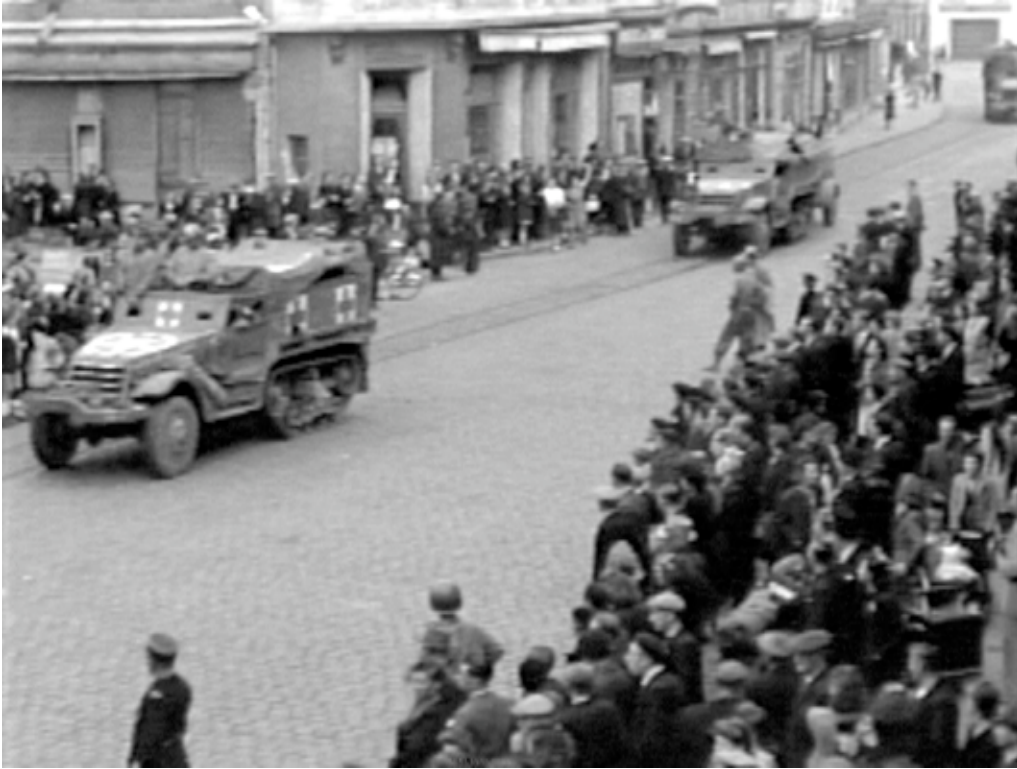
111-ADC-2278_1: A 2d Armored Division ambulance passes through St. Amand, France, on 2 September 1944. (NARA, Signal Corps film)

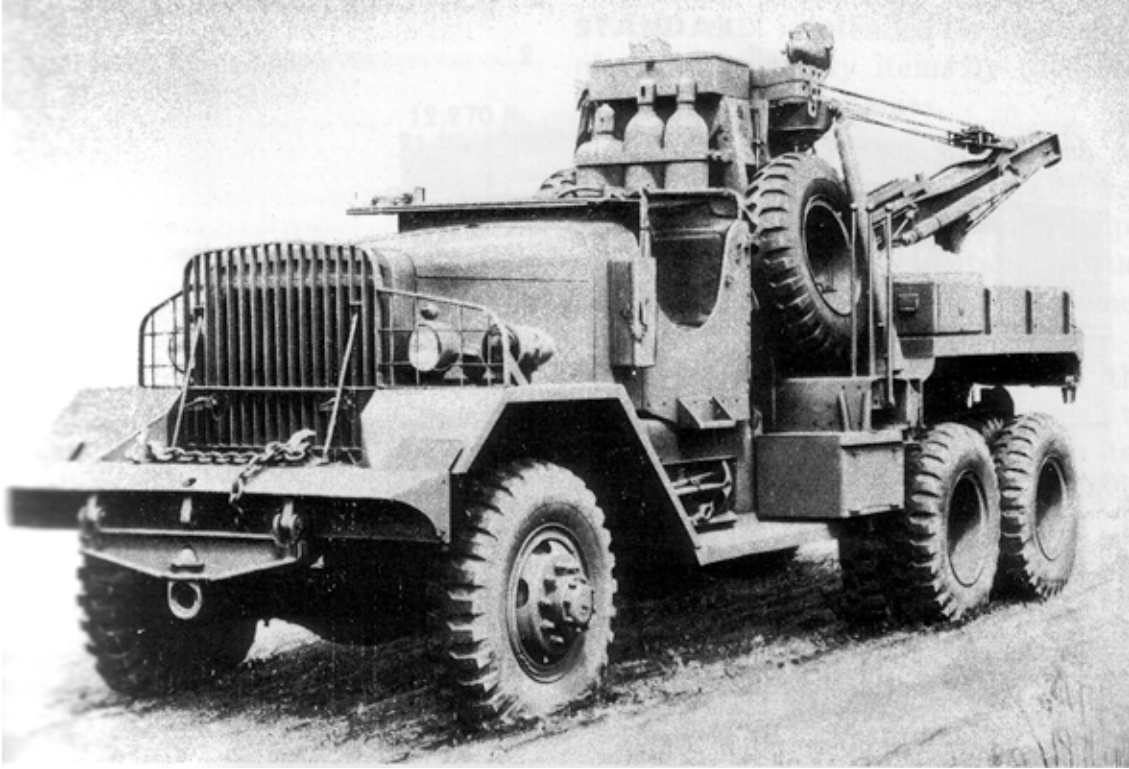
Army14: The M1 6x6 wrecker with winch was the first tank retriever. (U.S. Army photo)

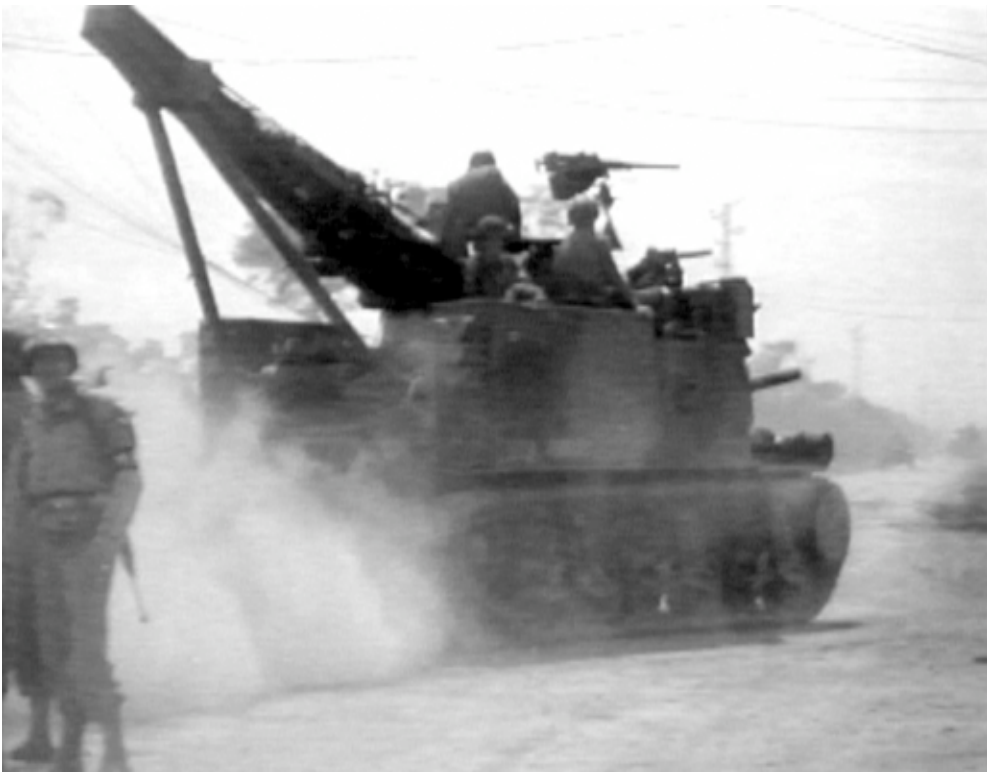
111-ADC-1677_2: A 2d Armored Division T2 advances during Operation Cobra in July 1944. Note the extra .50-caliber machine gun atop the turret and what appears to be a .30-caliber below and to the right of that. (NARA, Signal Corps photo)

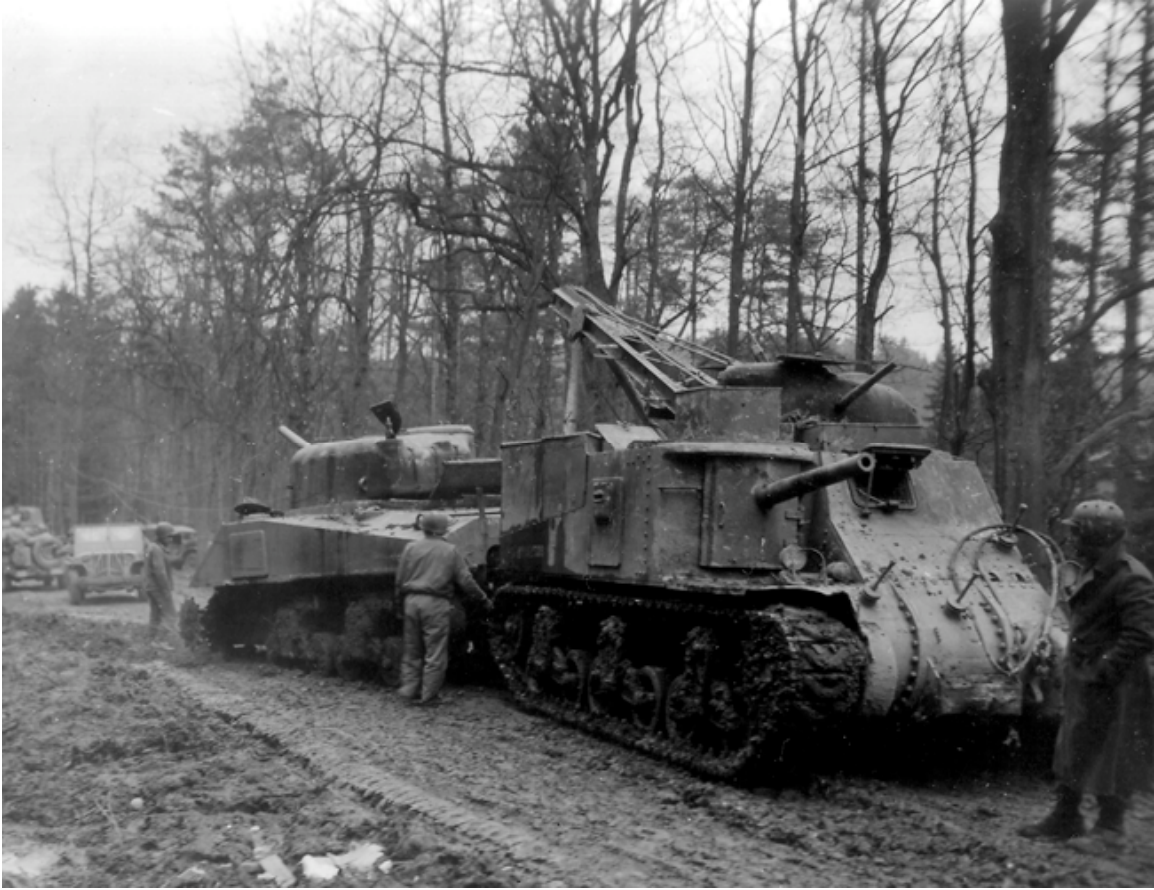
SC-197756: A T2 recovers a Sherman near Grosshau, Germany, in December 1944. Note the handle on the sponson door beside the fake 75mm gun. (NARA, Signal Corps photo)

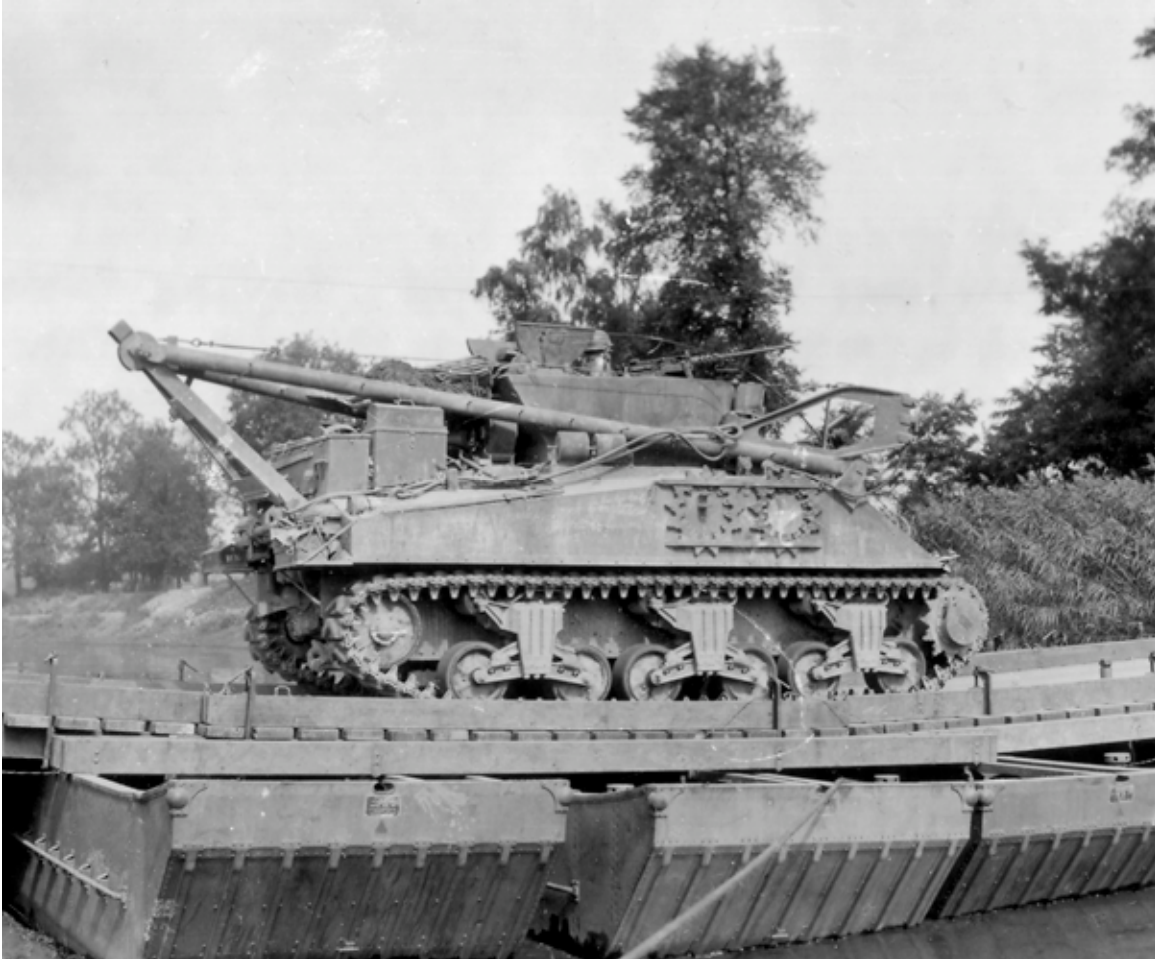
SC-194536: An M32 tank retriever in France in September 1944. (NARA, Signal Corps photo)

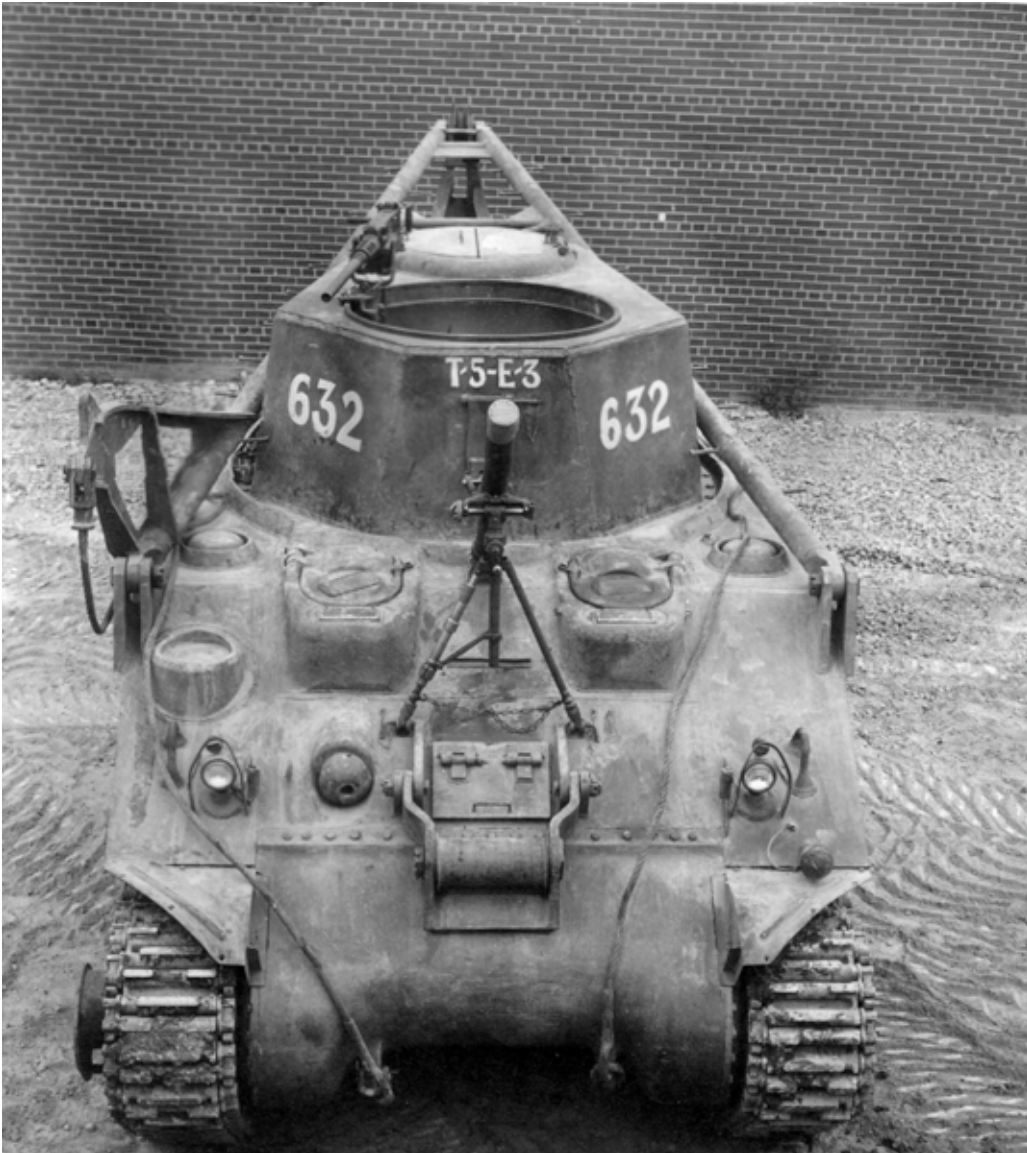
AFB5977: A tank recovery vehicle T5E3 (development vehicle for the M32) displays the 81mm mortar when mounted. (NARA, U.S. Army photo)

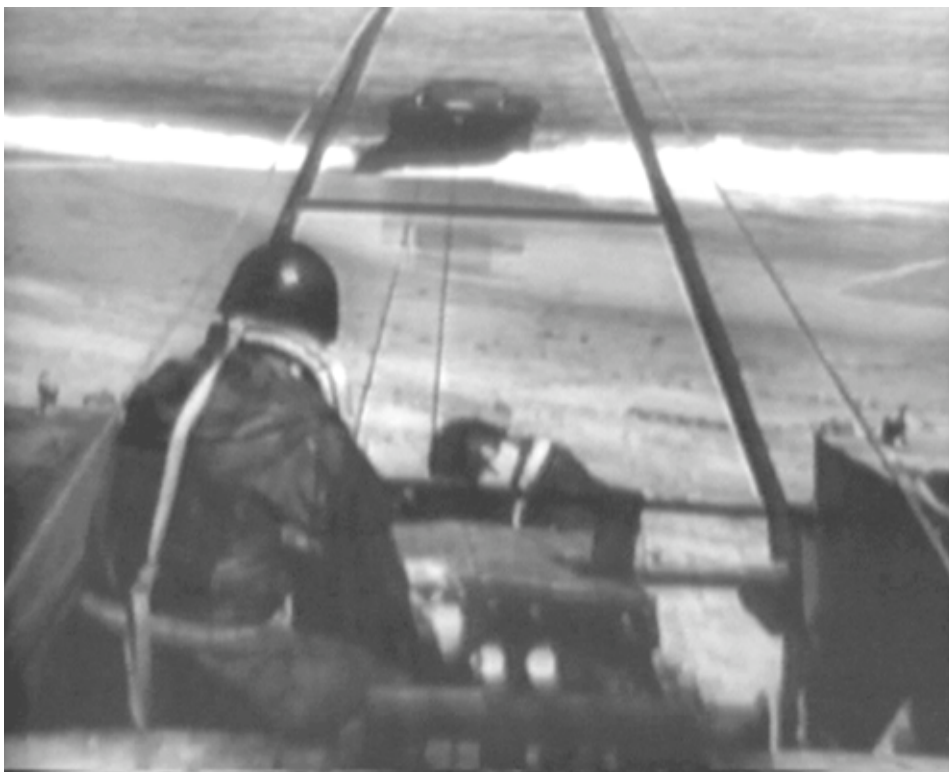
111-CB-60_5: The rear winch on an LVT retriever pulls a disabled amtrac from the surf. (NARA, U.S. Army film)

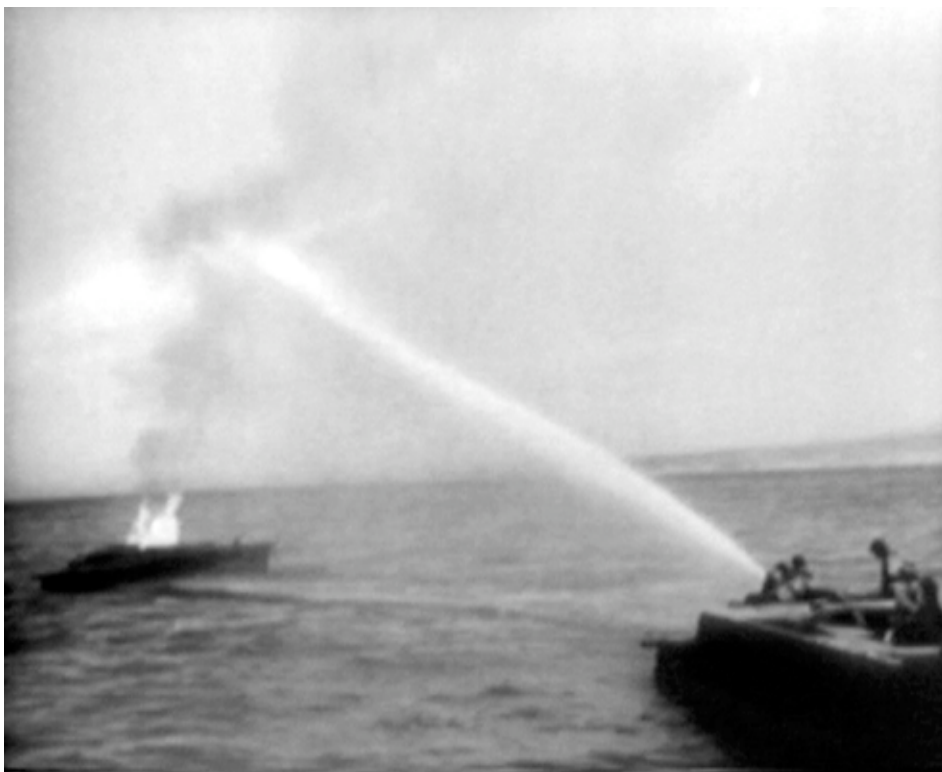
111-CB-60_5: An LVT retriever sprays down a burning amtrac.
(NARA, U.S. Army film)
